Outside Door Handle Cracks/Breaks

Model	Model Year	Model Type	VIN Range	Vehicle-Specific Equipment
Macan	2015-2019	95B	N/A	N/A

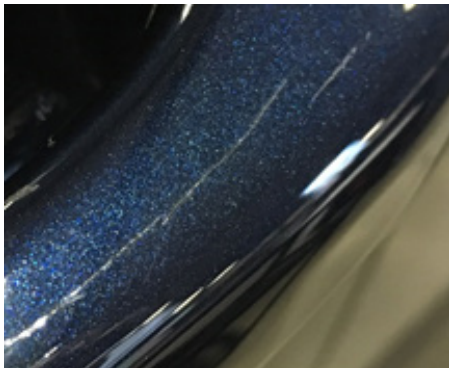
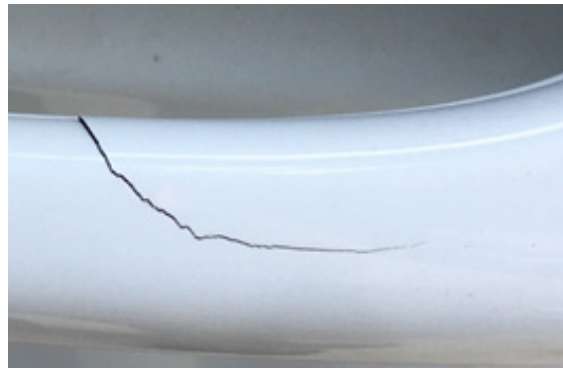
The outside door handle may crack and break. It initially looks like the paint is cracking, but will grow to larger size cracks.

A material incompatibility in the handle itself has been found to cause this issue.

The door handle should be replaced. All old parts have been removed from stock. New part numbers have a C index:

95B.837.205.C

95B.837.206.C
