Subject Clad Wheel Finish Peeling off/BubblingOff/Bubbling		Market USA
Service Category Suspension	Section Tire/Wheel	
Applicability 2014-2020 Highlander 2020 Sienna

2014-2020	Highlander	2020	Sienna
2014-2020	Highlander HV

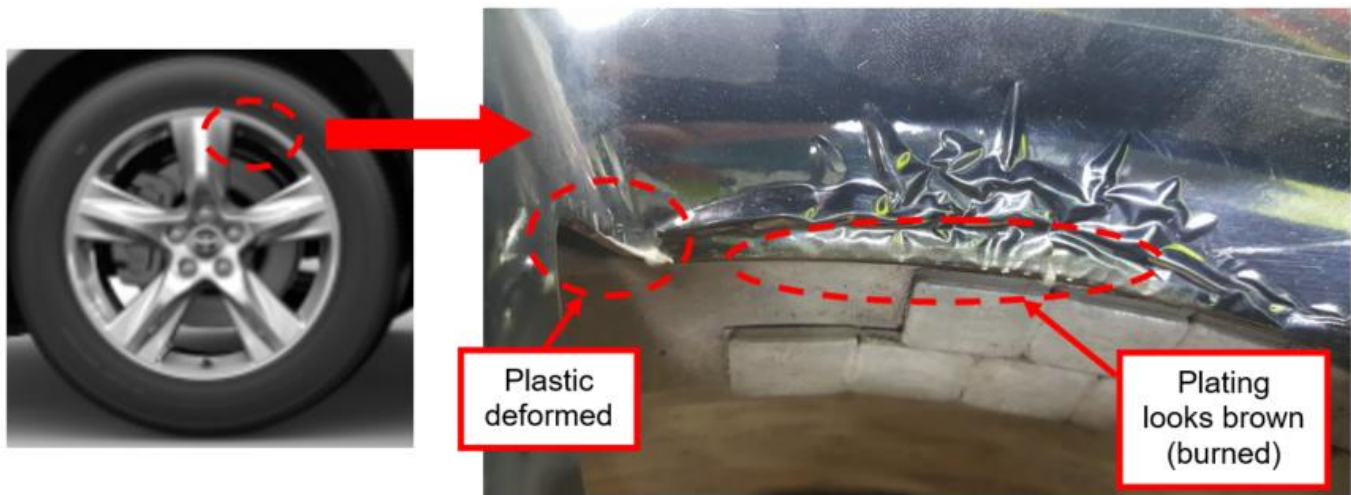
Some Highlander and Sienna clad/chrome wheels might experience bubbling and/or peeling off on the wheel coating (see picture below). Table below shows the wheel part numbers affected by the issue.

NOTE: Wheel blemishes caused by this process are non-warrantable

During stick-on wheel weight removal process, some technicians may utilize a heat gun to make weights flexible. The excessive heat from the heat gun causes the wheel coating to peel off and/or bubble. Do not utilize any heat tool to remove stick-on wheel weights.
