Fresh/Recirculation Servo Actuator Separation

Service Category Vehicle Interior

Section Heating/Air Conditioning

Some 2018 model year Camry and Camry Hybrid and 2019 model year Avalon and Avalon Hybrid vehicles may exhibit decreased front windshield defroster performance at extremely low ambient temperatures. This condition may be the result of the fresh/recirculation servo actuator separating from the servo. This condition does not affect the airflow of the defroster. Follow the Repair Procedure in this bulletin to address this condition.

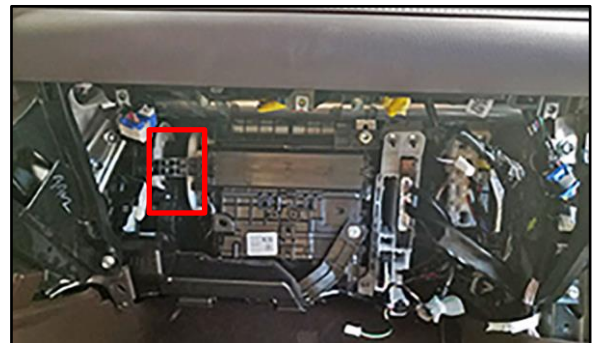
Figure 1. Actuator Installed

- [2019](#) Avalon HV:
Vehicle Interior – Interior Panels/Trim – “Interior Panels / Trim: Instrument Panel Safety Pad: Removal”
 - C. Check the fresh/recirculation servo motor actuator.
 Is the actuator separated from the blower assembly?

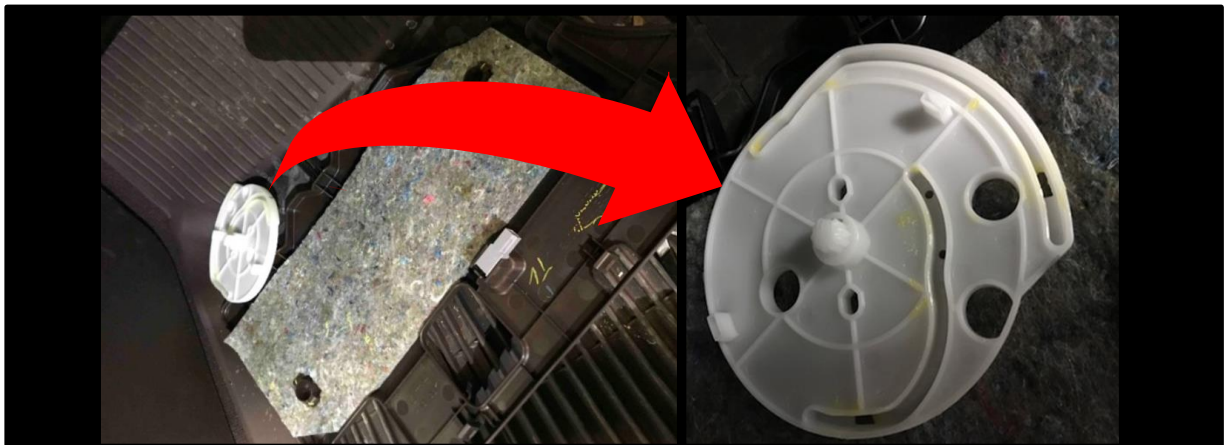
Figure 2.

2. Check for the servo motor actuator on the passenger kick plate or in the passenger side foot well.
Is the servo motor actuator present?
 - **YES** — Continue to step 3.
 - **NO** — Go to step 4.
