JTB00578NAS3 TECHNICAL BULLETIN 20 FEB 2019

501-14: Handles, Locks, Latches and Entry Systems

Keyless Entry System Lock Function May Not Operate and/or Operates Intermittently

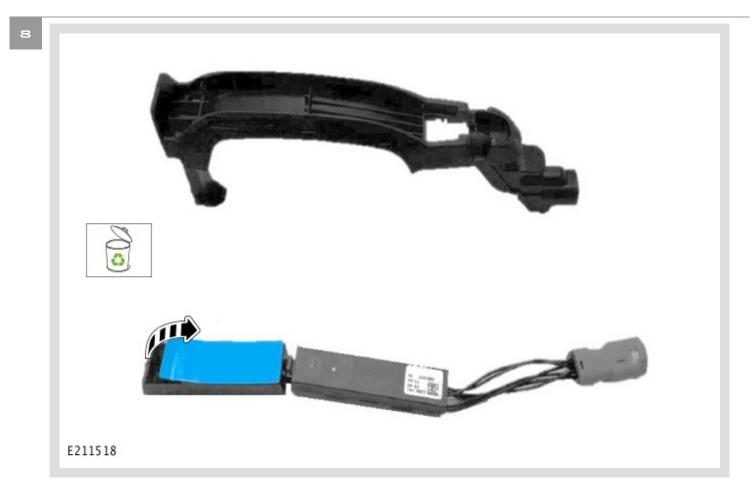
Prepare the door exterior handle strap inner and electronic module for assembly.

Remove the yellow backing from the tape on the electronic unit.

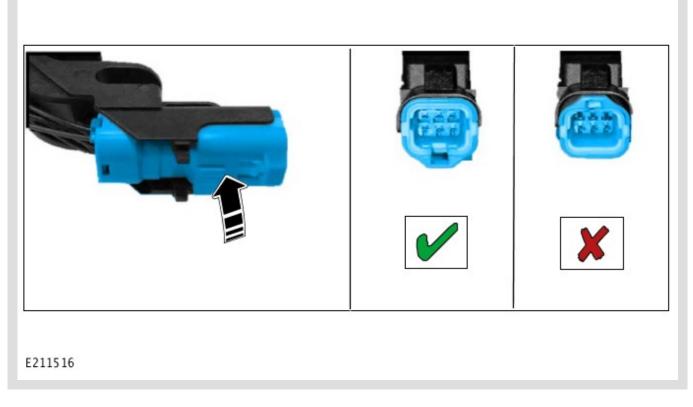
Clip the electrical connector into the handle strap inner (\checkmark).

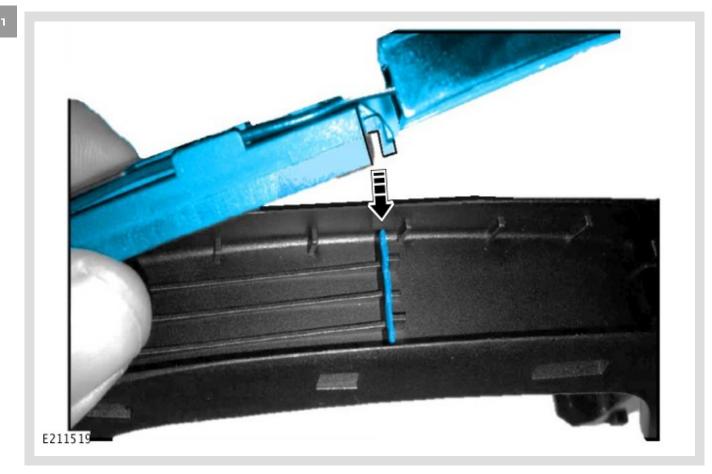
Install the antenna and electronic unit into the handle strap inner; align the clip with the handle strap inner rib.

Firmly press the electronic unit onto the handle strap inner; make sure the self adhesive tape makes good contact.

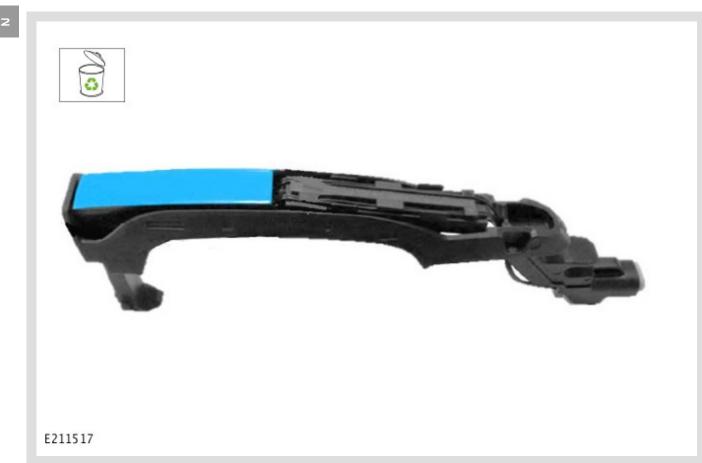
Remove and discard the white tape from the electronic unit.
