Latest Vehicle Concern Fixes

Incorrect Function of Climate Seat Control from Touchscreen	I-PACE 19MY
<p>Customer Voice:</p> <ul style="list-style-type: none">A customer may express a concern that after selection of the seat squad icon on the Touchscreen, the function turns on, then off again. <p>Technical Description:</p> <ul style="list-style-type: none">This may be caused by a Car Configuration File (CCF) error. <p>Status:</p> <ul style="list-style-type: none">TSB JTB00681NAS1 will be published to address this issue, should a customer express a concern please refer to this TSB.

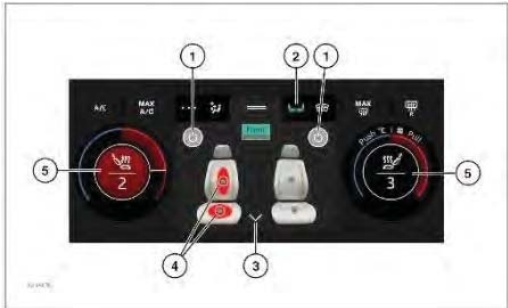
<p>The diagram shows the climate control panel with five numbered callouts: 1 points to the fan speed control, 2 points to the front passenger seat heater control, 3 points to the front driver seat heater control, 4 points to the rear seat heater control, and 5 points to the temperature control dials.</p>
