Rear air suspension- Dust cover loose on SPA

<b>REF NO:</b> TJ 30517.5.0	<b>ISSUING DEPARTMENT:</b> Technical Service	<b>CAR MARKET:</b> United States and Canada	
<b>PARTNER:</b> 3 US 7510 Volvo Car USA		<b>ISSUE DATE:</b> 2019-02-11	<b>STATUS DATE:</b> 2019-02-14
<b>FUNC GROUP:</b> 7261	<b>FUNC DESC:</b> Cylinder; bellows	Page 1 of 18

TJ Instruction VCC-488219-1

TJ Instruction VCC-488219-2

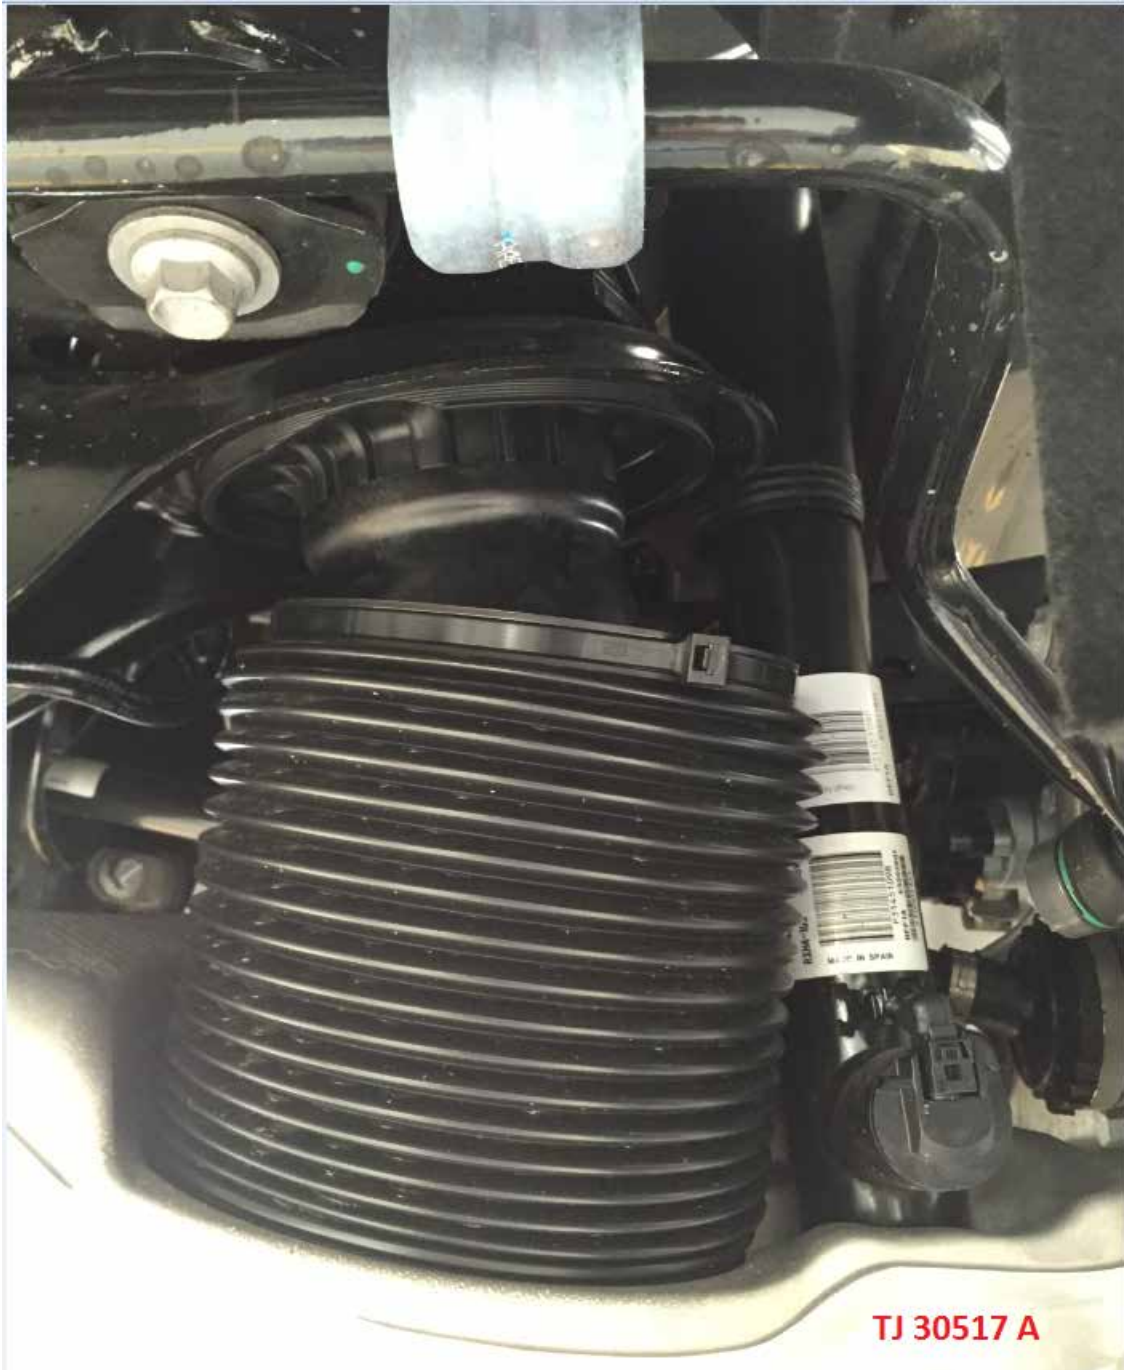
If the dust cover is loose from the top of the rear air suspension- see picture TJ 30517 A.PNG. Follow advice under service.

If a car comes in with a loose dust cover, replace complete air spring according to VIDA.

If the dust cover on the other side is not loose and has a plastic tie strap (black or white), update the plastic tie strap on the air spring with a new metal tie strap according to attached instruction

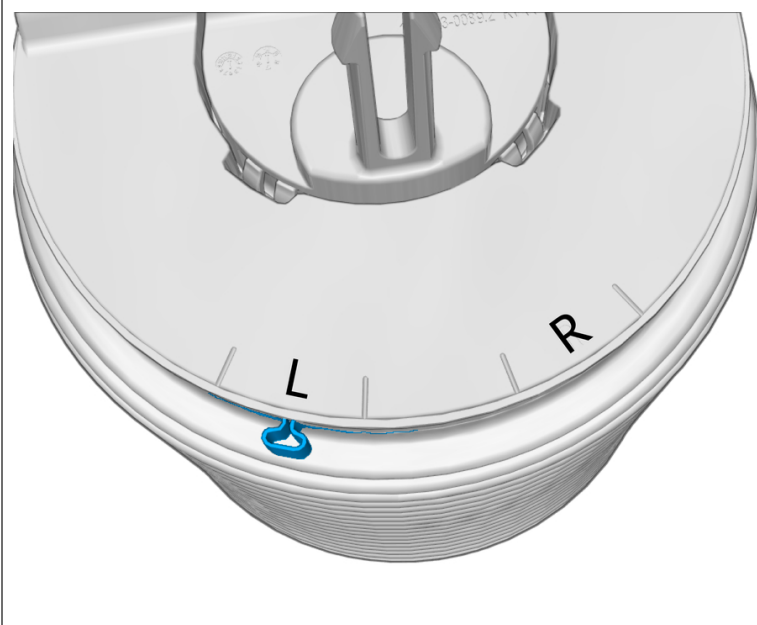
Applies to the left-hand side:

**Caution! Make sure that the component is positioned correctly.**

Tighten the cable tie.

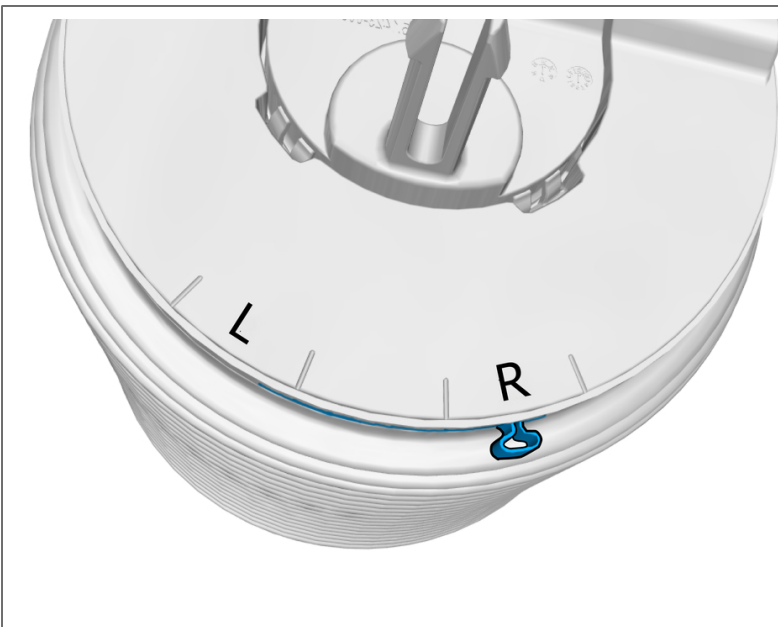
Applies to the right-hand side

On both sides.

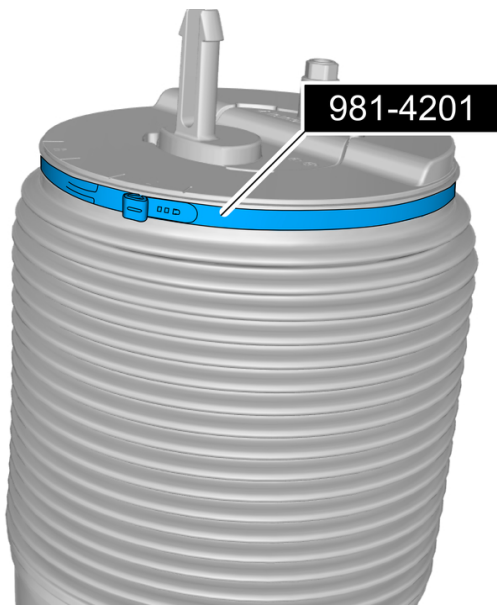
**Note! Make sure that a new clamp is installed.**

Install the marked component.

Special Tool: T9814201, Lock grip pliers

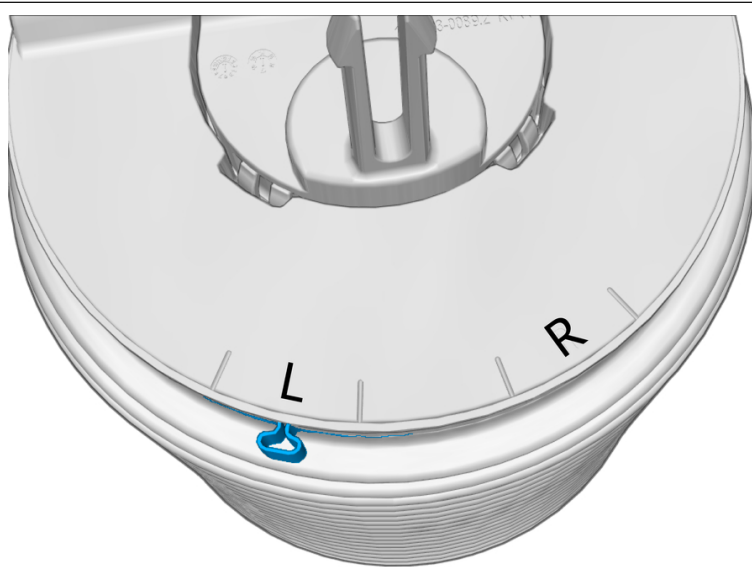
Applies to the left-hand side:

**Caution! Make sure that the component is positioned correctly.**

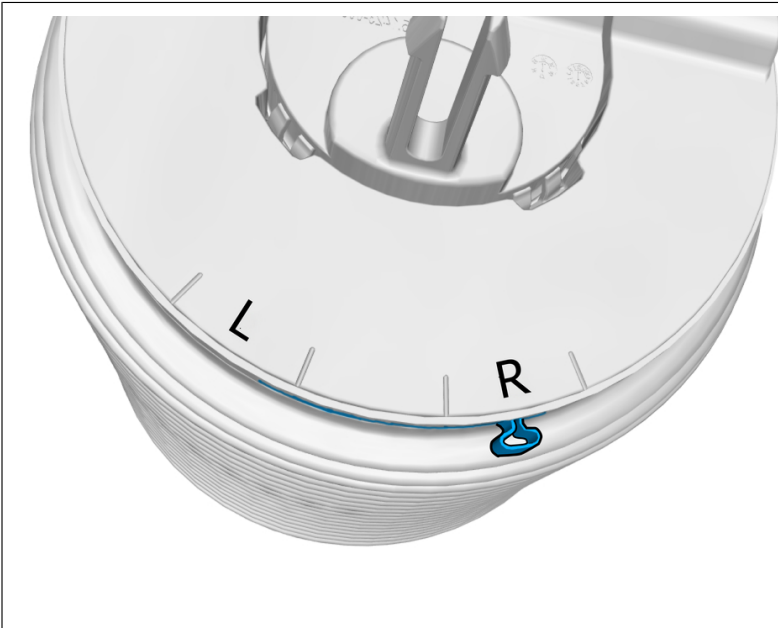
Applies to the right-hand side

**Caution! Make sure that the component is positioned correctly.**

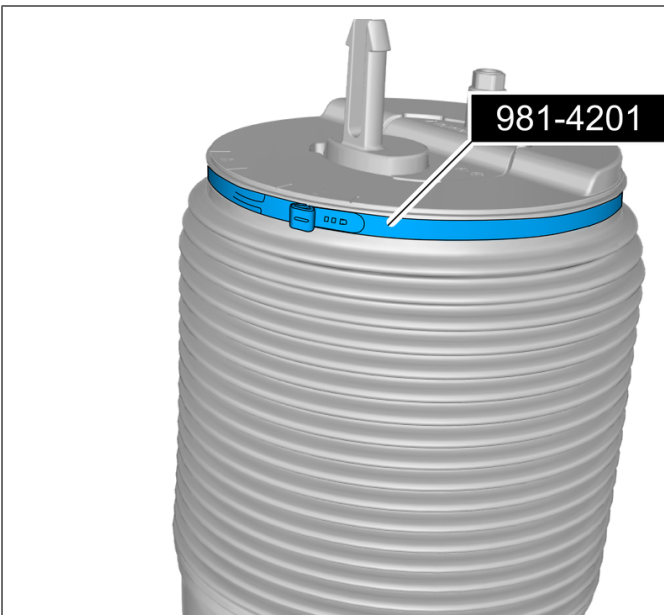
On both sides.

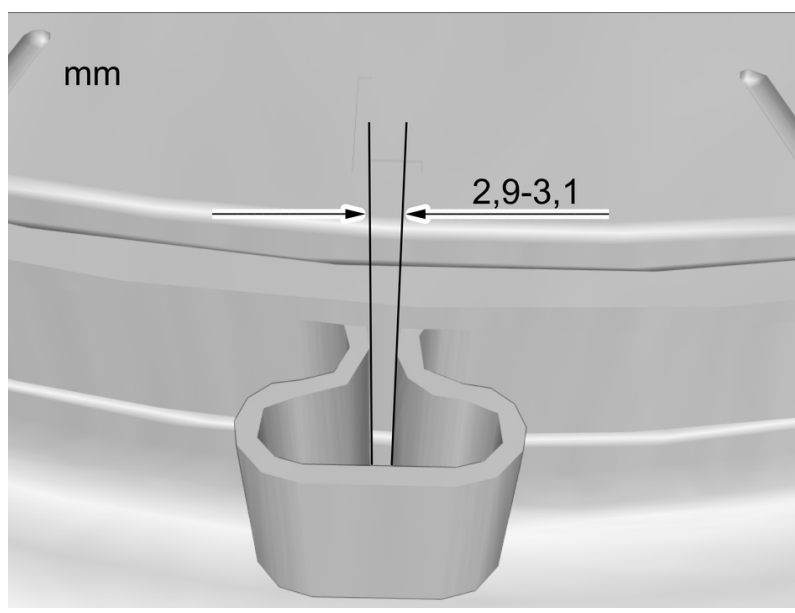
**Note! Make sure that a new clamp is installed.**

Install the marked component.

Special Tool: T9814201, Lock grip pliers

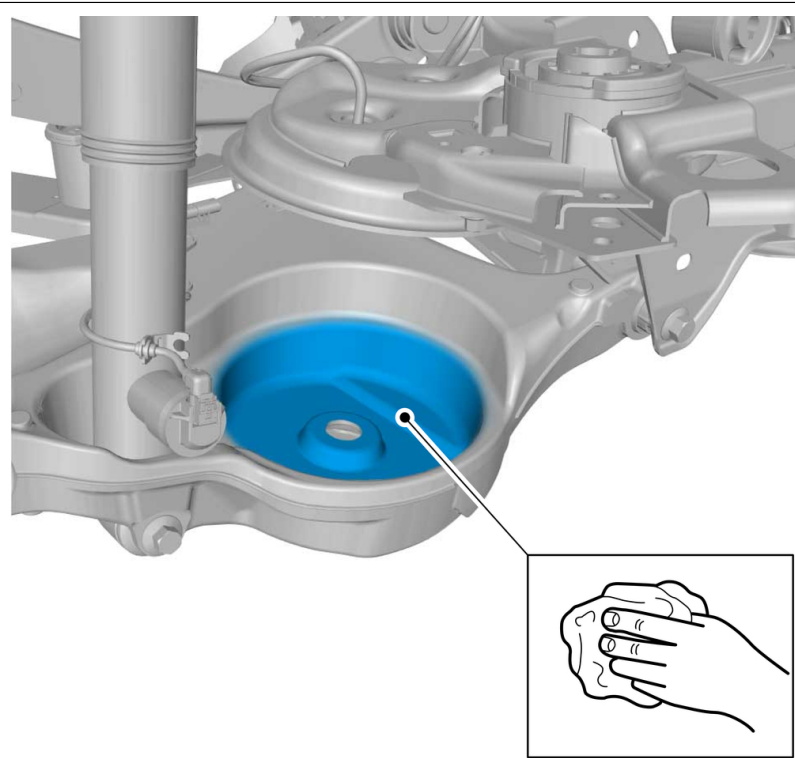
**Caution! Make sure the component is fitted as illustrated.**
