Technical Service Bulletin

50E6 UPDATE – Vehicle Emissions Control Information Label (FED_EMS)

March 12, 2019

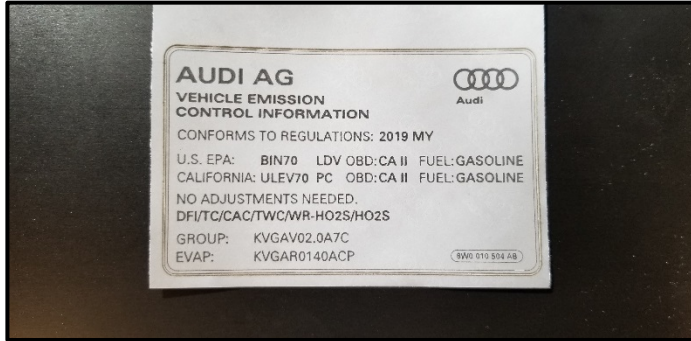
- Open hood.
- Locate the Vehicle Emissions Control Information Label.
- Clean the Vehicle Emissions Control Information Label and surrounding area as necessary to remove any dirt or debris.
- Remove the paper backing from the new label, align new the label on top of the old label, and apply the new label to the vehicle.

- Ensure minimal air bubbles are created when installing the new label.

- The surface of the existing label must be clean, dry, and free from oil residue prior to applying the replacement label.
- The replacement label **MUST** cover the existing label completely.
- Handle the replacement label carefully. Do not touch the adhesive backing.
