Technical Service Bulletin

60 Panoramic sunroof noises

60 19 24 2054203/1 March 7, 2019.

Model(s)	Year	VIN Range	Vehicle-Specific Equipment
Q7	2017	All	Not Applicable
Q7	2018	000001 - 044739	Not Applicable

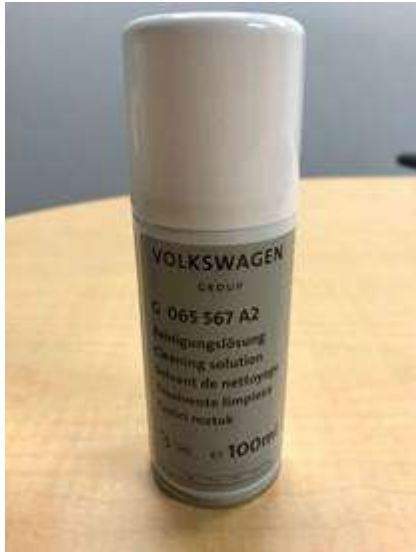
Figure 1. All purpose cleaner: **G 065 567 A2.**

The only maintenance materials approved for use on the sunroof frame are the cleaner and lubricant specified above. Alternative cleaners and lubricants used on this sunroof mechanism may cause permanent mechanical damage and worsen the level of noise from the sunroof mechanism.

If the sunroof mechanism has been lubricated with an unapproved lubricant it must be thoroughly cleaned off of the mechanism components using the cleaner G 065 567 A2 and lubricated with the approved lubricant G 060 567 A2.

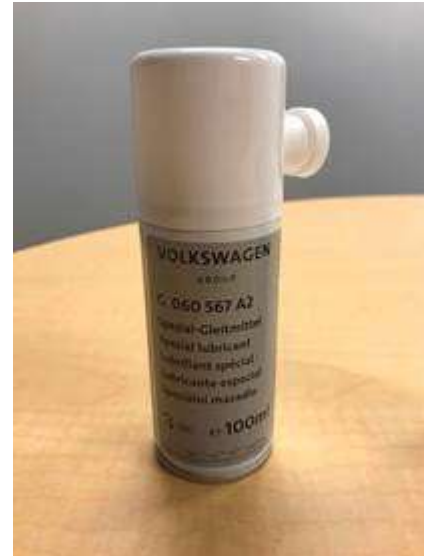
Figure 2. Special lubricant: **G 060 567 A2.**

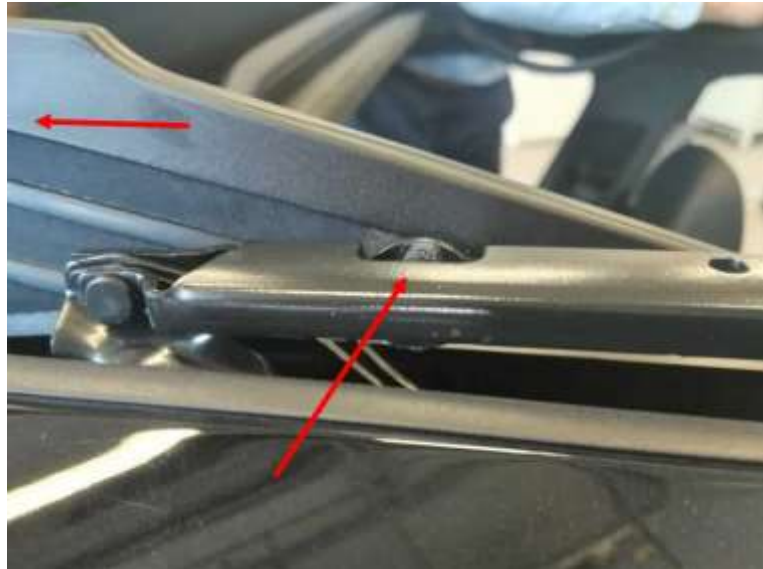
2. Figure 3 shows the left slide and tilt mechanism. The upper left arrow points to front of the vehicle. The lower arrow points to the first mounting point of the glass panel.

Figure 3. Left side of slide and tilt mechanism.

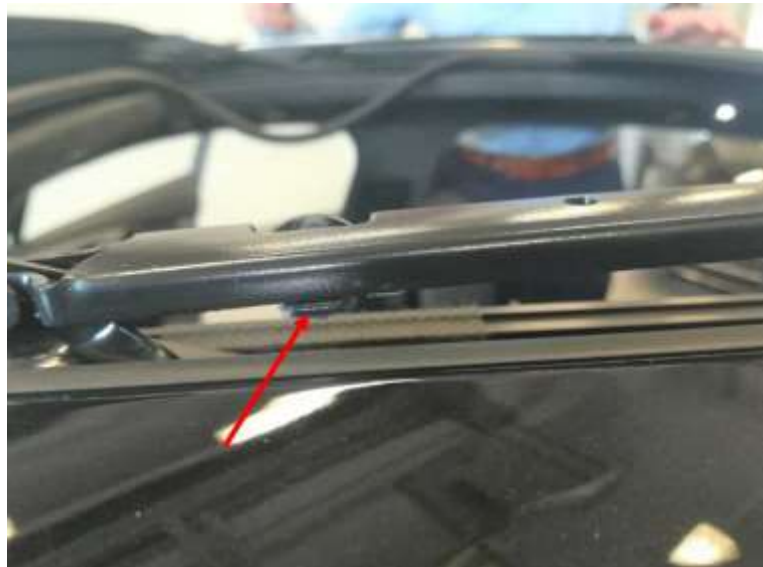
Figure 4. Lug to be lubricated on slide and tilt mechanism.

3. There is a lug under the first mounting point (Figure 4, red arrow). This point has to be lubricated with G 060 567 A2 lubricant.

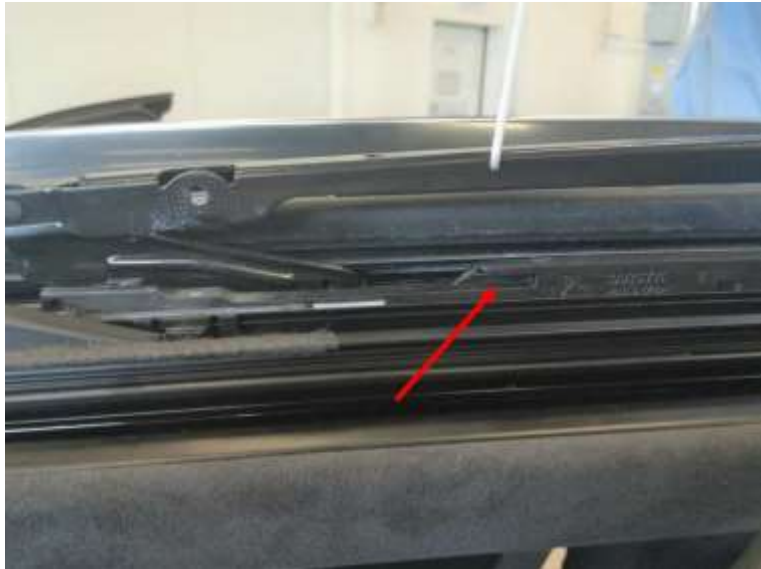
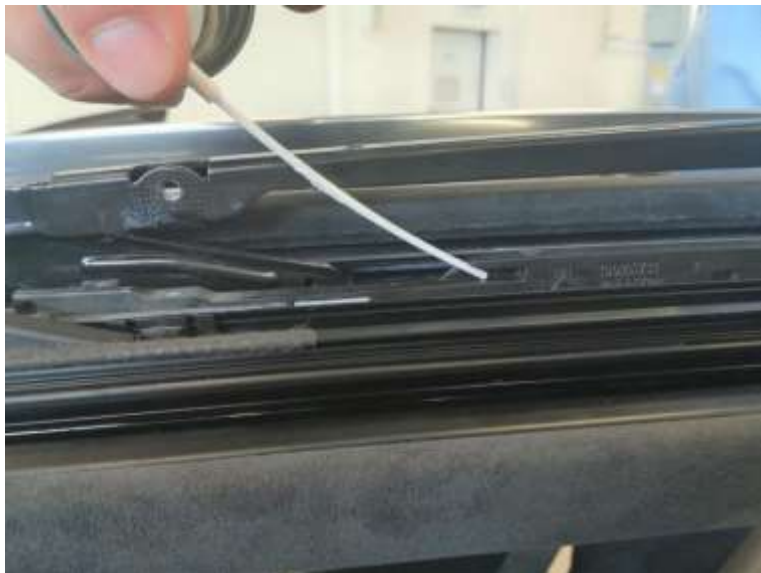
Figure 5. Groove in the slide and tilt mechanism.

6. Lubricating the groove in the slide and tilt mechanism.

4. Figure 5 and 6 shows the right slide and tilt mechanism from the inside. The groove indicated by the red arrow should be lubricated with G 060 567 A2 lubricant.

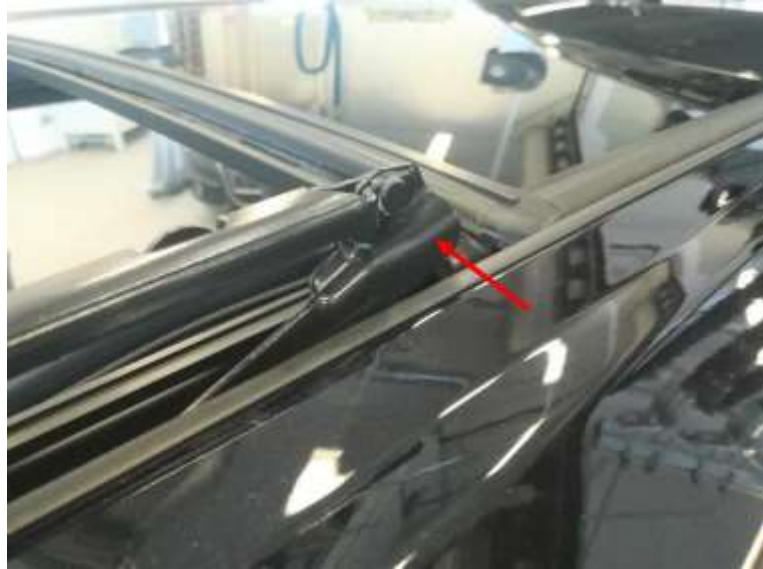
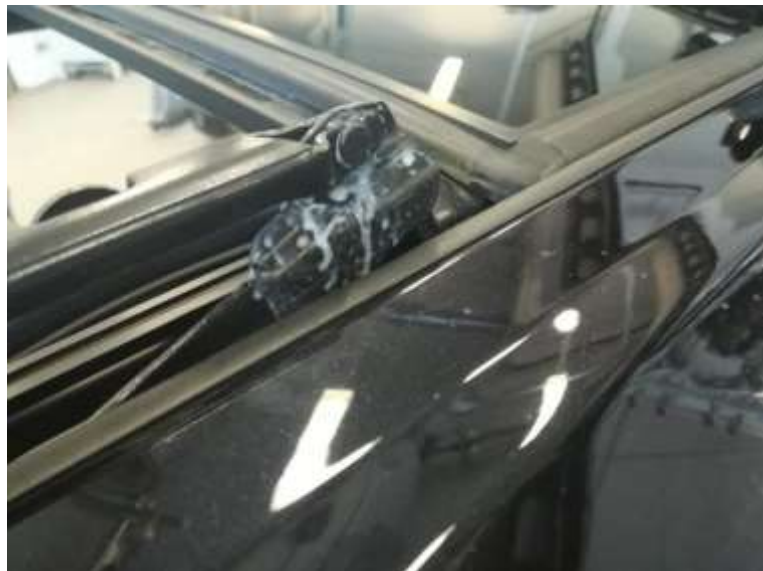
Figure 7. Section of slide and tilt mechanism to be lubricated.

Figure 8. Bracket after lubrication.

5. Figure 7 and 8 shows the rear section of the left side and tilt mechanism that must be lubricated with G 060 567 A2 lubricant. The outer area of this bracket will be lubricated (see red arrow).

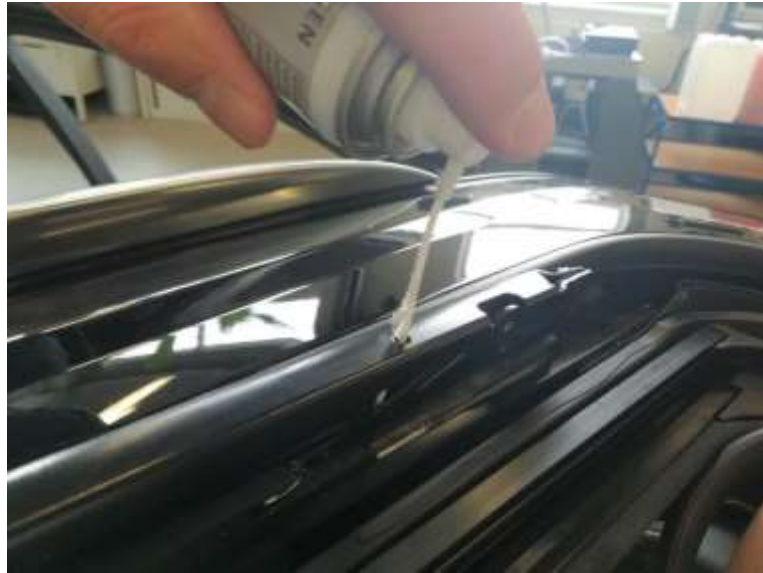
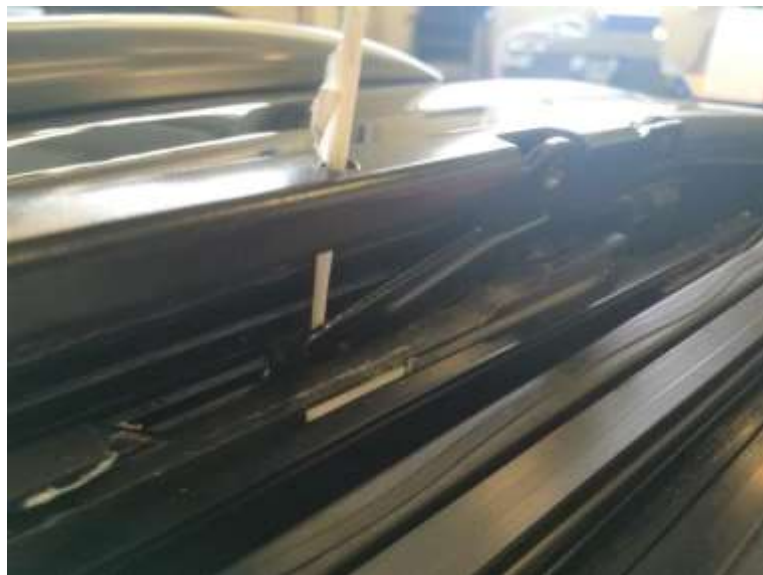
Figure 9. Accessing the channel through the arm of the slide and tilt mechanism.

Figure 10. Close up view of the lubrication of the channel under the arm of the slide and tilt mechanism.

6. Figure 9 and 10 shows the left front slide and tilt mechanism. The channel that must be lubricated can be accessed with the spray tube through the first hole in the arm as shown.

Perform this procedure to both sides of the sunroof slide and tilt mechanism.
