# Technical Service Bulletin

<b>Subject:</b> <b>REAR A/C VENT COVER LOOSE / DETACHED FROM CARPET</b>	<b>Bulletin No.:</b> 09-016/19
	<b>Last Issued:</b> 03/28/2019

2016-2018 CX-9 vehicles with VINs lower than JM3TC\*\*\*\*\*222848 (produced before Feb. 7, 2018).

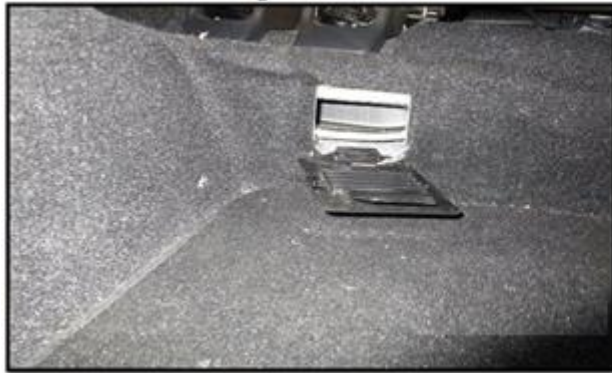
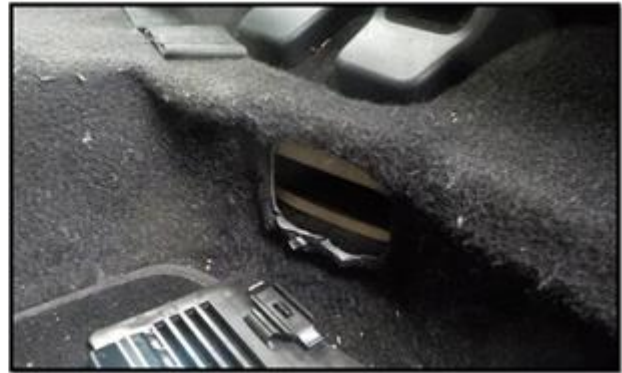
Some customers may notice the rear A/C vent cover is loose / detached from the carpet, which may also be torn or damaged. This concern may be caused when excessive force is applied to the A/C vent cover clip, resulting in a loose or dislodged vent cover. To eliminate this concern, the clip position and configuration of the rear A/C vent cover have been changed to improve its durability.

1. Verify the customer concern.
2. Replace the carpet with a modified one according to the instructions on MGSS online (FLOOR COVERING REMOVAL/INSTALLATION).

- New modified carpet includes new modified A/C vent covers (K131-68-6D1 02).
- If vent covers become loose or detached in the future, replace the vent covers separately.
- New modified vent covers are not compatible with old carpet. New modified vent covers are only compatible with new modified carpet.
- The selector lever component and bracket do not need to be removed.
