Service Action

Code: 19M4

Subject	Coolant Expansion Tank Tensioning Strap
Release Date	March 29, 2019
Affected Vehicles	U.S.A. & CANADA: Certain 2008-2015 MY Audi R8 Coupe <i>Check Campaigns/Actions screen in Elsa on the day of repair to verify that a VIN qualifies for repair under this action. Elsa is the <u>only</u> valid campaign inquiry & verification source.</i> <ul style="list-style-type: none">✓ Campaign status must show "open."✓ If Elsa shows other open action(s), inform your customer so that the work can also be completed at the same time the vehicle is in the workshop for this campaign.
Problem Description	In certain vehicles, the coolant expansion tank may develop cracks over time.
Corrective Action	Install an additional tensioning strap to the coolant expansion tank.
Parts Information	Dealers will be sent an initial allocation prior to customer notification. Parts will be managed with a weekly Upper Order Limit. Please see Parts On Command (POC) for your Upper Order Limit quantity.

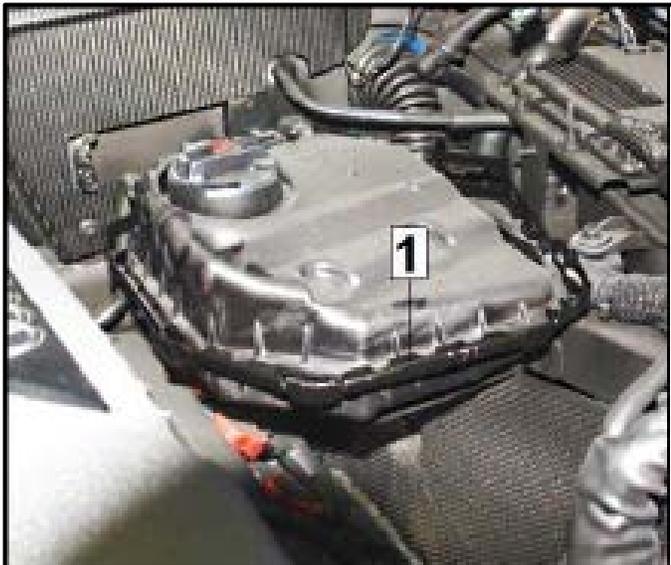
- Install tensioning strap <1> on the coolant expansion tank.

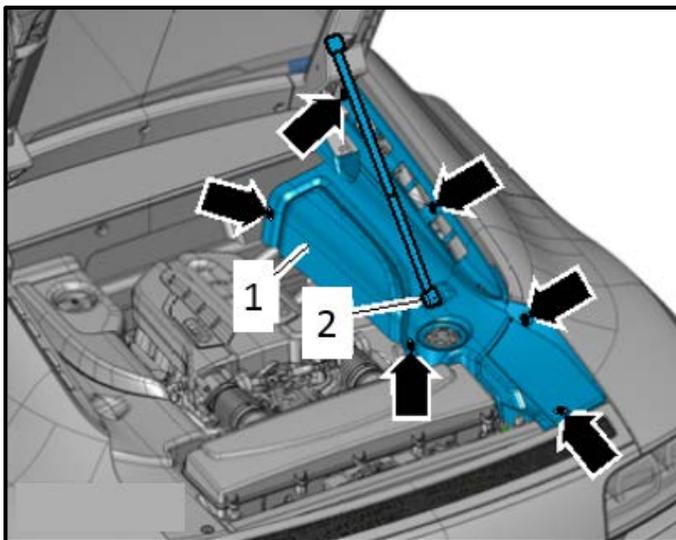
Remove the right engine compartment trim <1>:

- Loosen the quick-release fasteners <arrows>.
- If equipped: Disconnect the connector for the engine compartment lamp.
- Support the rear lid or secure it from falling.
- Disconnect the bottom of the rear lid strut <2>.
- Raise the back of the engine compartment trim <1> and guide the front of it out at the lid hinge.
- Reinstall the bottom of the rear lid strut.

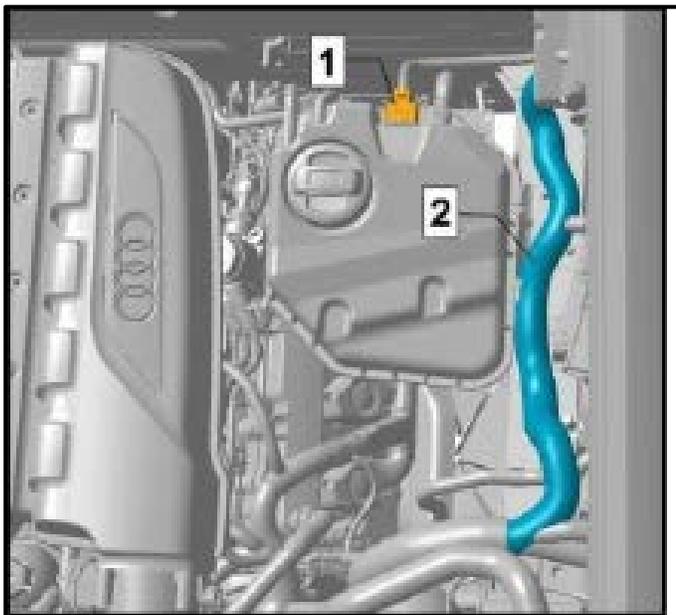
Prepare for tensioning strap installation:

- Disconnect electrical connector <1>.
- Unclip wiring harness <2> using -80-200- and push to the side.

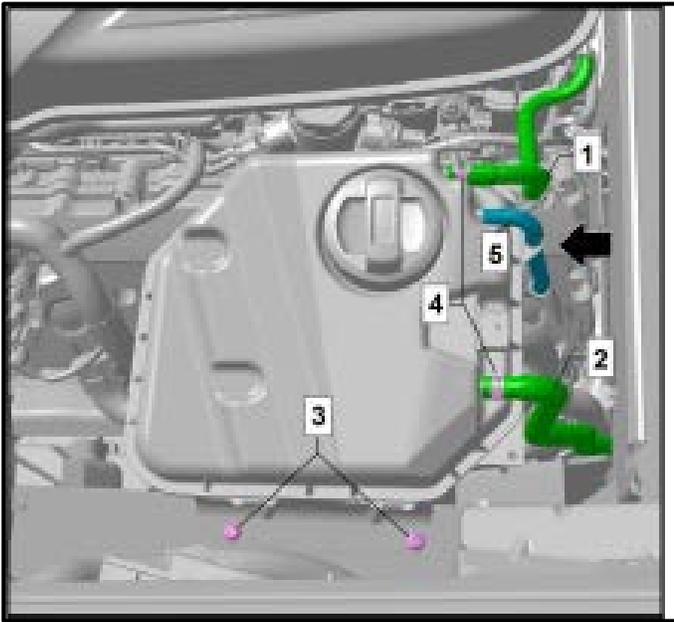
Remove hoses from coolant expansion tank:

- Open spring-type clips <4>.
- Disconnect coolant hoses <1 and 2> from coolant expansion tank.
- Pull overflow hose <5> out of retainer <arrow> on coolant expansion tank.
- Remove bolts <3>.

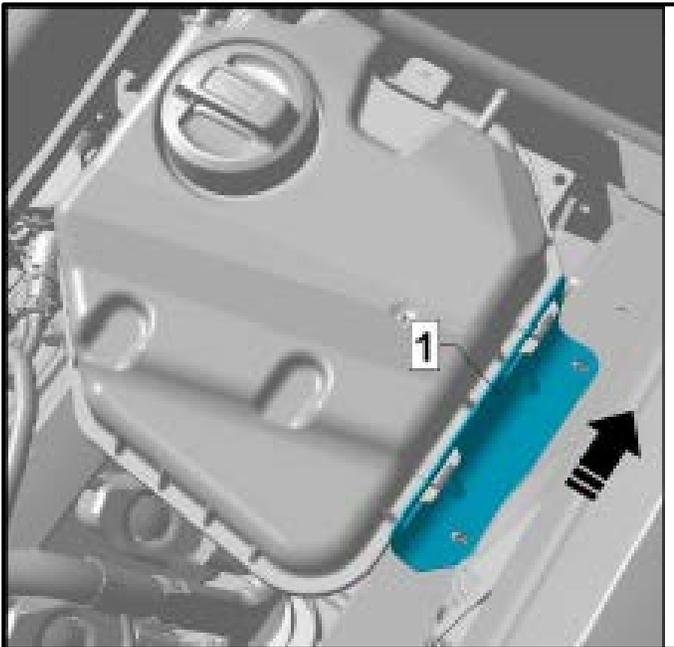
Remove bracket <1>:

- Release bracket <1> in direction of <arrow> and detach from coolant expansion tank.

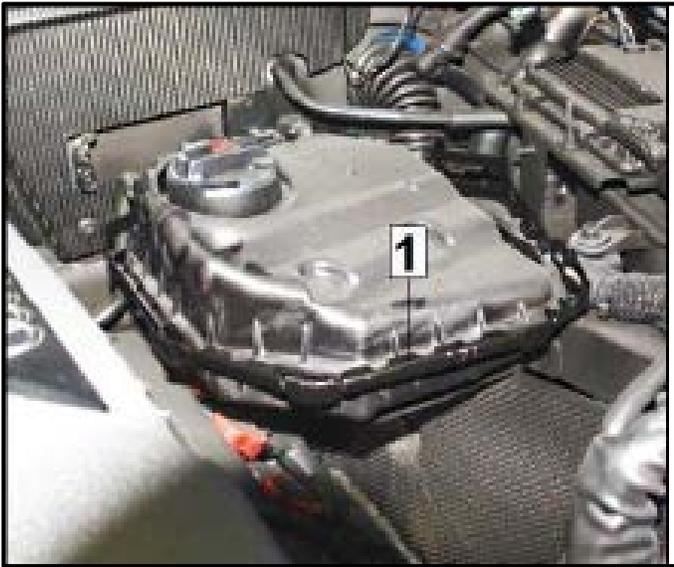
Install tensioning strap <1>:

- Fit tensioning strap <1> around weld seam on coolant expansion tank.

The overflow hose may have to be slightly lifted.

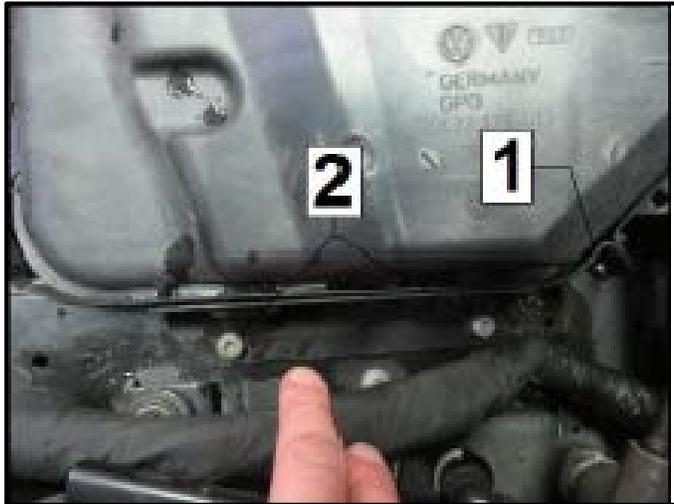
Secure tensioning strap and install bracket:

- Install tensioning strap bolt <1> and torque to 8 Nm.

- Slide bracket onto coolant expansion tank.
- Install bolts <2> and torque to 8 Nm.

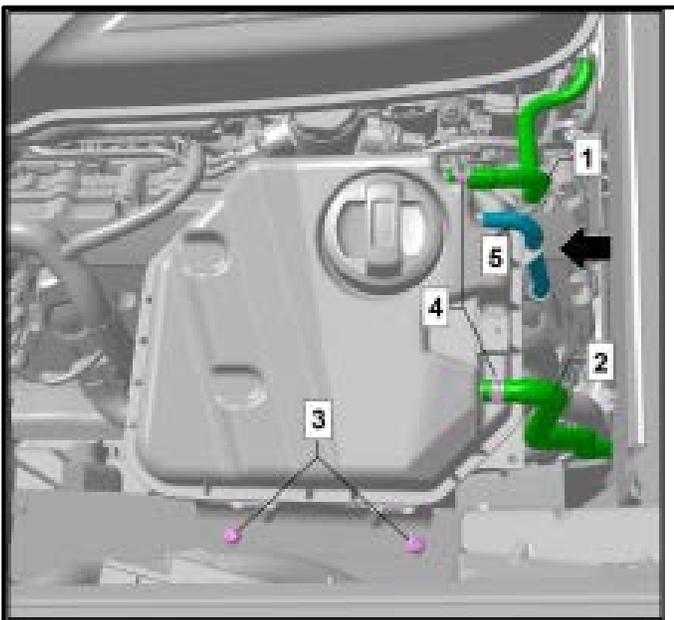
Reinstallation of coolant expansion tank:

- Reinstall hoses <1, 2 and 5> and secure clamps.
- Install and torque bolts <3> to 8 Nm.
- Check coolant level:
 - The coolant level must be up to the "MAX" marking <arrow> when the engine is cold.
 - Coolant level may be above "MAX" marking with engine at operating temperature.

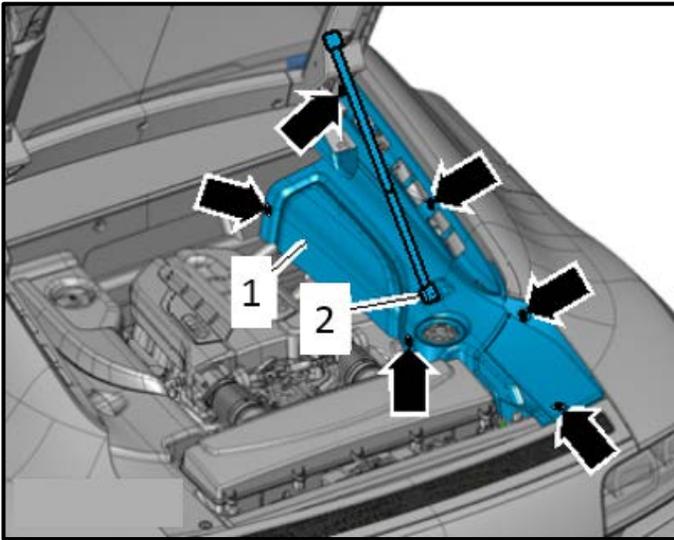
Reinstall right engine compartment trim:

- Reinstallation is the reverse of removal.
