## CR173 – Check and possible installation of the bushing part no. 71210181A on the rear sprocket Hypermotard 950 (all model versions) Technical Service Bulletin SRV-TSB-19-003

Date: March 14, 2019  
To: Dealer Principal, General Manager, Service Manager, North American Dealer Network  
From: Richard Kenton, Technical Director  
Eric Bradley, Technical Training and Publications Manager

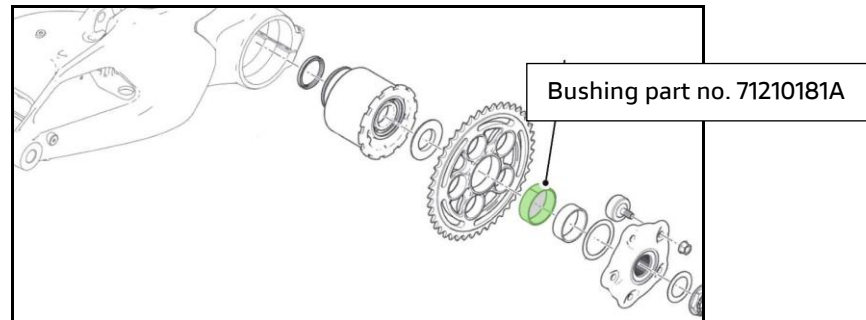
Part 1: During quality inspections performed after production, it was discovered that bushing part no. 71210181A may not have been installed on the rear sprocket Z43 with the first batch of bikes shipped.

This Service Campaign requires inspection for the presence of bushing part no. 71210181A on the rear sprocket and to install it if missing.

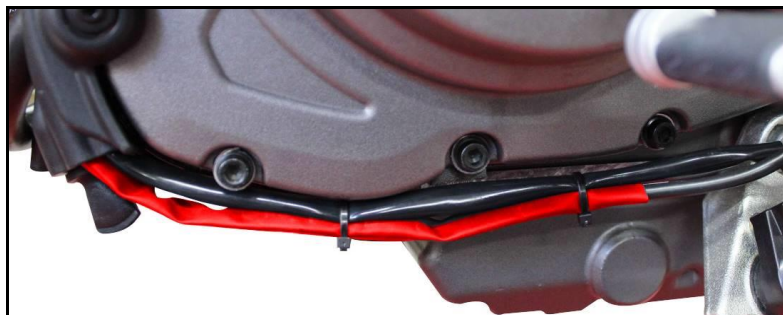
Part 2: For the Hypermotard 950 SP and all Standard models with Ducati Quick Shift up/down (DQS) installed as an accessory, it is necessary to apply a black heat-shrinking sheath or similar product in PVC HT 105°C on the DQS (Ducati Quick Shift) sensor cable.

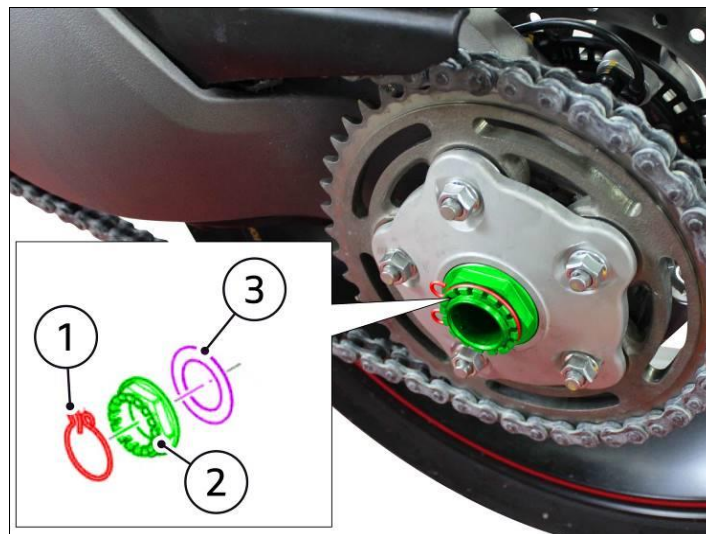
1. Put the front wheel in a vice and make sure it is securely mounted. Use retaining straps if necessary.
2. Working on the motorcycle left side, remove the **clip (1)** and the **nut (2)** with the relevant **washer (3)** that fix the flange-rear sprocket assembly to the rear wheel shaft.

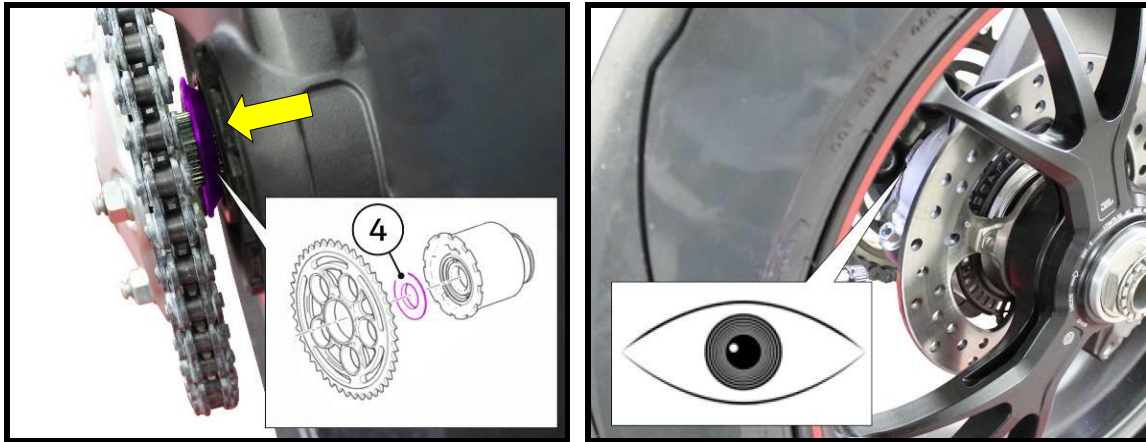
3. Without loosening and removing the chain, move the flange-rear sprocket assembly away from the rear wheel shaft in order to perform a visual inspection as shown in the figure

To perform the visual inspection position the **spacer (4)** on the chain tensioner eccentric to move it away from the flange-rear sprocket assembly

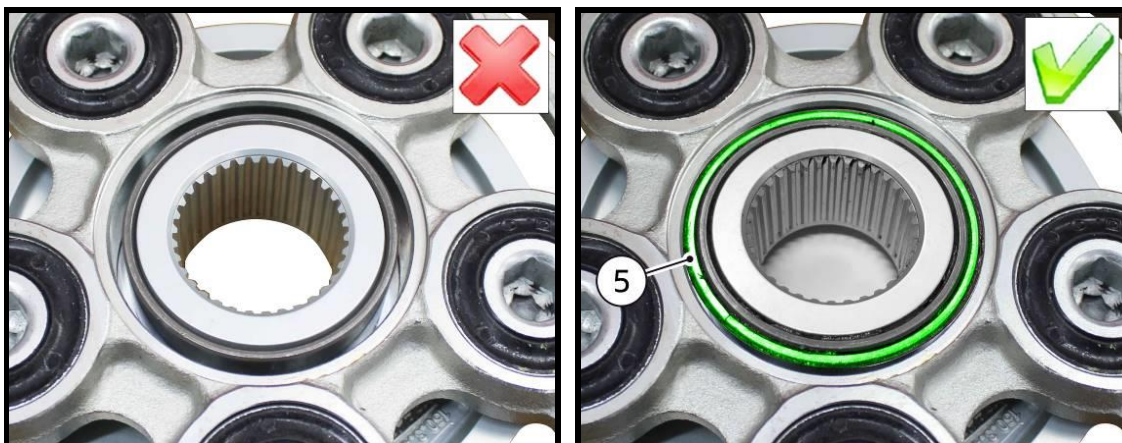
- If the **bushing (5)** is missing, the assembly is **NON-CONFORMING** and it is necessary to install the missing bushing. Follow the instructions in Part 2
- If the **bushing (5)** is present, the assembly is **CONFORMING**; perform the reassembly procedure beginning from Part 2 - Step 6

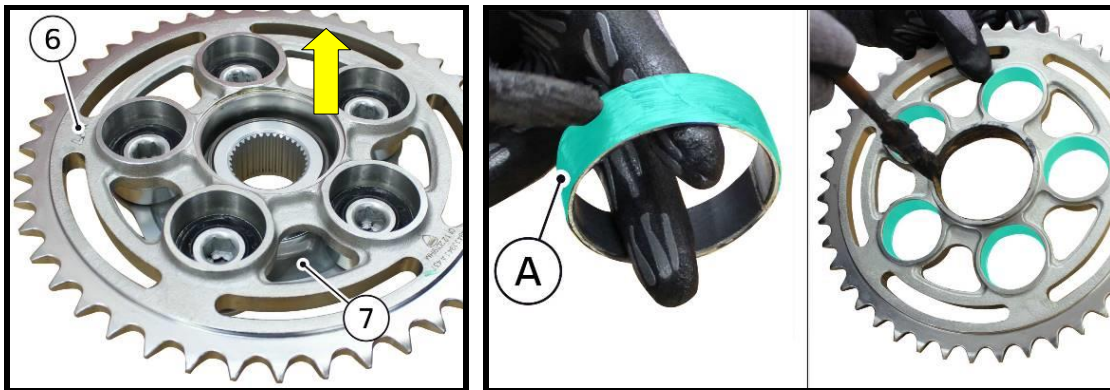
1. Remove the flange-rear sprocket assembly by loosening the two screws that retain the rear eccentric hub to the swinging arm and then loosening the chain
2. Separate the **rear sprocket (6)** from the **flange (7)**
3. Take **bushing (A)** part no. 71210181A and apply Shell Gadus S2 V220 2 grease (or equivalent) on the external surface of the bushing and on the internal mating surfaces of the rear sprocket with the silent-blocks as shown in the figure

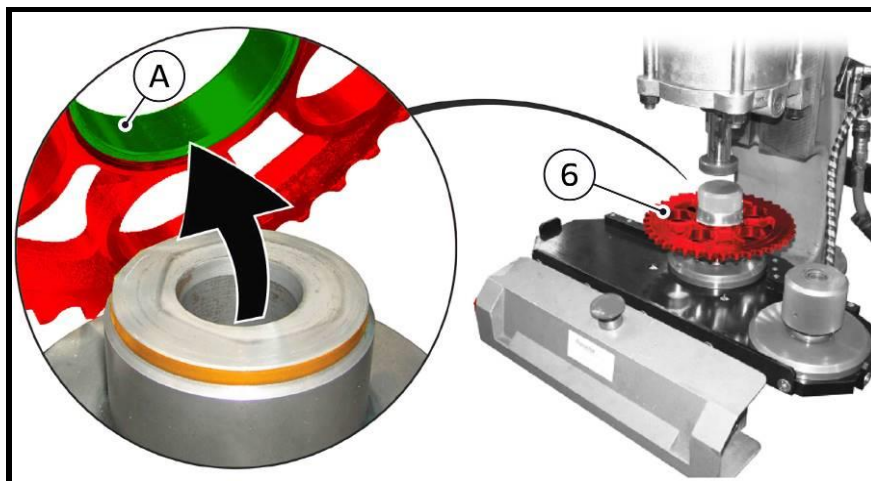
4. Use a press and a drift to fit the **bushing (A)** on the **rear sprocket (6)**

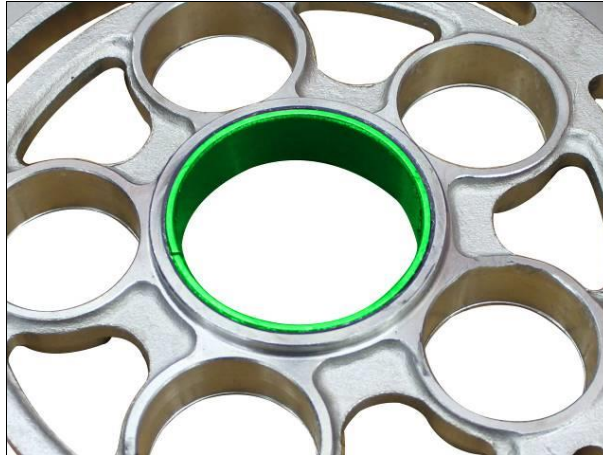
Make sure the bushing is seated correctly so that its upper and lower profiles are aligned with the rear sprocket surface.

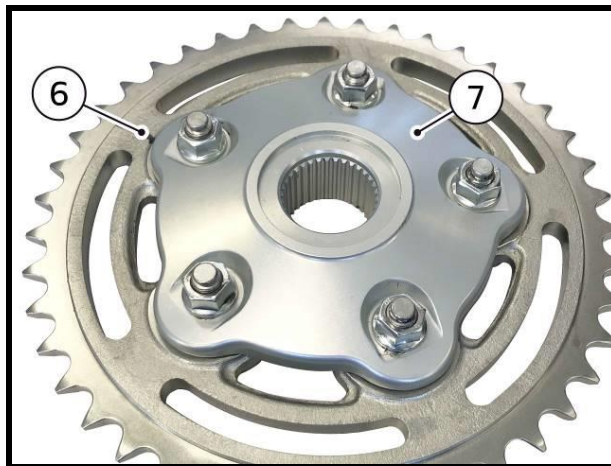
5. Fit the flange (7) on the rear sprocket (6) ensuring that it is fully home as shown

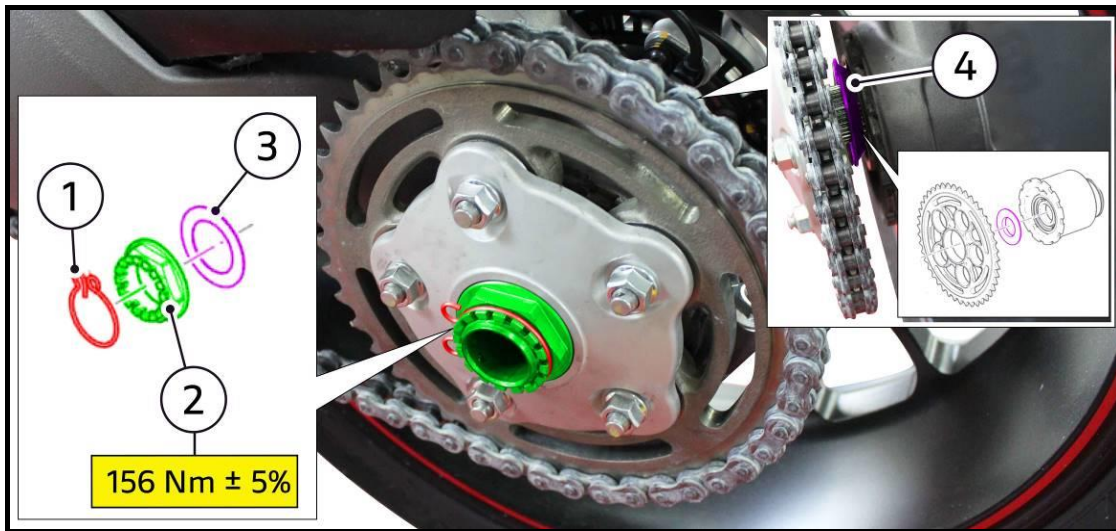
6. Install the flange-rear sprocket assembly with the suitable **spacer (4)** on the chain tensioner eccentric and install the chain on the rear sprocket
7. Apply Shell Gadus S2 V220 2 gear on the rear wheel shaft and on the thread of **nut (2)**
8. Start **nut (2)** with **washer (3)** and tighten to **156 Nm ± 5%**
9. Fit the **clip (1)** as shown in the figure

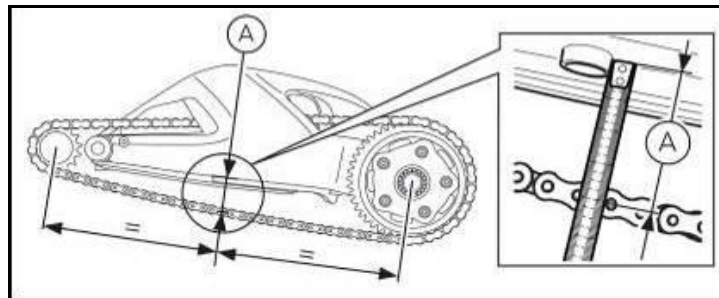
10. Tension the final drive chain by following the procedure below:
  - 10.1 Turn the rear wheel until you find the position where chain is tightest
  - 10.2 Set the vehicle on the side stand
  - 10.3 Push down the chain with just a finger at the point of measurement and then release it
  - 10.4 The measurement taken from the chain sliding shoe lower edge and the center of chain pins must be:
    - A = 65 ÷ 67 mm (Hypermotard 950)
    - A = 69 ÷ 71 mm (Hypermotard 950SP)

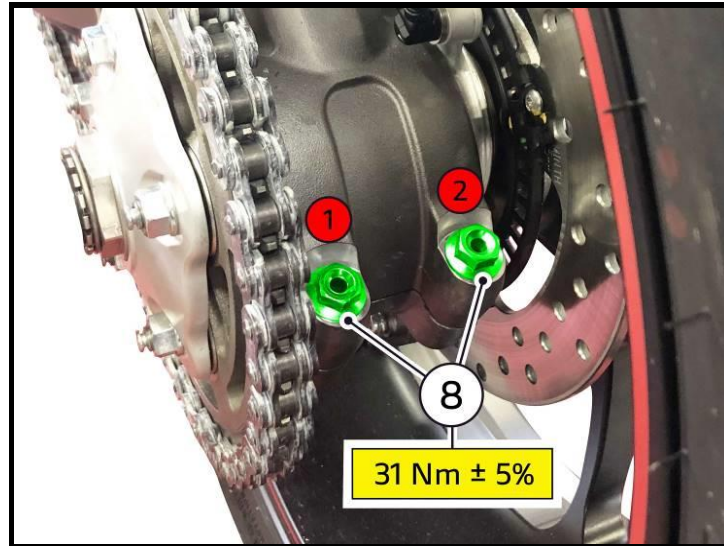
11. Tighten the **2 screws (8)** retaining the rear eccentric hub to the swinging arm **31 Nm ± 5%** in the 1-2-1 sequence

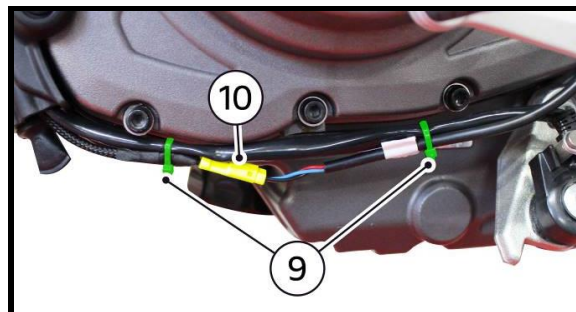
1. By working on the left side of the motorcycle, remove the **2 small self-locking ties (9)** that fix the DQS sensor cable to the side stand sensor cable
2. Disconnect the **connector (10)** of the DQS sensor

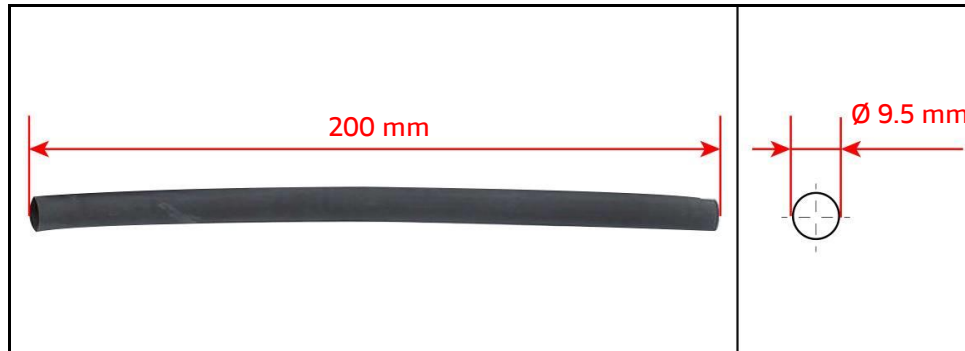
3. Take a black heat-shrinking sheath or alike PVC HT 105°C of the following size:
- Length: **200 mm**
  - Diameter: **9.5 mm**

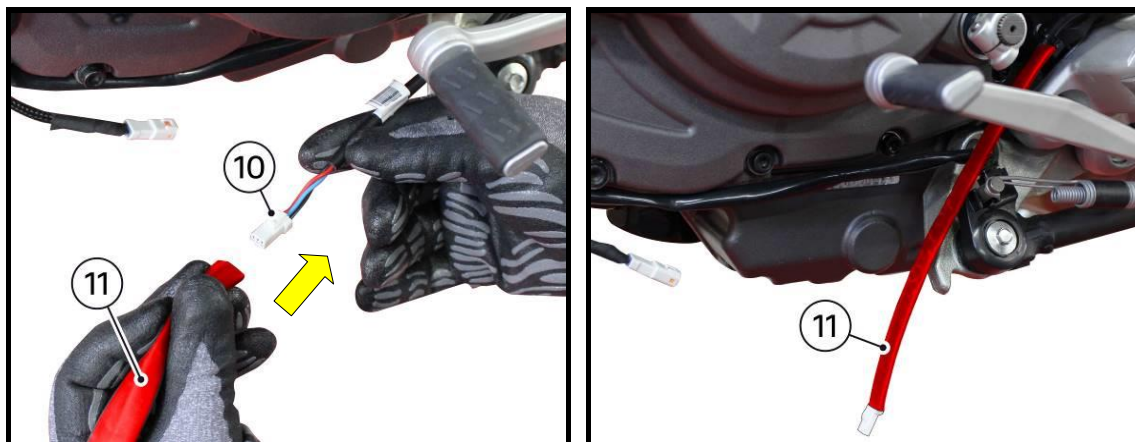
4. Insert the DQS sensor **connector (10)** inside the **sheath (11)** and let it slide until it comes out of the opposite side as shown in the figure

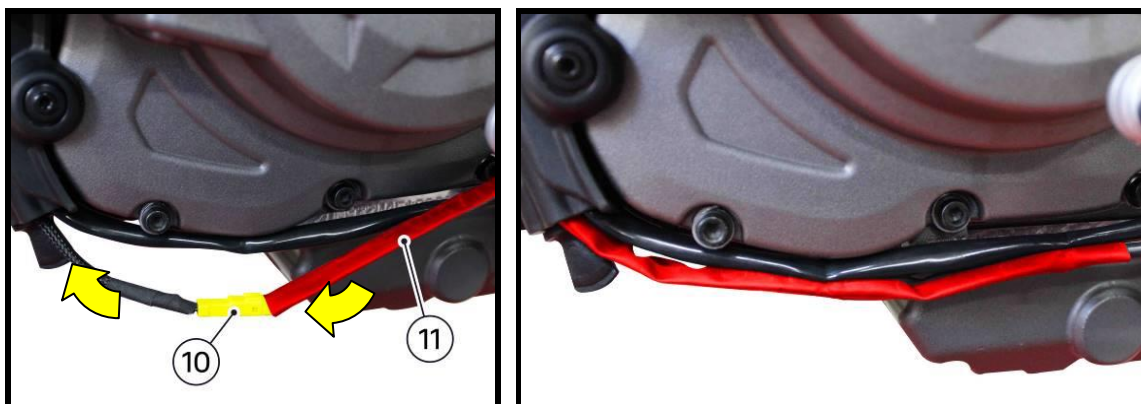
5. Connect the DQS sensor **connector (10)** and slide the **sheath (11)** until inserting the front end inside the cover as shown in the figure

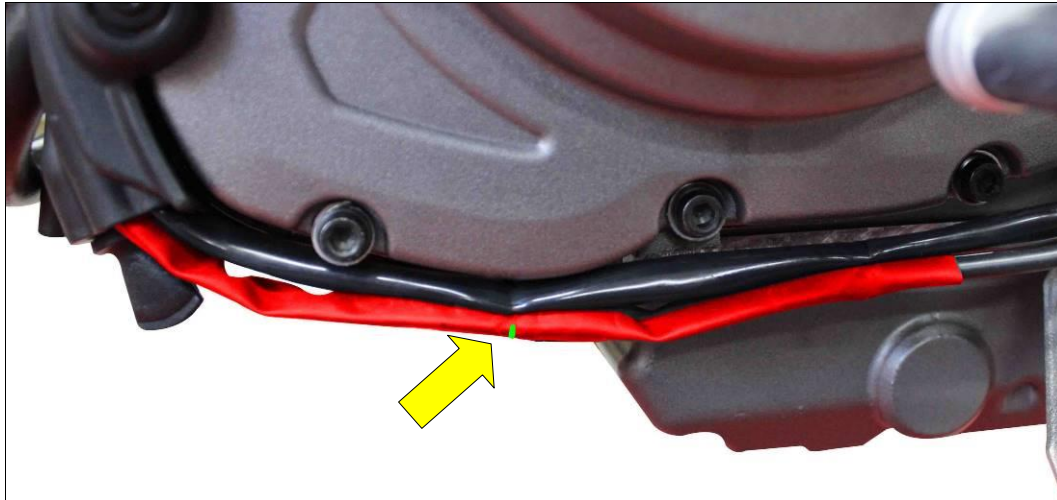
6. Use a felt-tip pen to mark the lower part of the sheath in correspondence of the DQS sensor connector as shown in the figure

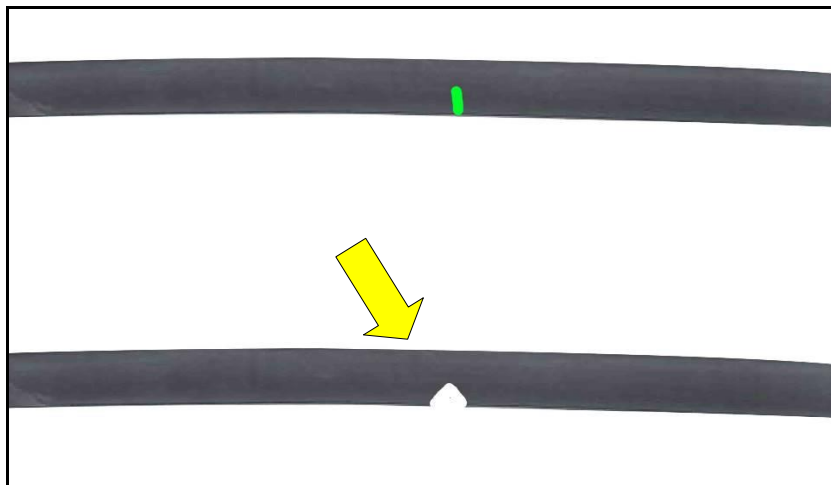
7. Move the sheath in order to disconnect the DQS sensor connector and slide the sheath out
8. Use scissors to make two cuts on the previously made mark as shown in the figure to create a notch for connector release access

9. To reinstall the sheath, repeat the procedure from steps 4 and 5

Aim the sheath so that the cut is in the lower part of the DQS sensor connector.

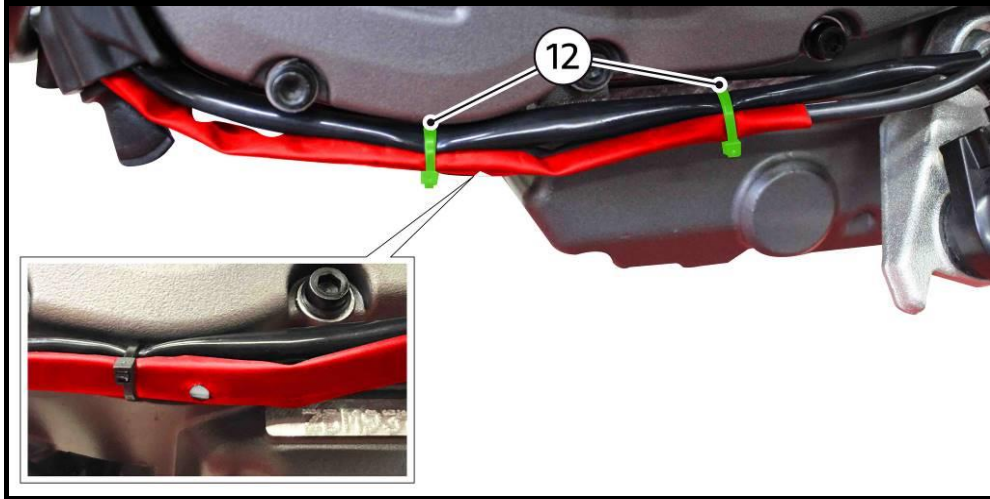
10. Tie the DQS sensor cable to the side stand sensor cable by means of 2 small self-locking ties (12) as shown in the figure
