LTB01089NAS2

TECHNICAL BULLETIN

415-00: Information and Entertainment System

Steering Wheel / Speed Control Switches and Paddle Shifters Inoperative

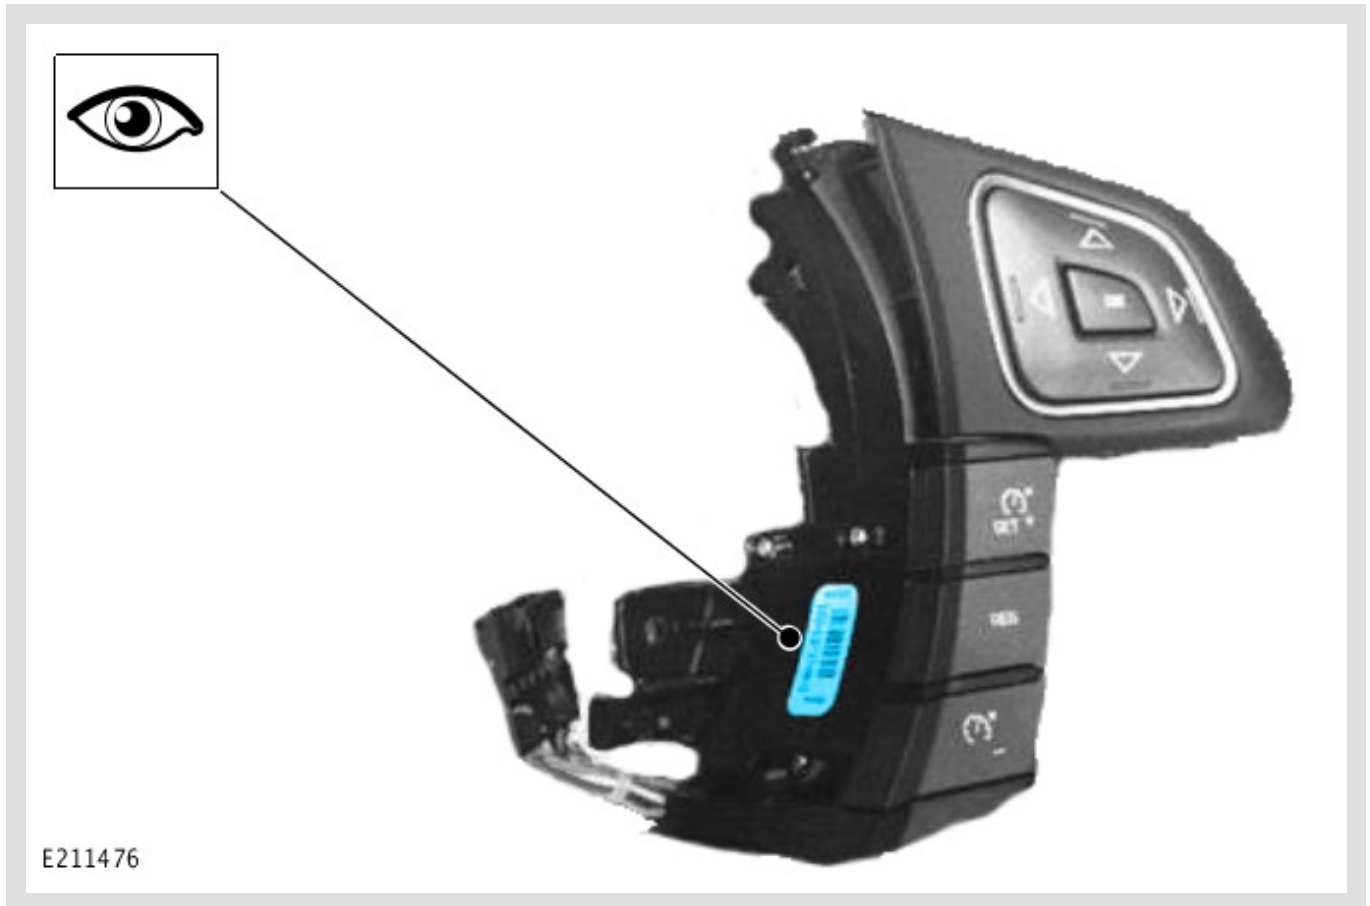
Switch shown removed from the vehicle for illustration purposes only.

Confirm the part number (on the label) of the existing steering wheel right control switch.

- If the part number on the steering wheel right control switch is GJ32-13D767-HA or GJ32-13D767-JA, **do not continue with this Technical Bulletin.**
 - Submit a TA (Technical Assistance) request as the customer's concern is not related to the information within this Technical Bulletin.
- If the part number on the steering wheel right control switch is GJ32-13D767-FA or GJ32-13D767-GA, go to Step 3.

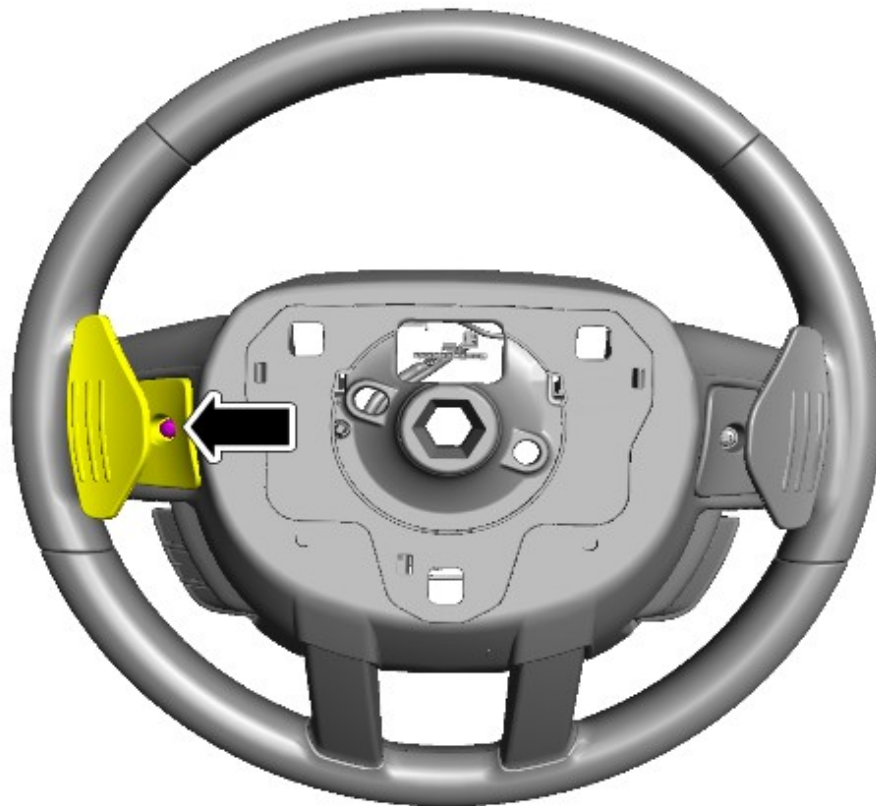
E212022

Remove the right paddle shifter fastener and position the right paddle shifter to one side. Do not disconnect the paddle shifter electrical connector.

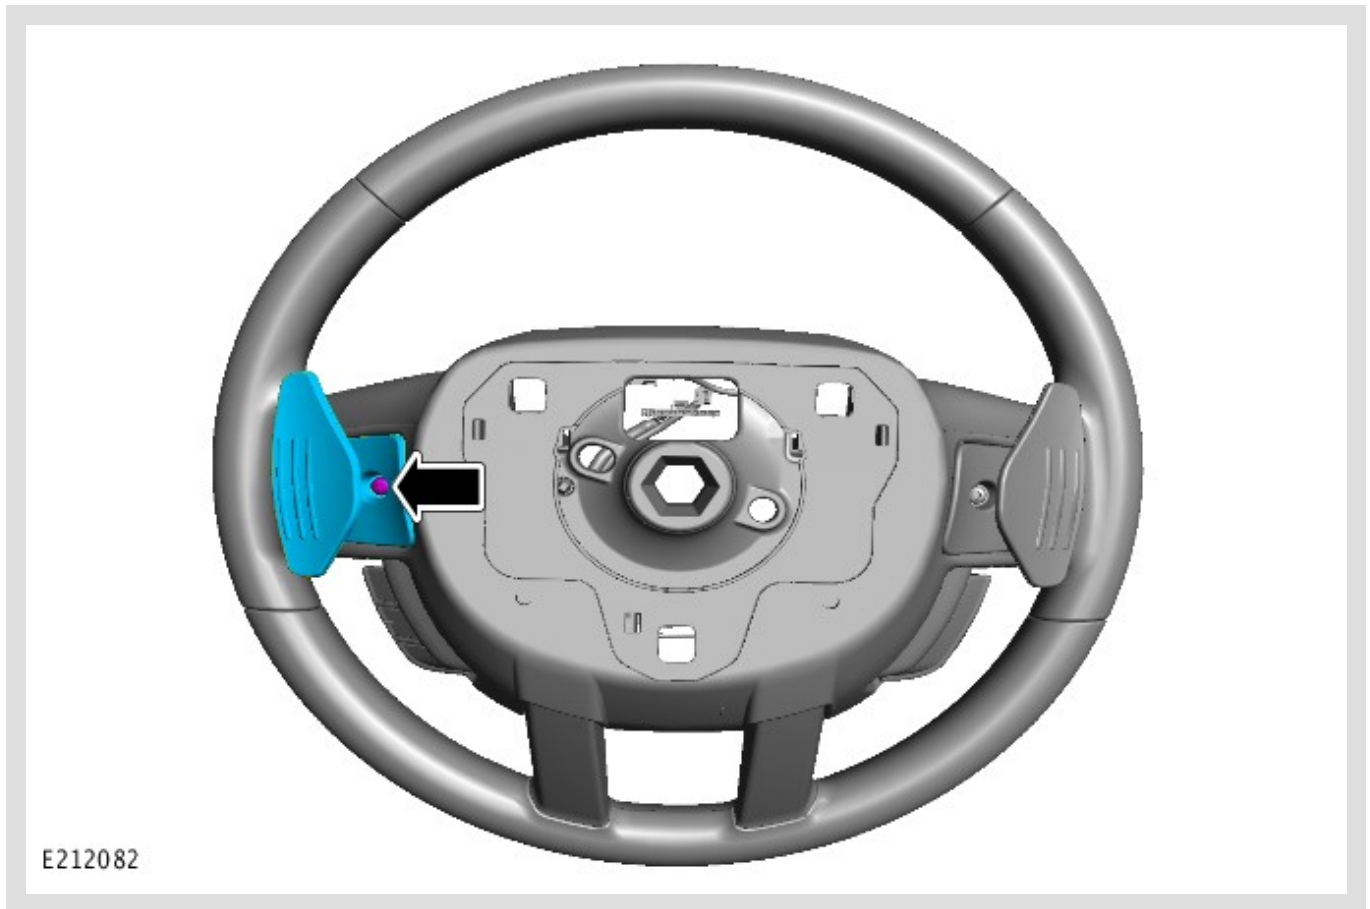
Install the right paddle shifter.

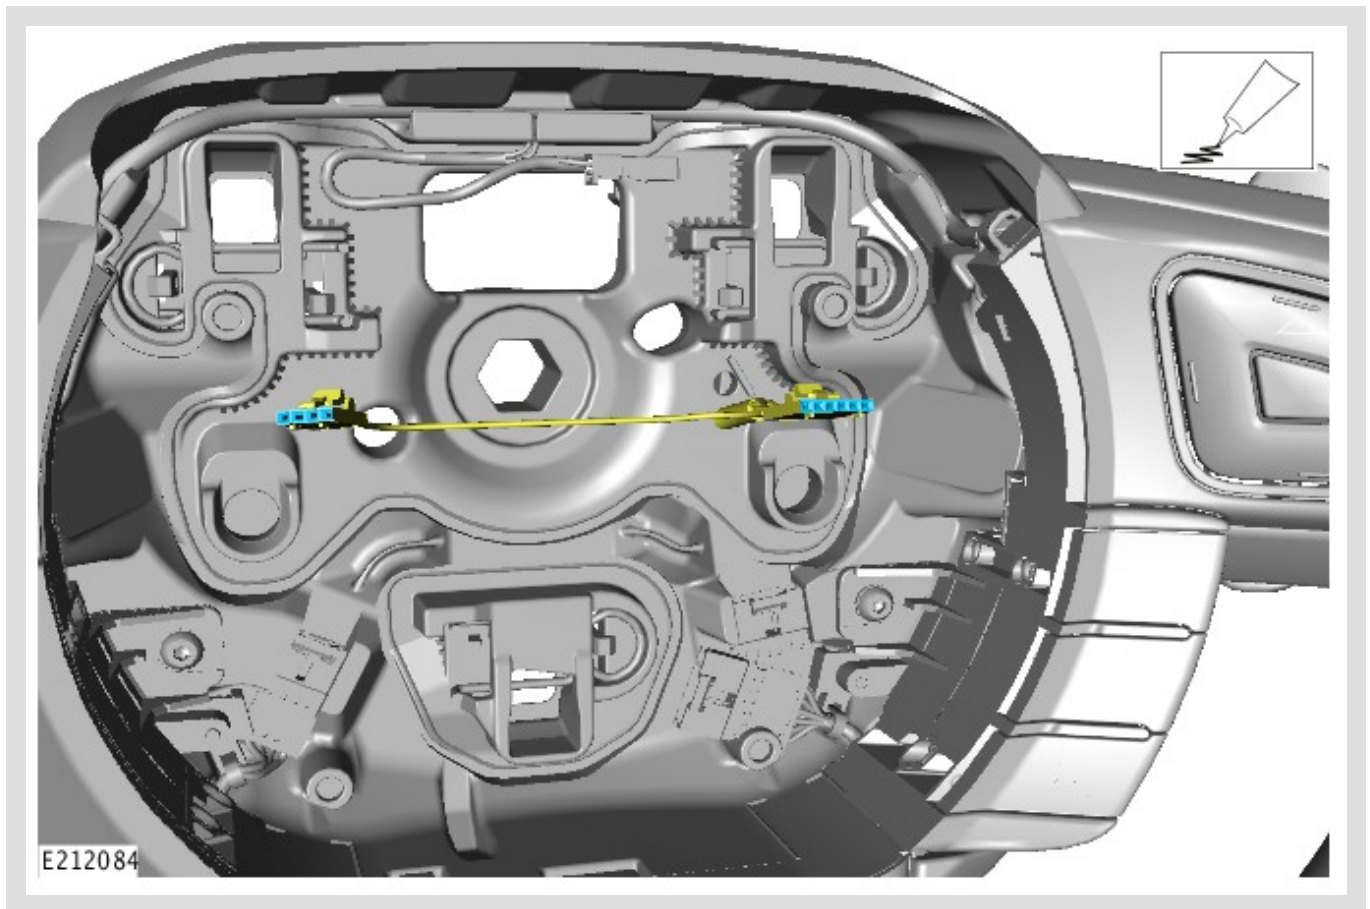
- Make sure there is an even covering of Nyogel on the contact surface.
- Remove any excess Nyogel.

Apply the Nyogel to the front of the steering wheel left control switch lower electrical connector and the front of the steering wheel right control switch lower electrical connector.
