Daimler Trucks

**North America LLC      Customer Advisory Letter**

**Subject : Proactive Sam Chassis Replacement**

**Models Affected:** 37 2015 Cascadias for [REDACTED]

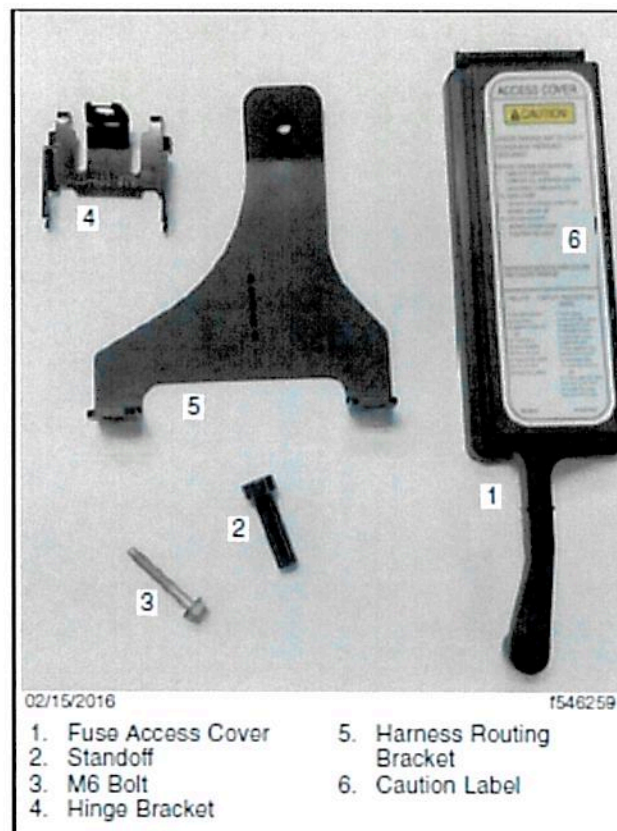
**Fig. 1, SAM Chassis Cover Parts**

See [Fig. 1](#) and [Table 1](#) for SAM Chassis cover parts.

1. Replace Sam Chassis Module Refer to Workshop manual section 54.02 subject 100. **Save all old modules**
2. Install new Sam Chassis cover as instructed in SB 54-294
3. Install A22-68255-000 drip shield on front wall See figure 1 part marked #1
4. Insure drip loop in harness See figure 1 & 2 circled "A"
5. Replace fuses in the Sam Chassis with PDC's

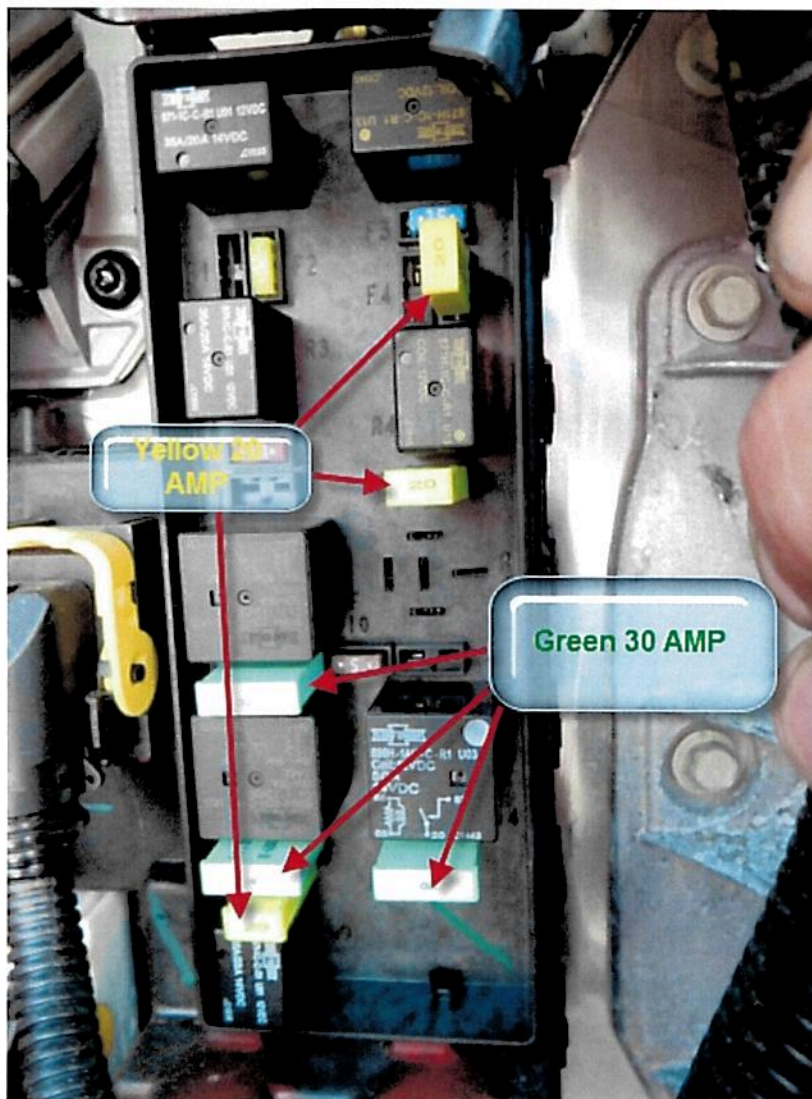
QTY 3, 23-13914-120 Yellow 20AMP PTC  
QTY 3, 23-13914-230 LTGreen 30AMP PTC  
The PTCs install as;  
Yellow - Fuse 5 = Left Turn  
Yellow - Fuse 8 = Right Turn  
Yellow - Fuse 13 = Tail Light  
Green - Fuse 12 = Stop  
Green - Fuse 9 = Trailer Marker  
Green - Fuse 14 = Trailer power
