SERVICE ADVISORY # 18-332

Coleman Water Heater Switch

Models Included: 2019 Coleman Travel Trailers: 1805RB, 2425RB, 2435RK, 2515RL, 2605RL, 2835BH, 2855BH, 2925RE, 3015BH

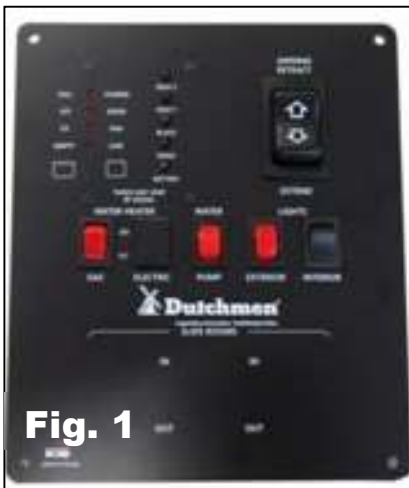
Fig. 1

Locate and remove monitor panel near main entrance door, Figure 1.

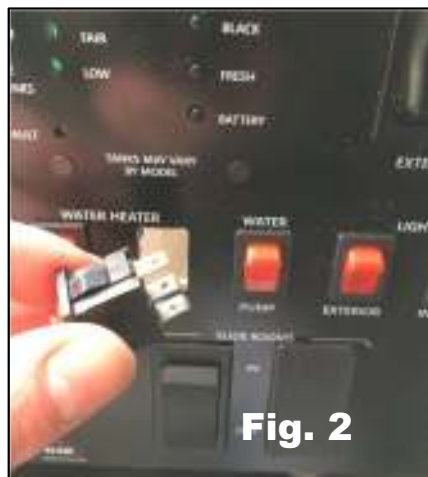
Fig. 2

Remove switch plug in the W/H electric switch location, see Figure 2, and install the KRV # 115566 – Switch – Monitor Panel Small – Illuminated Red in its place with brass-colored blade at the top. See **Step 3** for wiring instructions.

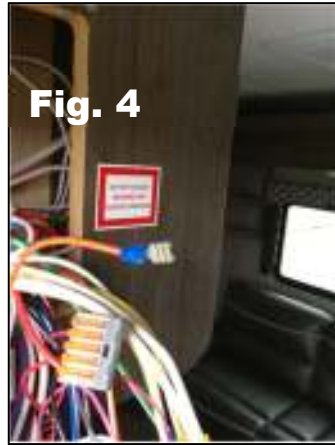
Locate single-capped 14 ga orange wire at the incoming wire bundle, Figure 3. Remove cap, strip end of wire, and install quick slide terminal KRV # 267575 – Terminal – Quick Slide – 14-16 ga – Insulated, Figure 4.

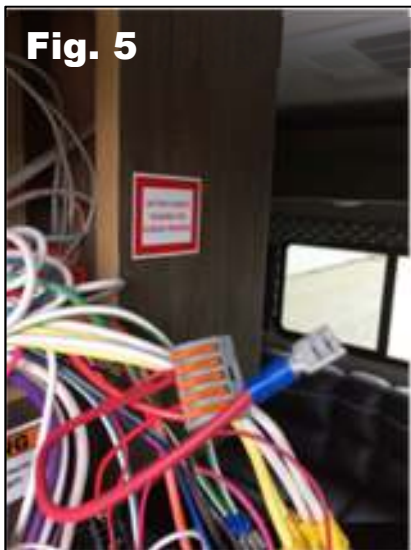
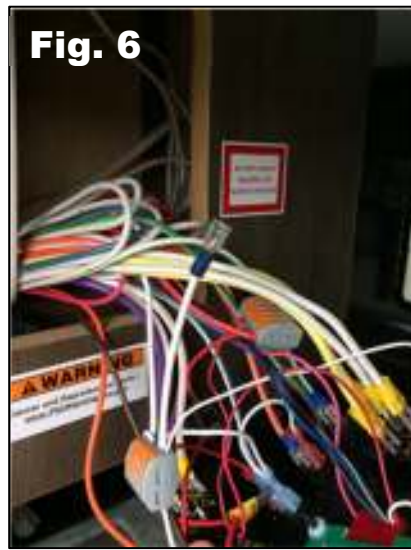
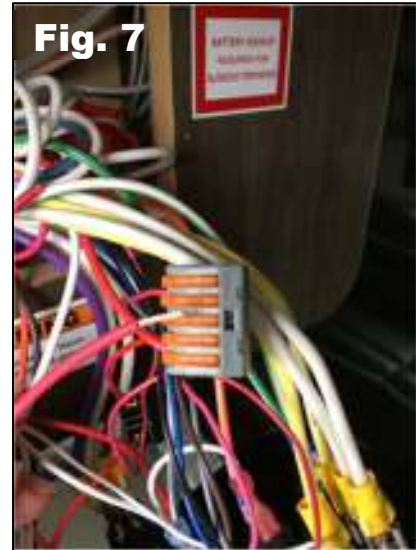
Strip both ends of locally obtained red and white 14 ga wires and install one quick slide terminal KRV # 267575 – Terminal – Quick Slide – 14-16 ga – Insulated on one end of each wire. Then install the bare stranded ends from each of the red and white 14 ga wires into the Wago connectors that has the corresponding color of wire, Figures 5, 6, 7.

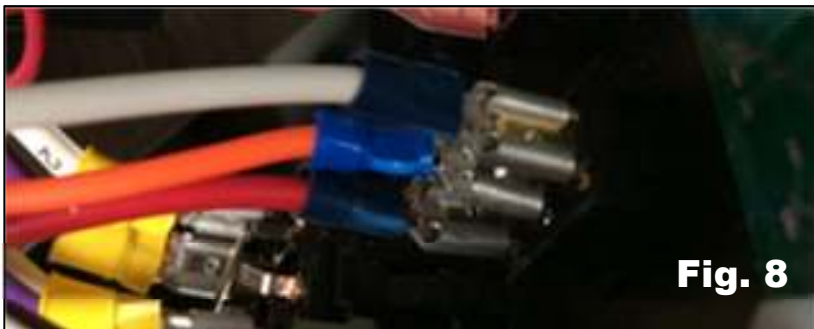
Connect wires into back of switch, the order being from top down (brass blade is at the top) white, orange, red, Figure 8
