Paint Blistering Due to Corrosion on Lower Door Sill

YEAR(S)	MODEL(S)	ADDITIONAL INFORMATION
2016 - 2019	Tacoma

Some 2016 – 2019 model year Tacoma vehicles may exhibit corrosion or paint blistering on the front and/or rear lower door sill(s). Follow the Repair Procedure in this bulletin to address this condition.

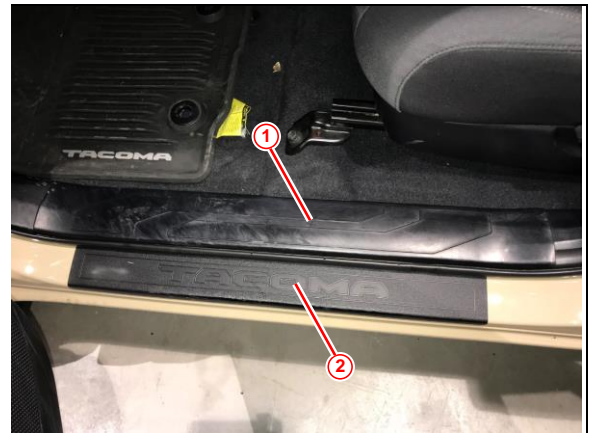
Figure 1.

1	Door Scuff Plate
2	Door Sill Protector

2. Sublet the vehicle to a body shop to repaint the door sill(s).
 - A. If the vehicle has door sill protectors installed, remove the door sill protectors on the affected door BEFORE painting. A NEW door sill protector MUST be ordered and installed AFTER the vehicle has been repainted.
 - B. If burrs are present on top of the flange, sand down the burrs BEFORE repainting.
 - C. Repaint the lower door sills following the paint manufacturer's system specifications.
 - D. AFTER repainting, continue to step 3.

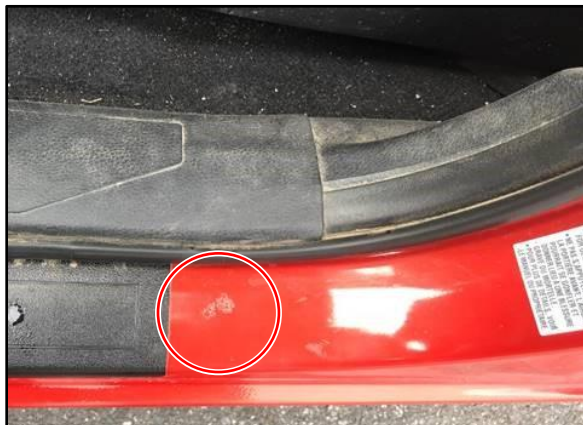
Figure 2.

- Confirm the condition exists.
Is corrosion or paint blistering present on the surface of ANY lower door sill?
 - YES** — Proceed to step 2.
 - NO** — This bulletin does NOT apply. Continue diagnosis using the applicable Repair Manual.

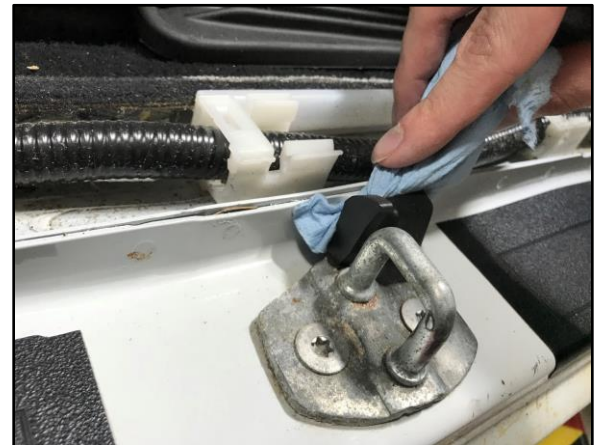
Figure 4.

4. Apply clear flange tape.
 - A. With the door sill repainted, remove the plastic door scuff plate and kick panel. Remove the lower half of the door open trim weatherstrip to allow for easier installation.
 - B. With a clean rag and rubbing alcohol, remove ANY debris or dirt from the outer, upper, and inner portions of the lower door sill flange (upper rocker flange). On the C Cab, be sure to clean between the flange and the striker, as shown.
 - C. If the door sill protector is installed, align the clear flange tape flush against the door sill protector. Be sure NOT to allow ANY gaps. Do NOT overlap the protector and the clear flange tape.

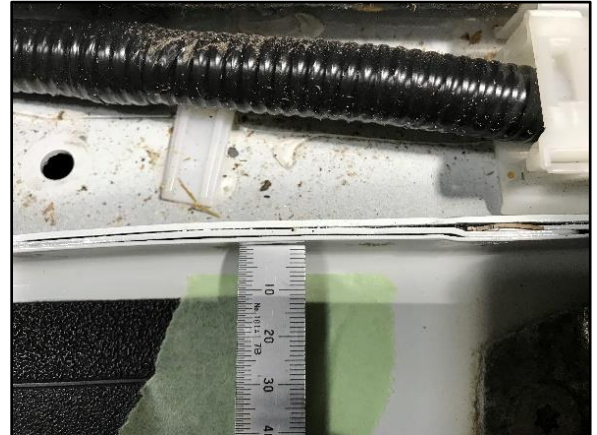
Figure 5.

- D. If the vehicle is NOT equipped with a door sill protector, ensure the clear flange tape is aligned to the flange with the following procedure:
- (1) With a ruler, measure 6 mm, or ¼ in., from the outside of the flange, as the clear flange tape will cover both the pinch weld flange and part of the sill area.
 - (2) Mark this distance with the flat side of a small piece of masking tape. Mark this distance in AT LEAST three locations along the lower door sill to help align the clear flange tape.
- E. After the paint has dried, lightly apply the clear flange tape on the outward facing side of the flange.
- (1) For D Cab front and rear doors, the tape should be applied to the flange, starting just AFTER the first spot weld where the sealer was applied as shown.
 - (2) For C Cab, use the same starting location as the D Cab front door.

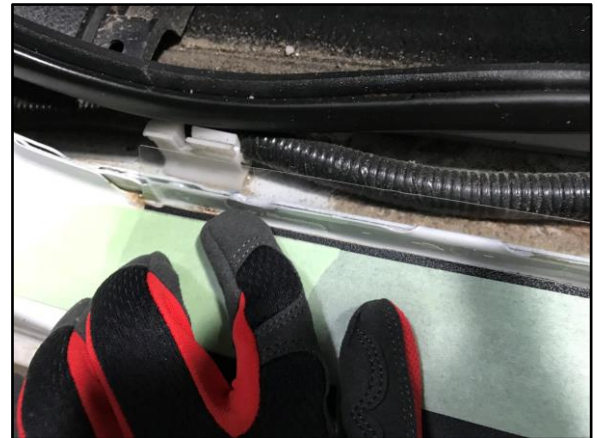
Figure 6.

- F. Whet out (press out air bubbles) the front side of the flange, starting from the bottom and working up. Do NOT allow ANY air bubbles or wrinkles, especially on the front side of the flange.

In hard-to-reach areas, place a shop rag over a plastic pry tool to whet out the clear flange tape. Be sure NOT to scratch ANY painted surfaces.

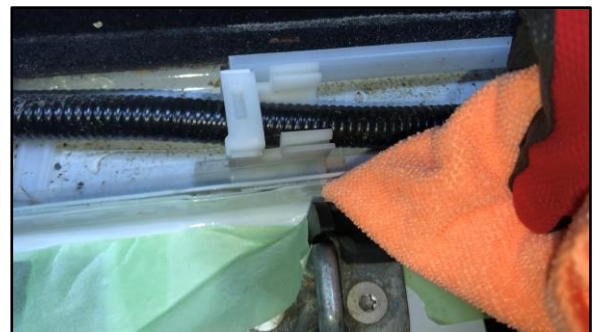
Figure 7.

- G. Continue to whet out the top and down the back side of the flange, making sure NO air bubbles or wrinkles are present.

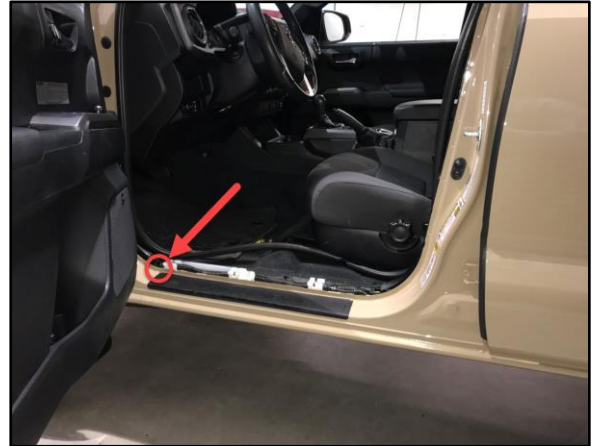
Figure 8.

5. Apply the 3M sealer (P/N 08361) or equivalent to the specified location (bowl area) on the lower sill flange as shown.

Ensure the sealer does NOT dry on the visible portion of the sill AFTER the door open trim weatherstrip is installed.

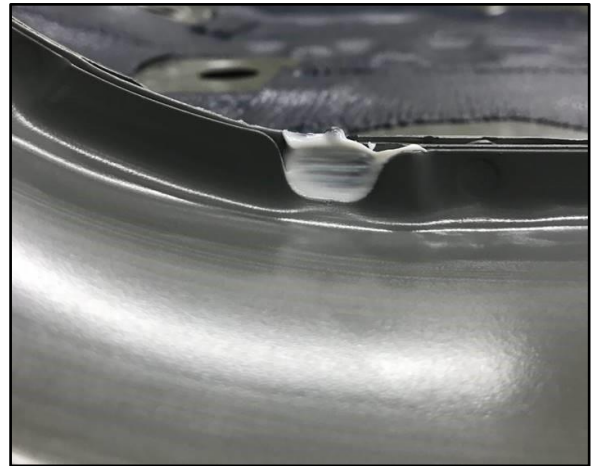
Figure 9.

6. Remove the masking tape.
7. Reinstall the door open trim weatherstrip.
8. Reinstall the door scuff plate.
