LATEST VEHICLE CONCERN FIXES

Headlight Micro-cracking	F-TYPE 15 – 17 MY
<p><u>Customer Voice:</u></p> <ul style="list-style-type: none">- A Customer may report the headlights have small cracks on the lenes <p><u>Technical Description:</u></p> <ul style="list-style-type: none">- The micro-cracking is found on one and or both headlamp lenses on 15-17 MY F-TYPE. The issue is found concentrated above the headlamp beam on the clear part of the headlamp. <p><u>Status:</u></p> <ul style="list-style-type: none">- Currently Under Investigation- Raise an EPQR for any repairs performed and hold any parts replaced for return.

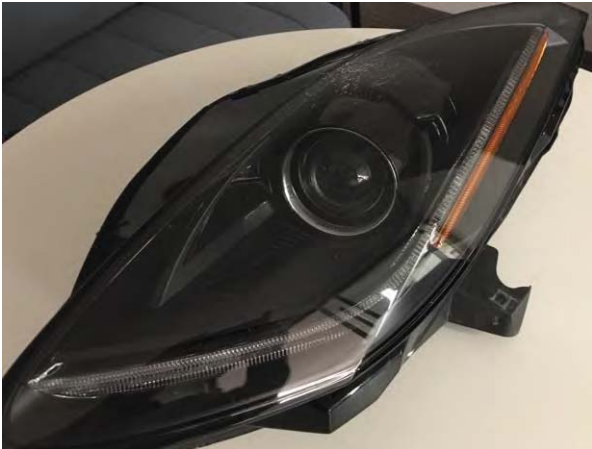
A close-up photograph of a car's headlight assembly. The clear lens is the primary focus, showing several fine, hairline cracks that are most prominent in the upper portion of the lens, above the main projector beam. The surrounding housing is black plastic.
