Technical Service Bulletin

69 Front seatbelt is twisted

69 19 38 2054504/1 April 1, 2019.

Model(s)	Year	VIN Range	Vehicle-Specific Equipment
A6, A7, A8, and Q8	2019	All	Not Applicable

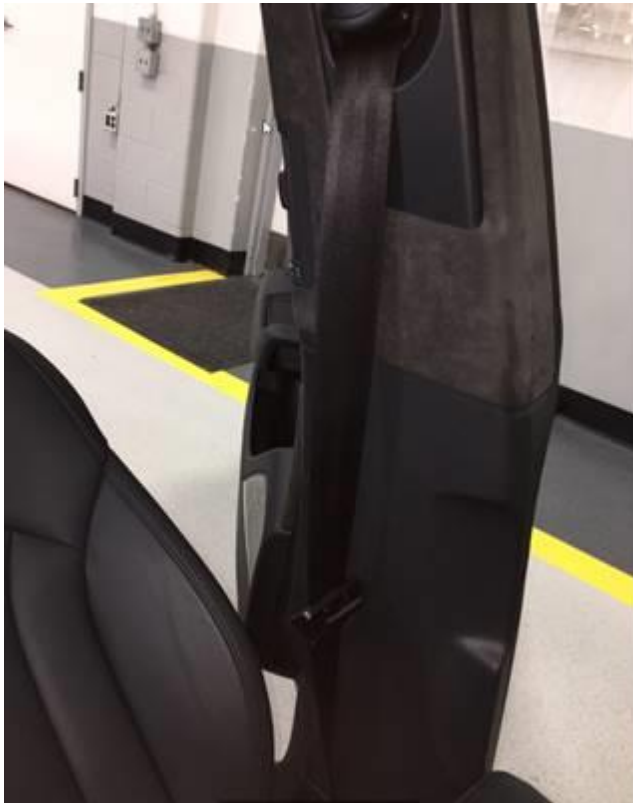
For the new C8, D5, and Q8 vehicles, the seatbelt diverter assembly in the upper B pillar was changed and the opening is larger than previous models. This allows for the belt to become twisted under certain circumstances when releasing the belt after unbuckling the seatbelt assembly.

1. The twist that is within the seatbelt assembly can be removed without any disassembly of the B pillar trim on either side of the vehicle. The pictures below show the twist and how it could look (Figure 1 and 2).

Figure 1. Example of a twisted seatbelt.

2. To remove the twist from the seatbelt assembly, all you need to do is feed a twist in the opposite direction that the seatbelt is currently twisted.

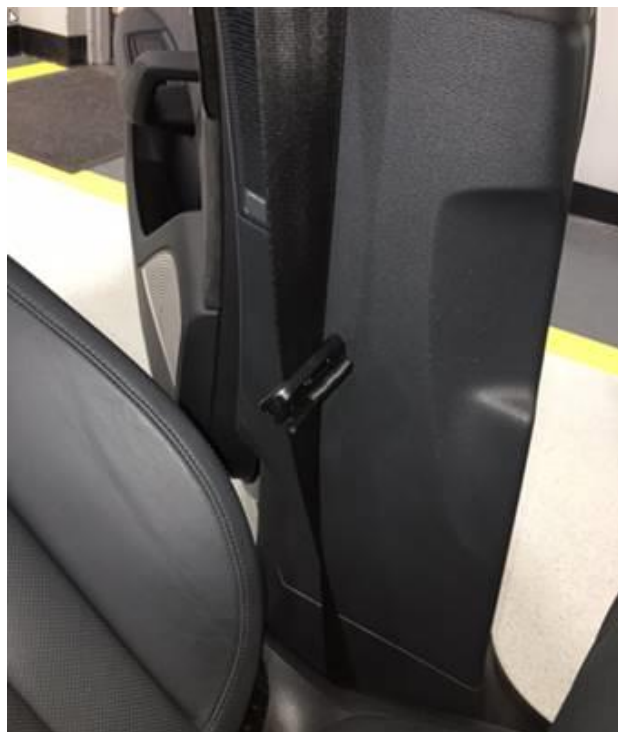
Figure 2. Example of a twisted seatbelt.
