# TECHNICAL SERVICE BULLETIN

Technical Service Bulletin: 10G-0997

Forest River is alerting you to an issue involving certain 2019 through 2020 – Flagstaff – FLTE16THG, FLTE16THG-W and 2020 – Rockwood - RLTG16THG and RLTG16THG-W travel trailer recreational vehicles. Please see the information below which describes the issue and provides you with details on the steps you should take to have your vehicle repaired.

## 16TH SOFA REMEDY

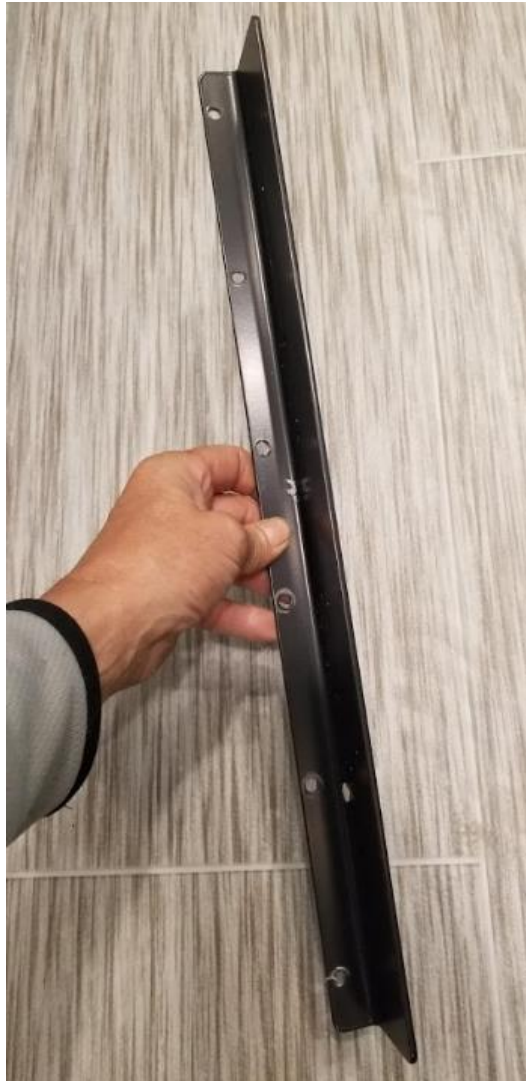
- (4) 23647 FLIP DOWN SOFA LEG SUPPORT 02D20010 (TALON)  
(24) 14A100SUX0Z 14 X 1 HEX HEAD LAGS
