Service Bulletin

Bulletin No.: 16-NA-111

Subject: Information on Malfunction Indicator Light (MIL) Illuminated, DTC P0420 and P0430 Set

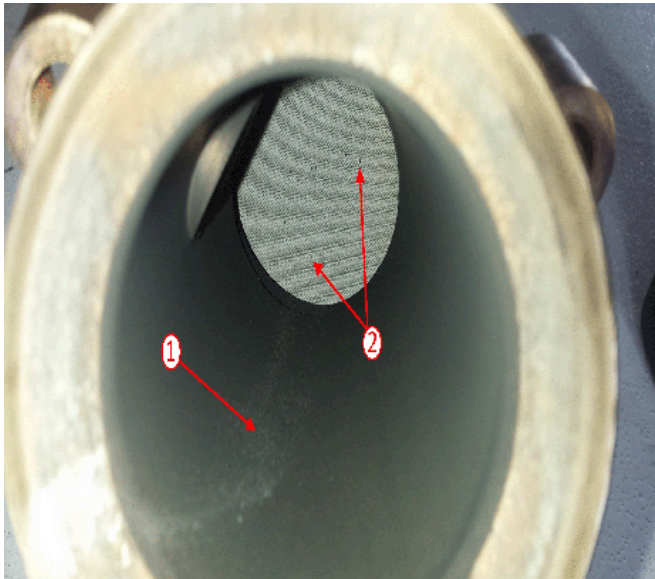
4487580

<p style="text-align: right;">4487575</p> <p>This may be caused by excessive sand and/or debris entering the air filter box and bypassing the seal of the air filter due to not properly sealing, causing damage to the HO2 sensor element (3) and the catalytic converter to become blocked with sand and debris particles (1, 2).</p>
<p>Correction</p>	<p>Do not replace any of the parts until the air filter housing has been validated to be completely sealed. If the condition is evident, inspection of the air box and air filter seal must be done. Follow the Service Procedure steps in order to verify the sealing of the air filter to housing surface. After validating the air box has been sealed, repair the P0420 and the P0430 codes as needed.</p>

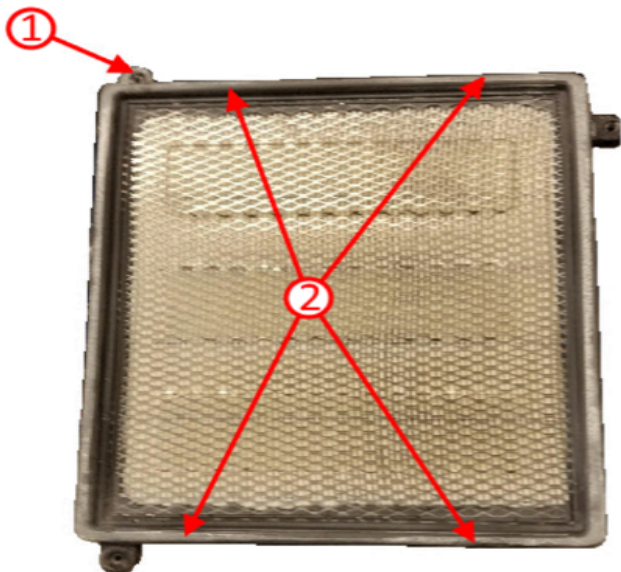
4484793

1. Inspect the air housing cover for any missing tabs and/or fasteners (1).
2. Remove the air filter housing cover and inspect the seal around the air filter (2).

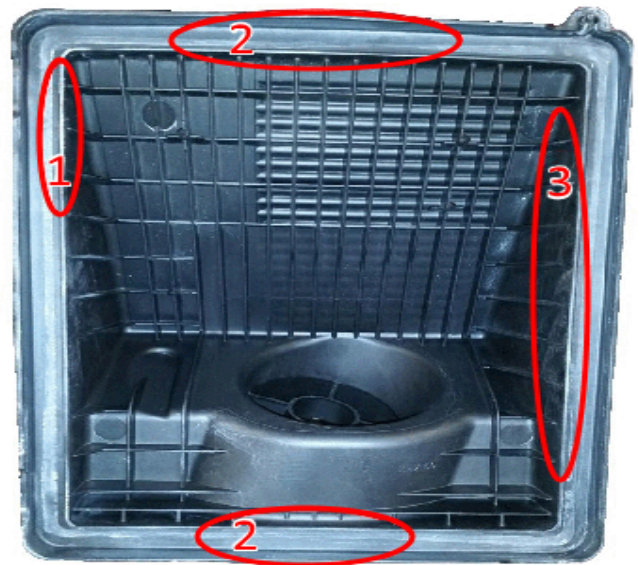
4484775

3. Inspect the air filter sealing surface for signs of not contacting the air filter seal (1, 2).

4. Inspect the air filter housing cover for dirt and/or debris bypassing the air filter (3).
5. Inspect the air cleaner outlet duct for any dirt and/or debris.
 - If dirt and debris has been found bypassing the air filter due to a faulty seal, replace the air filter as necessary.
 - If the air filter housing has been found not properly sealing, refer to *Air Cleaner Assembly Replacement* in SI.
