| Title | Volvo Chassis - Fixed Center Chassis Fairing Bracket Fatigue, Cracking, Breaking - Model Year 2018 And Newer |

| Volvo Model | VNL |

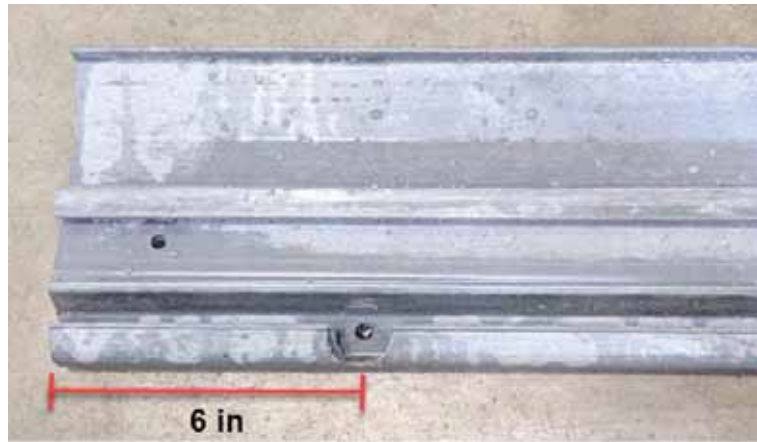
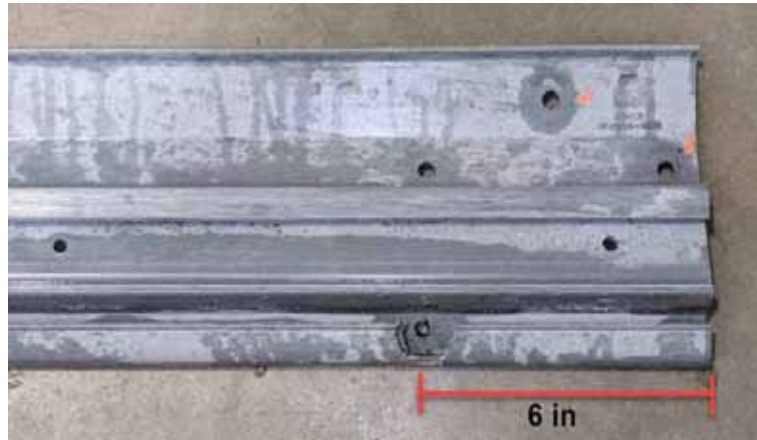
**2. Use 1in hole saw and drill a hole 6in from each end of lower support (See below pictures for more details)**

**2.1** Make sure the hole saw only drills through the outboard portion of the "hook"

**2.2** Pilot bit should drill through the lower support

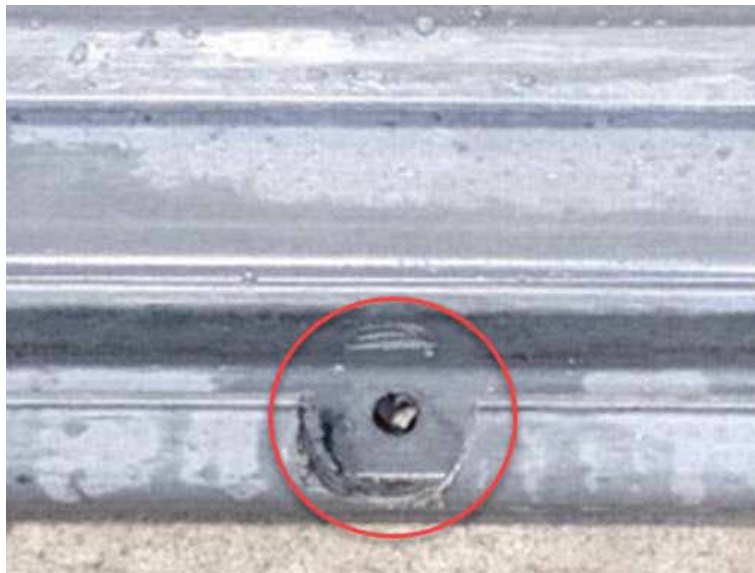
Hole saw should remove only the outboard portion of the support.

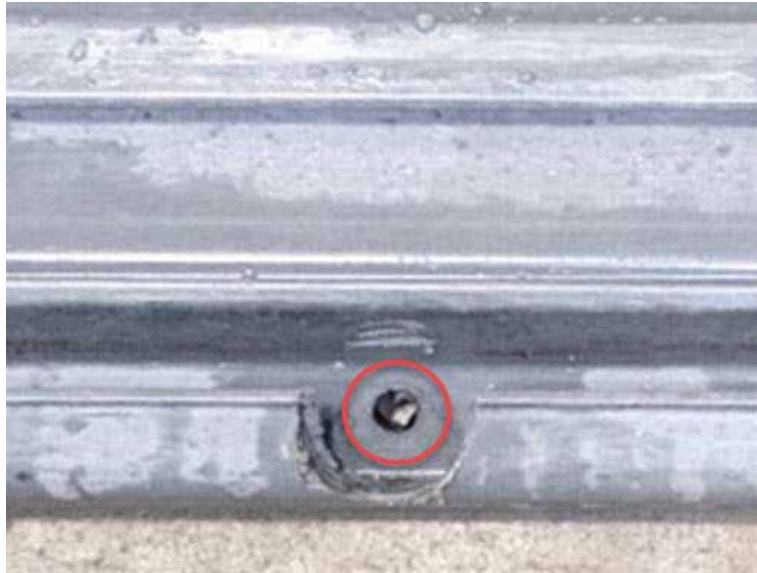
Pilot bit should drill through back of support to make a pilot hole to use as a reference once the fairing is placed back on the vehicle.

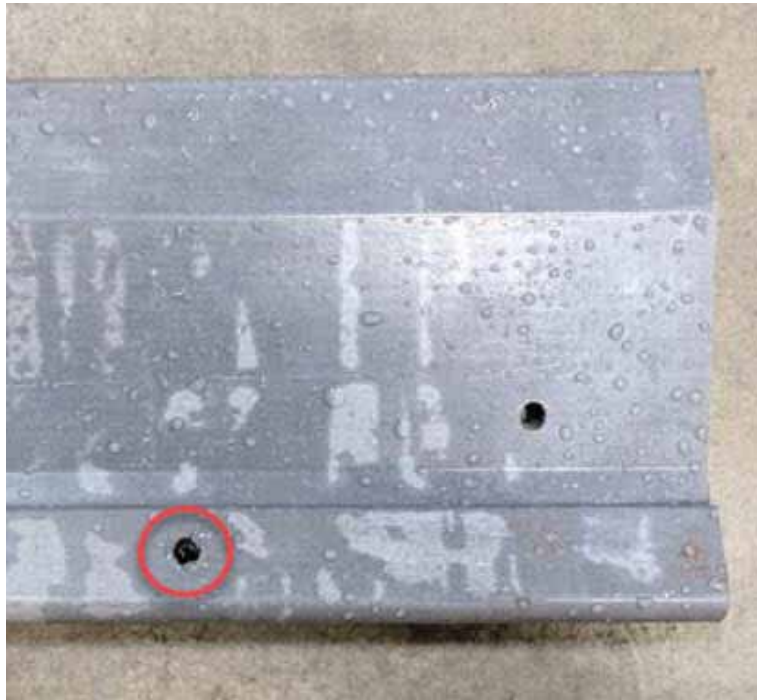
Pilot hole on rear side of support.

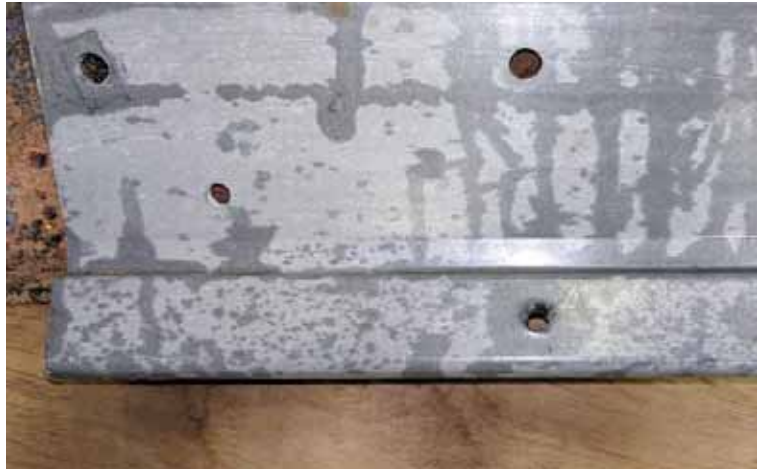
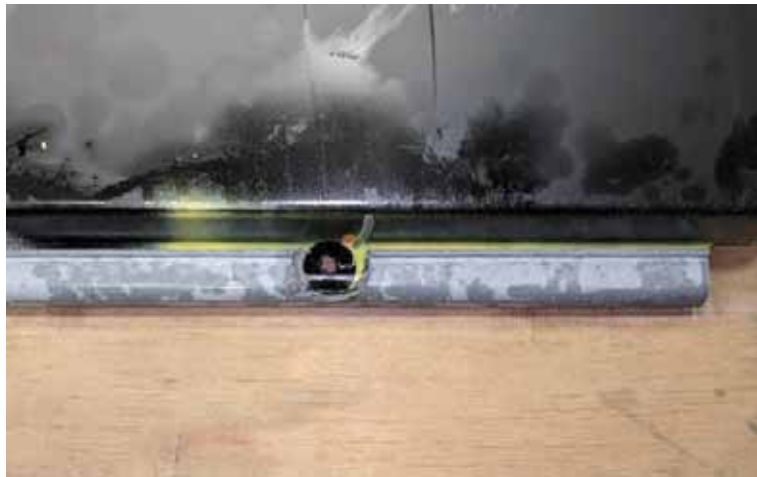
**3.1** Use pilot hole on back of lower support to drill through fairing skin using 9mm drill bit (or 11/32) – \*Do this for each end of the lower support\*

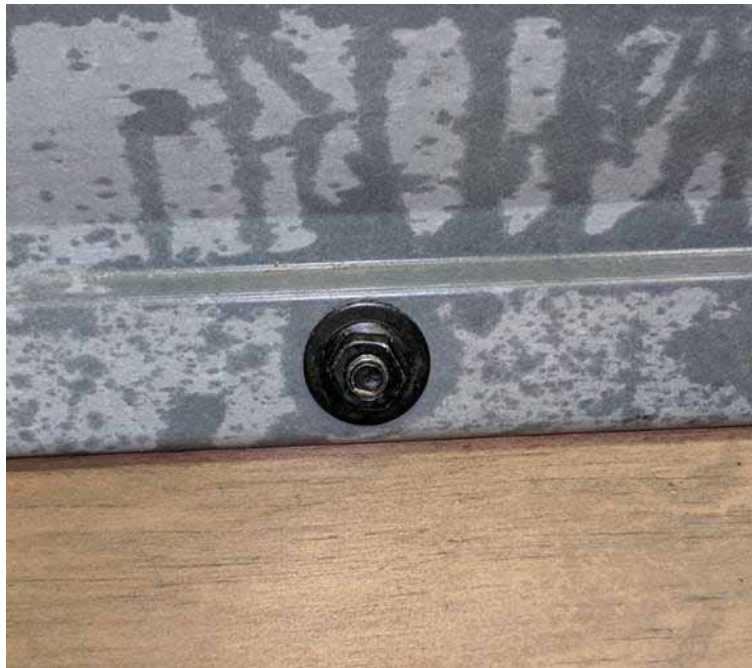
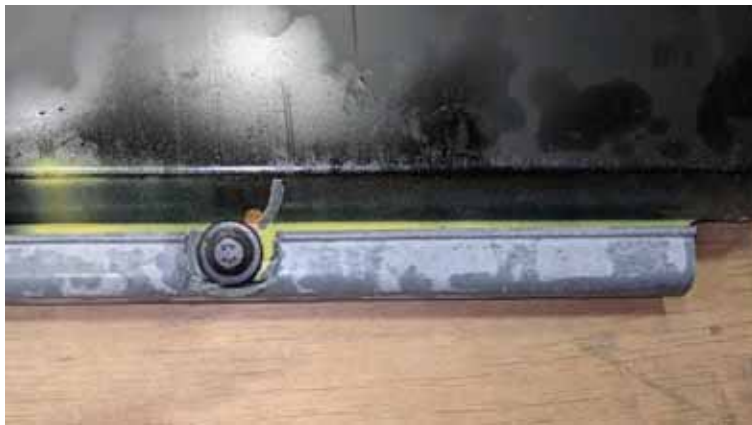
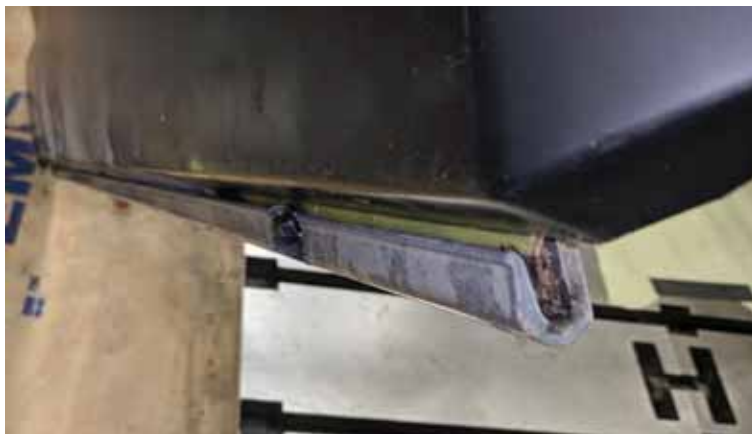
Outboard Side

4. Place bolt with washer through fairing skin from outboard side
5. Use flange lock nut on back of fairing support
6. Torque to 16 ft-lbs (22 Nm)
