# Campaign Service

**BULLETIN NUMBER:**  
CB19-N-001A

## NONCOMPLIANCE RECALL

### INCORRECT ODOMETER DISPLAY INSPECTION AND REPLACEMENT 19V-064 (Transport Canada 2019-052)

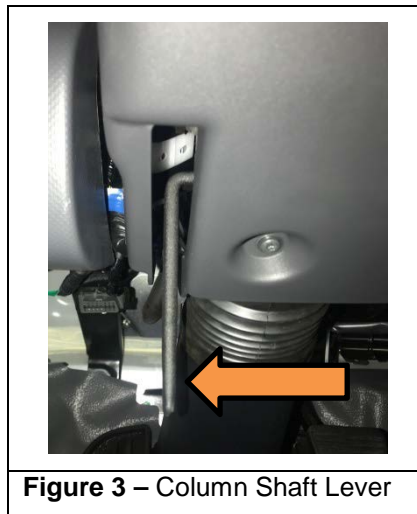
2. Block the vehicle wheels and apply the parking brake.
3. Disconnect the battery ground (-) cable.
4. Pull the column shaft lever to the front and adjust the column angle. Ensure the column shaft lever is locked in place. (See Figure 3.)

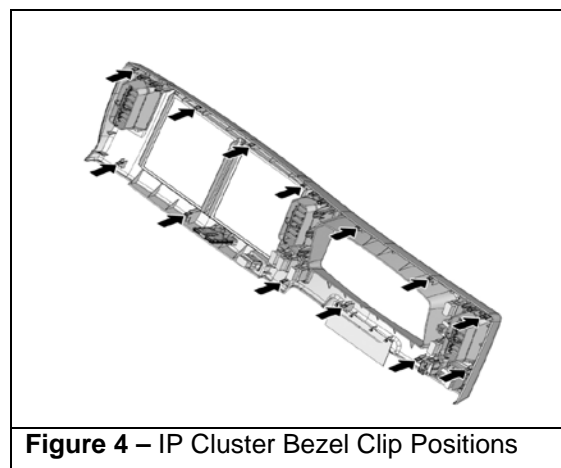
5. Remove the IP cluster bezel.
  - a. Remove the bezel at its thirteen (13) clip positions. (See Figure 4.)

**NOTE: Be sure not to scratch the bezel or damage the connectors when removing the bezel.**

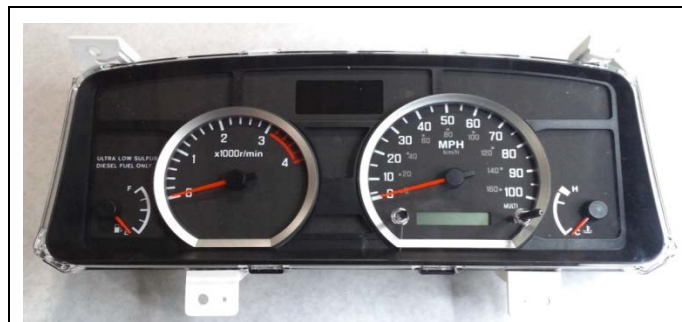
**Figure 6 – New IP Cluster**

7. Install the new IP cluster assembly. (See Figure 6.)

a. Connect the cab harness connectors.

b. Reinstall the four (4) Torx® bolts (T25).

**NOTE: Be careful not to pinch the harness between the IP cluster assembly and the instrument panel.**

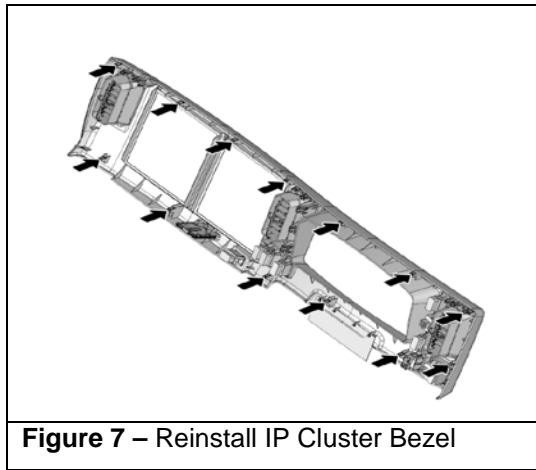
**Figure 7 – Reinstall IP Cluster Bezel**

8. Reinstall the IP cluster bezel. (See Figure 7.)

a. Connect the cab harness connectors.

b. Push and install the IP cluster bezel at its thirteen (13) clip positions.

**NOTE: Be sure not to scratch the bezel or damage the connectors when reinstalling the bezel.**
