## Grote MicroNova Dot LED Marker Lamps

SERVICE BULLETIN #491

3/19/2019

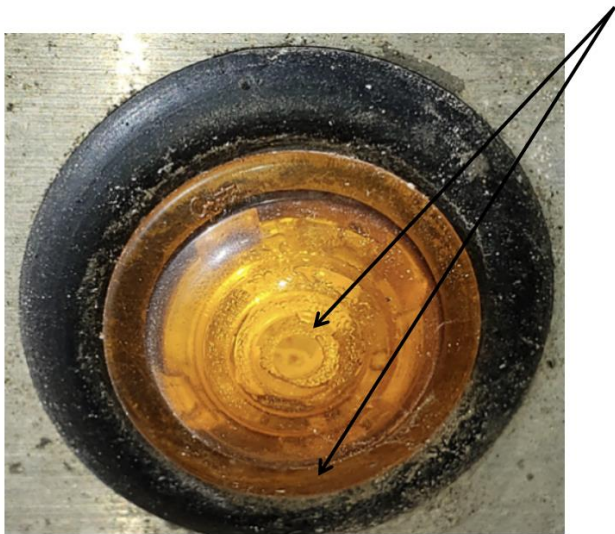
Image of lamp with subject condition (Note: Moisture at bottom of lamp and condensation behind lens):

(Covered by this bulletin and warranty).

Great Dane will replace, at no charge, any of the subject lamps that exhibit moisture or condensation on the interior of the lens. This replacement effort applies to all of the above-identified part numbers within the warranty period that have not experienced physical damage, such as from road hazards or other impact damage. The existing warranty procedure is applicable.

We highly recommend replacing working lights with physical damage due to the concern for corrosion and possible overheating.
