Title: DuraStar 08TSB BlindSpotter Wired to Battery Power

Applies To: DuraStar with 08TSB built between 11/23/2016 and 11/12/2018

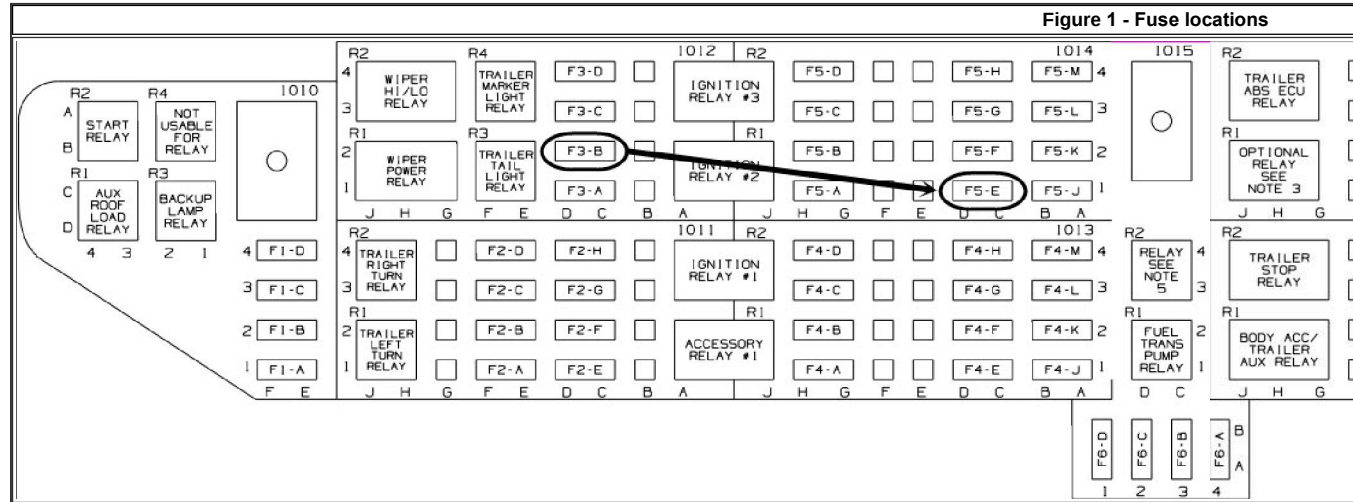
Wire 67TA will need to be moved from F3-B to F5-E
