Technical Service Bulletin

69 Airbag warning light on, DTC B1225F1 stored in the airbag control module

69 19 39 2051242/3 April 26, 2019. Supersedes Technical Service Bulletin Group 69 number 18-37 dated October 5, 2018 for reasons listed below.

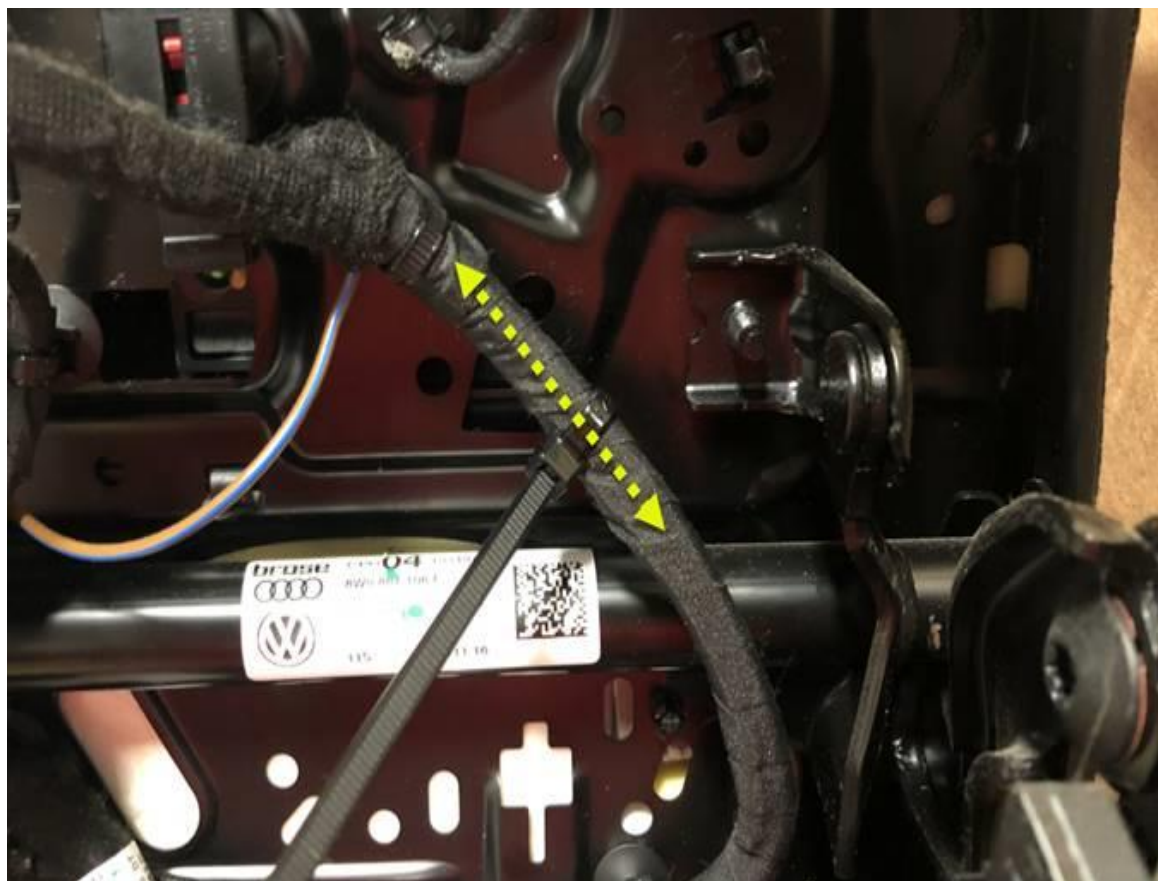
Figure 2. Attach the first cable tie in the yellow area.

2. You will attach the first cable tie in the yellow marked area on the harness between the cable tie clip and the crossbar tube as shown below (Figure 2).

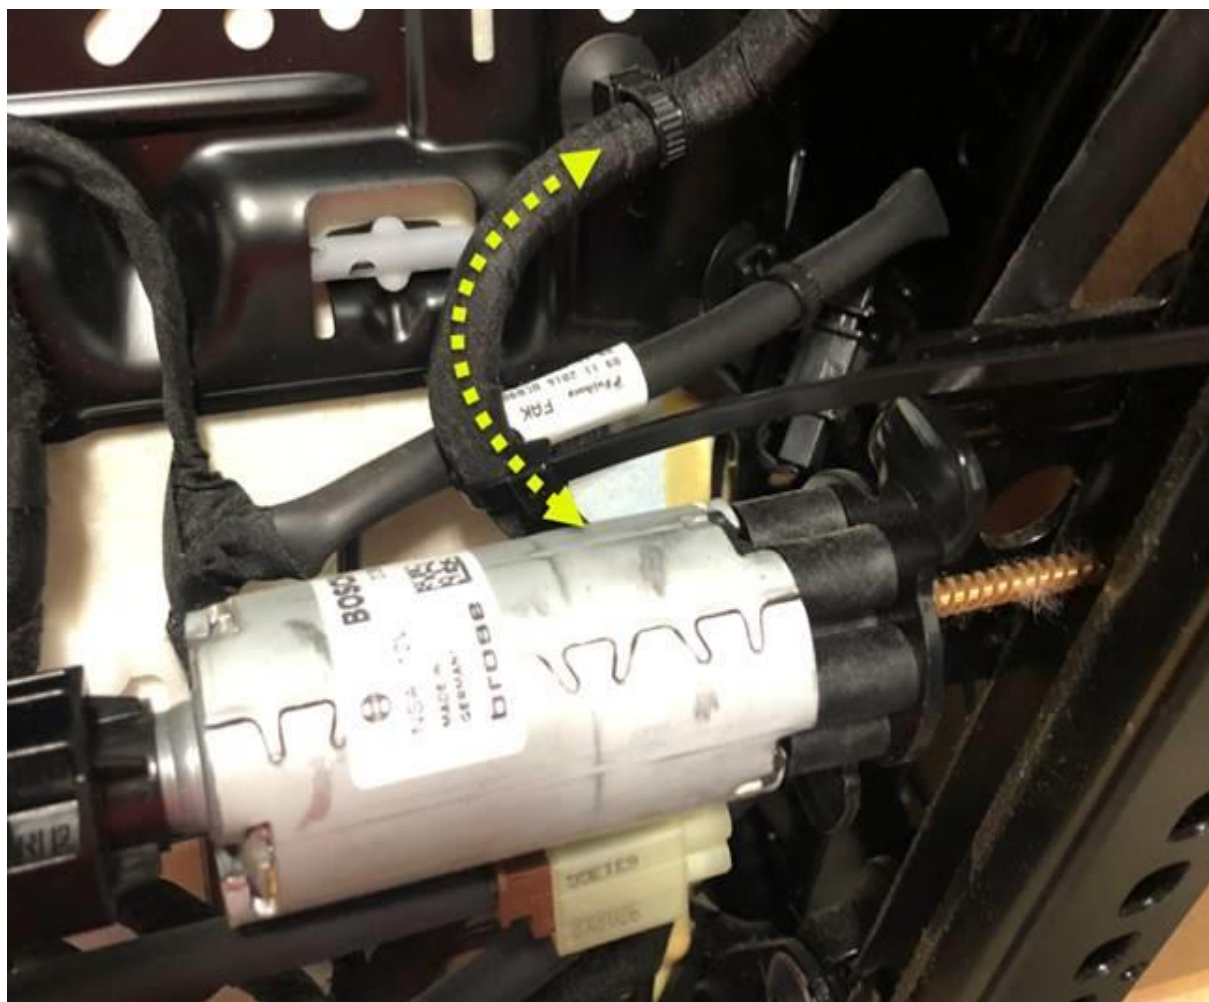
Figure 3. Attach the second cable tie to the yellow marked area.

3. The second cable tie position is to the rear of the crossbar tube where the harness drops down from the frame. Place the cable tie in the yellow marked area shown below (Figure 3).

When tightening the cable ties, only tighten them with your hands, do not use any tools to tighten the cable tie as this can damage the harness. Then cut off the excess length from the tie wrap.
