Service Action

Code: 34H8

Subject	DSG Gearbox
Release Date	May 01, 2019
Revision Summary	Updated work procedure, torque specifications updated on page 43 for ball joint nuts.
Affected Vehicles	U.S.A. & CANADA: Certain 2017 MY Audi A3 Sedan, A3 Cabriolet & TT Coupe <i>Check Campaigns/Actions screen in Elsa on the day of repair to verify that a VIN qualifies for repair under this action. Elsa is the <u>only</u> valid campaign inquiry & verification source.</i> <ul style="list-style-type: none">✓ Campaign status must show "open."✓ If Elsa shows other open action(s), inform your customer so that the work can also be completed at the same time the vehicle is in the workshop for this campaign.
Problem Description	Over time, affected vehicles may develop gearbox noise due to an insufficient supply of oil within the gearbox.
Corrective Action	Replace the DSG gearbox.
Parts Information	Parts allocation did not occur. Dealers should place orders by VIN for affected vehicles currently in dealer inventory. Dealers scheduling customer vehicle repairs must place their parts order by VIN and ensure that parts are on-hand when the vehicle arrives at the dealership for the scheduled repair appoin

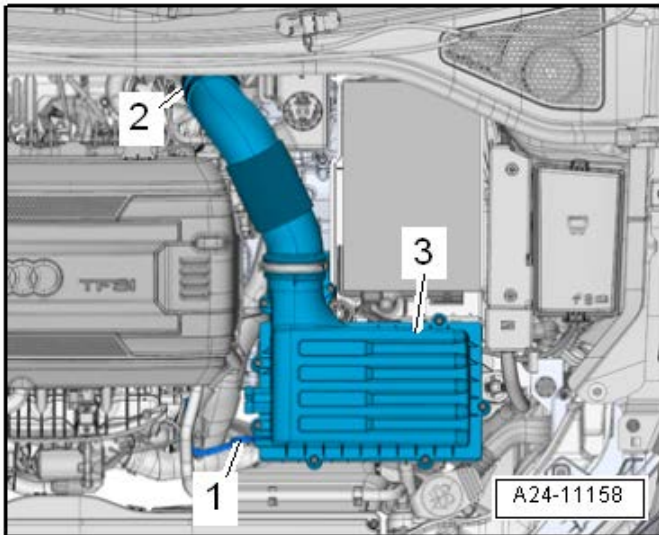
- Disconnect the vacuum hose <1>.
- Loosen the clamp <2> and remove the air guide hose.
- Carefully remove the air filter housing <3>.

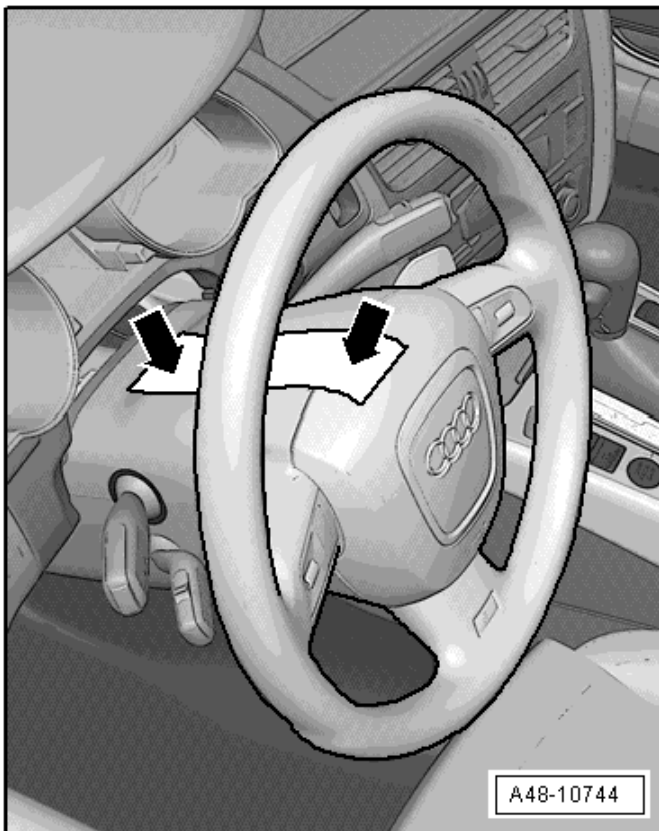
- Turn the steering wheel to the straight-ahead position and remove the ignition key so that the steering wheel lock engages.
- Turn the steering wheel so that the wheels are in the straight-ahead position and then tape it secure <arrow> so that it cannot turn.
- Vehicles with “Keyless Access Authorization System”:
 - Switch the ignition off and open the driver door so the steering wheel lock locks.

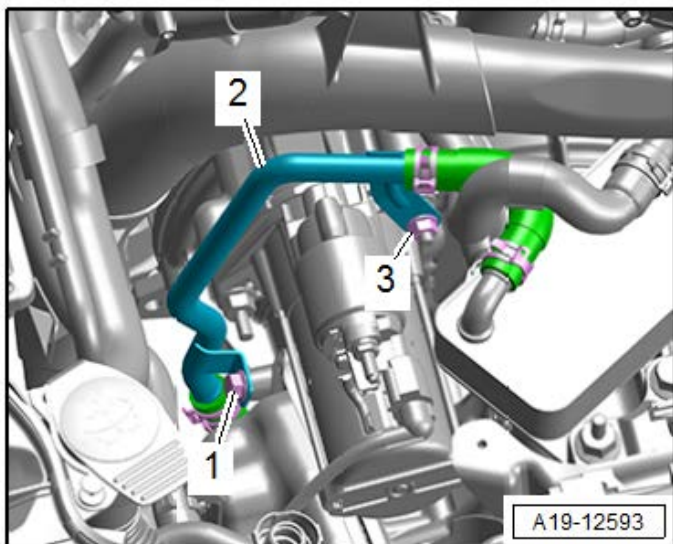
- If equipped, remove the nut <3> and bolt <1>.
- Free up the coolant pipe <2>.

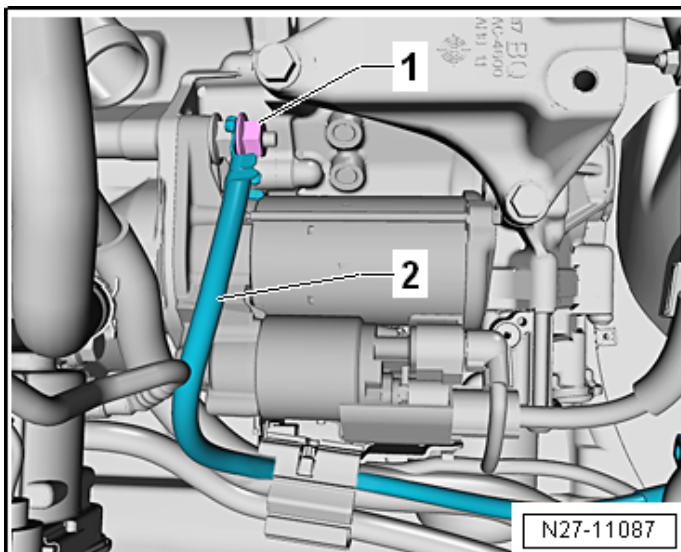
- If equipped, remove the nut <1> from the upper bolt of the Starter.
- Remove the ground cable <2>.

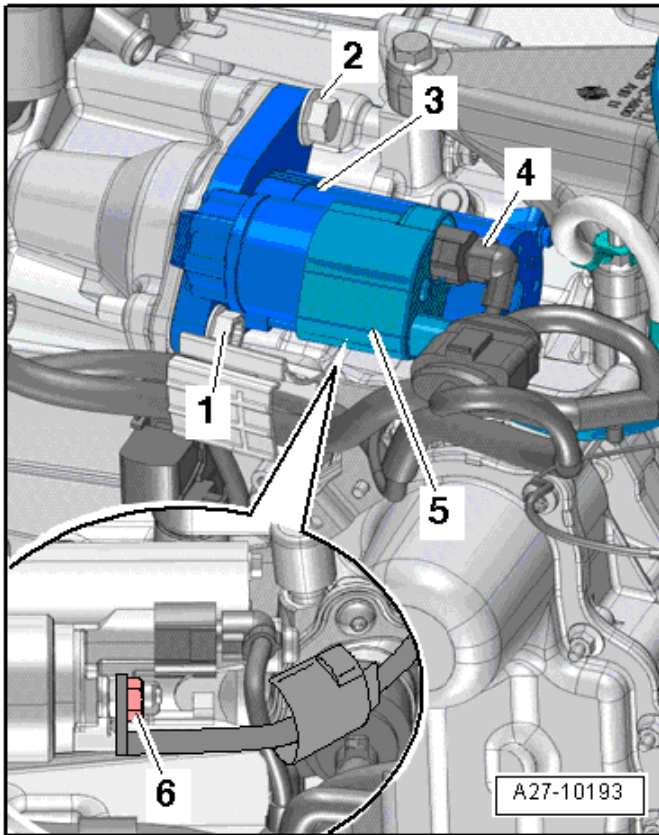
- Disconnect the connector <4> by sliding the retainer back and pressing the release down.
- Remove the cap <5>.
- Remove the nut <6> and terminal 30/B+.
- Remove the starter bolts <1 and 2>. Remove the lower bolt <1> first.
- Remove the starter <3> upward.

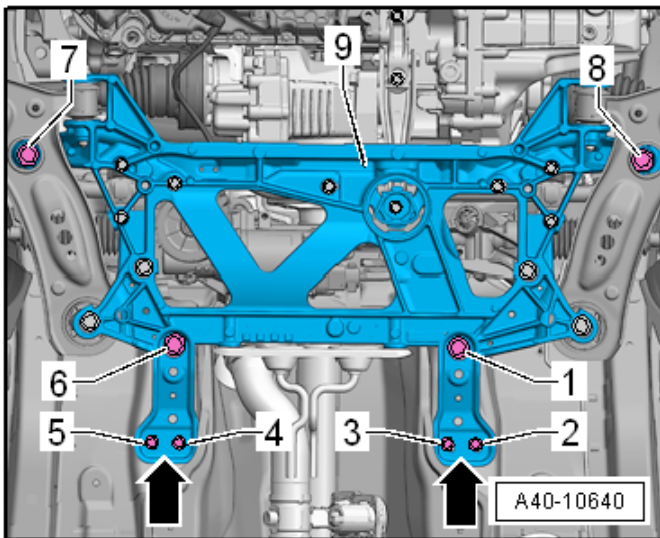
- When locating the subframe, the locating pins (-T10486-) must be installed one at a time. Do not remove the next subframe bolt until the locating pin is installed.
- The -T10486- may only be tightened to a maximum of 20 Nm, otherwise the threads of the locating bolts will be damaged.

- Remove bolt <1> and install -T10486-.
- Remove bolt <6> and install -T10486-.
- Remove bolt <7> and install -T10486-.
- Remove bolt <8> and install -T10486-.
- The subframe is now located.

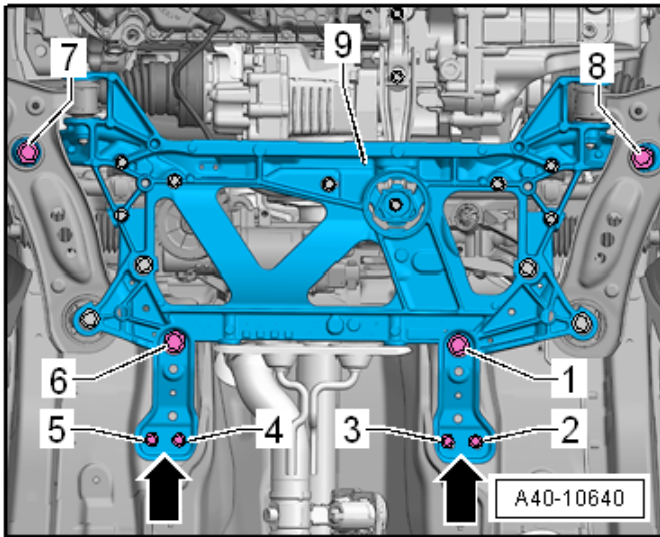
- Loosen the bolts <2, 3, 4, and 5> for the left and right support <arrows>.
- Slowly lower the subframe just enough to gain access to the steering gear heat shield and connectors. Do not put tension on the wiring.

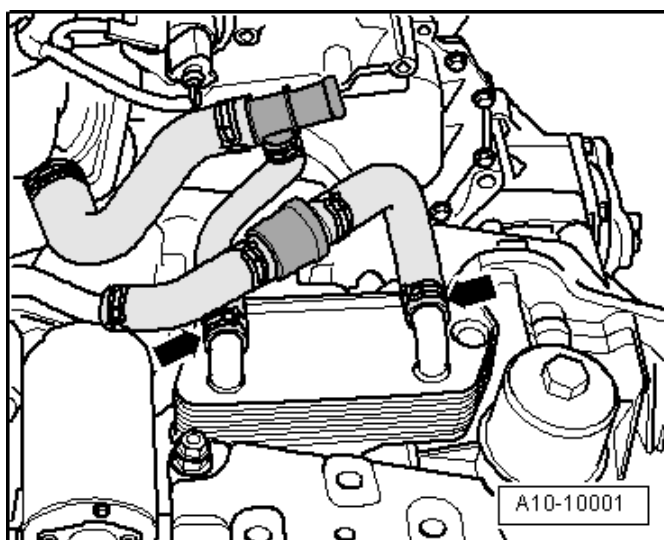
- Clamp off coolant hoses on transmission oil cooler with -3094-.
- Loosen the hose clamps <arrows>, remove the coolant hoses from the transmission fluid cooler.
- Seal the open lines and connections with clean plugs from the -VAS6122-.

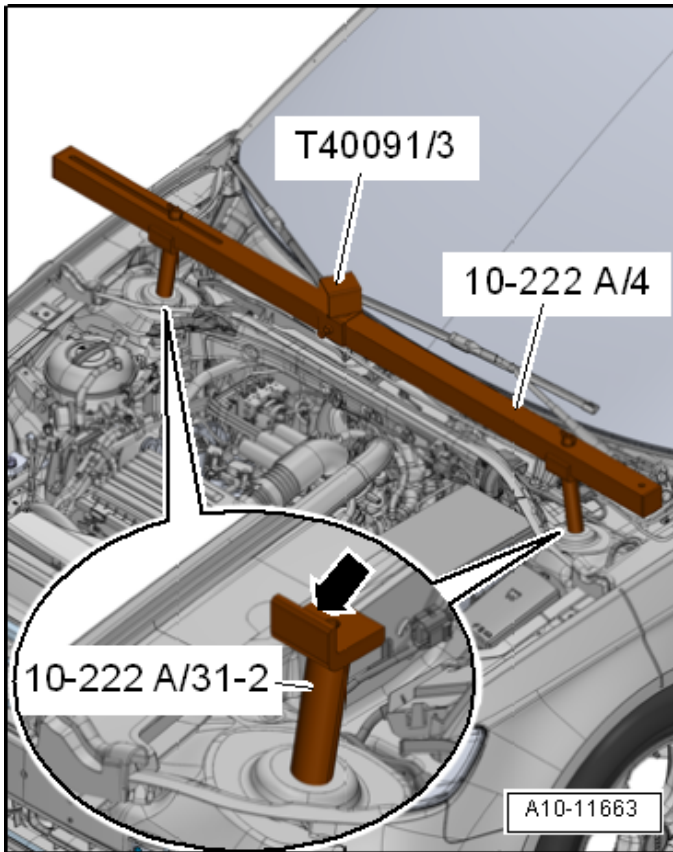
- Remove caps above the front suspension strut bolted connections.
- Place the -10-222A/31-1- and -10-222A/31-2- on the suspension strut mounts with the ribs <arrow> facing the direction of travel.
- Position the -10-222A/4- with -T40091/3- as shown in the illustration.

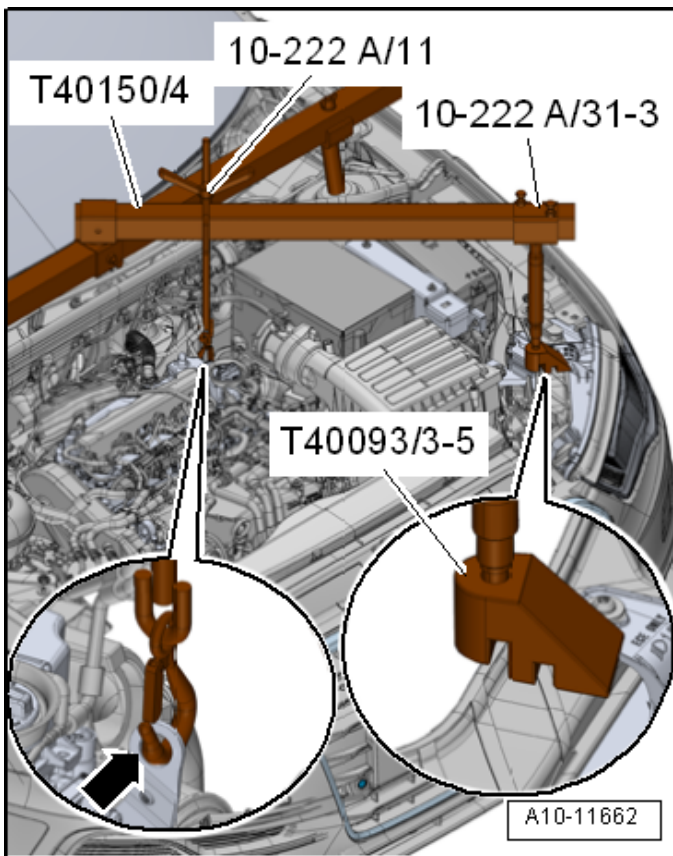
- Install the additional tools on the left in the engine compartment as illustrated.
- Attach the left -10-222A/11- carabiner hook to the engine lifting eye <arrow>.
- Slightly tension the engine/transmission assembly with the spindle, do not lift.

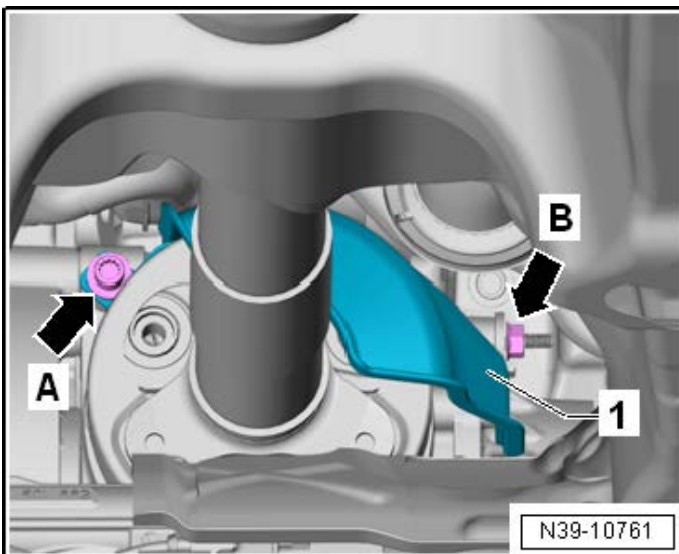
- Remove the bolts <A and B> from the bevel box and remove the heat shield <1>.

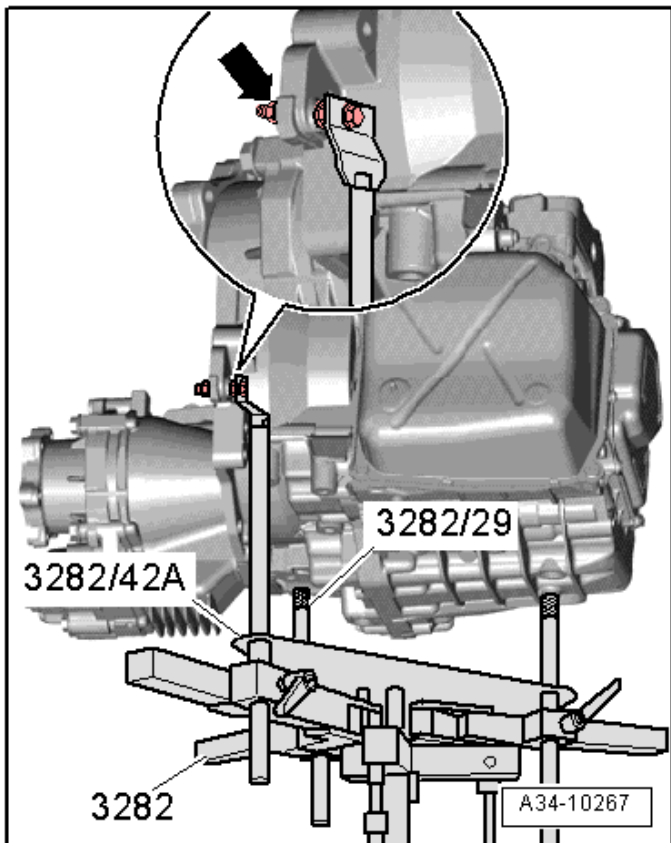
- To remove the transmission the -3282- must be equipped with the -3282/42A-.
- Place the -3282- on the -VAG1383A-.
- Align the arms of the transmission support so that they match up with the holes in the -3282/42A-.
- Install support elements as shown on the -3282/42A- The “retaining plate with hole” is used as a front support element.
- Place the -VAG1383A- under the transmission.
 - The arrow symbol on the adjusting plate points in the direction of travel.
- Align the -3282- so that it is parallel to the transmission.
- Install the -3282/29- in the transmission.
- Attach the “retaining plate with hole” securely to the transmission <arrow> as shown.
- Insert the last support element in the transmission as shown.
- Support the transmission by lifting it from underneath using the -VAG1383A-.

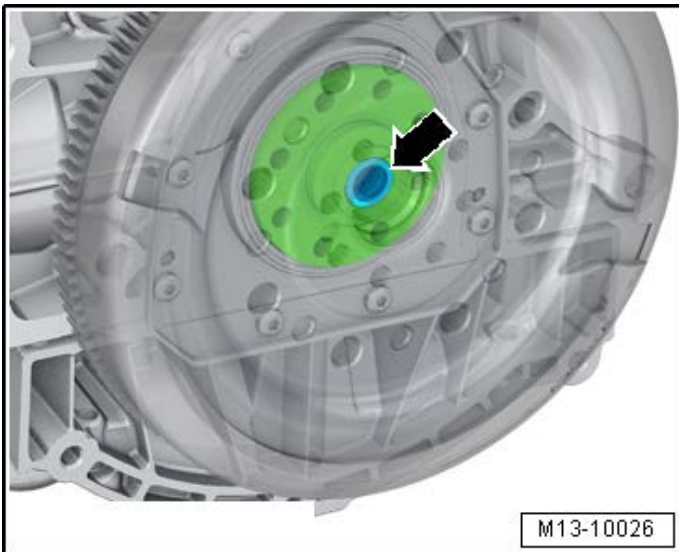
- Replace the needle bearing in the crankshaft.
- Always replace the needle bearing <arrow> after separating the engine and transmission.
- If the needle bearing in the crankshaft is damaged, the gears will no longer shift correctly.
- The front edges of the internal puller must not be broken off.

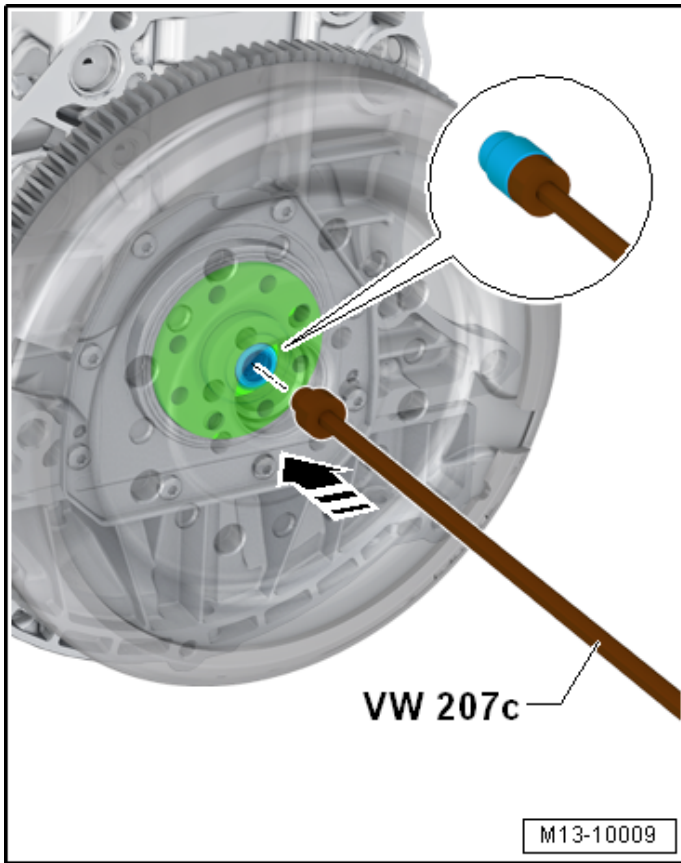
Installation Depth Dimension <a> = 2.0 mm

If the needle bearing was unintentionally pushed in too deeply, it must be replaced, because it will be damaged when it is removed again.

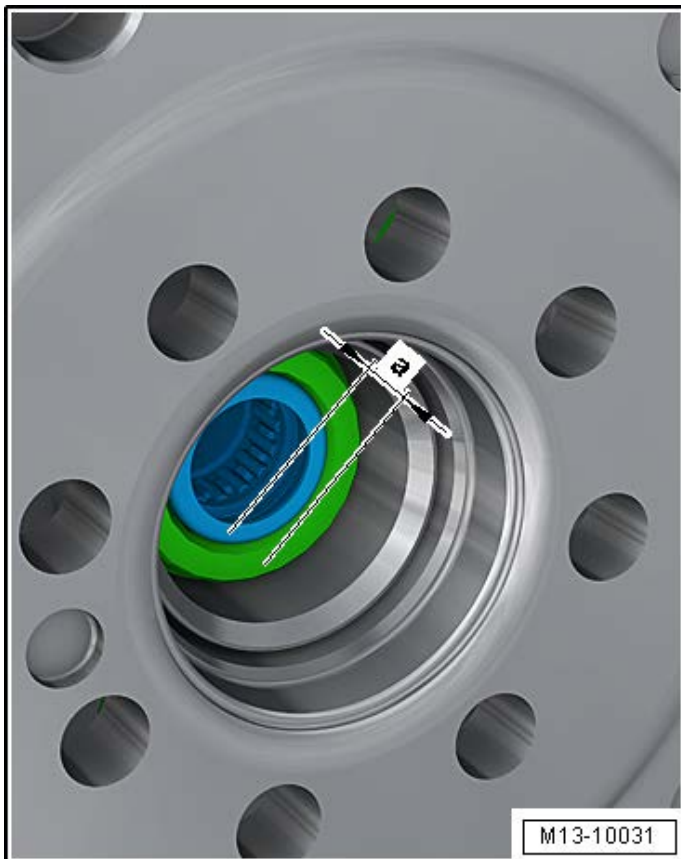
- Clean the bearing seat in the crankshaft and thinly coat with grease.
- Drive the needle bearing into the crankshaft up to the installation depth using the Bearing Installer - Bearing Press Piece -VW207C-.

- Installation Depth Dimension <a> = 2.0 mm

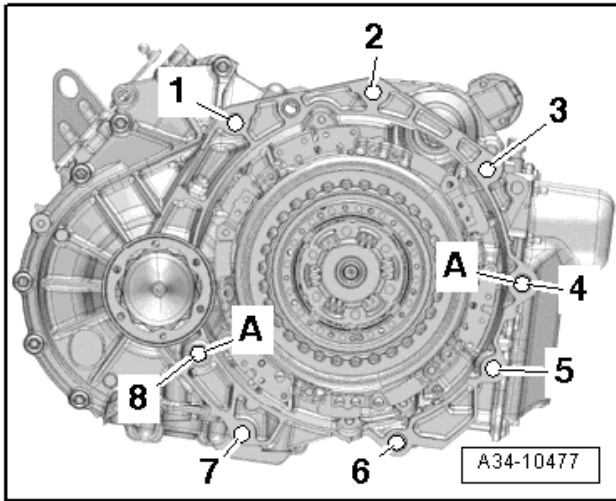
- Install and tighten to specification the lower transmission bolts first <5, 6, 7, and 8>.
- Once bolts <5, 6, 7, and 8> are installed and torqued to specification, remove the -3282- transmission support from the transmission and lower the -VAG1338A- engine and transmission jack.
- Install and tighten the remaining transmission bolts. See chart below for bolt locations, lengths, and tightening specifications.

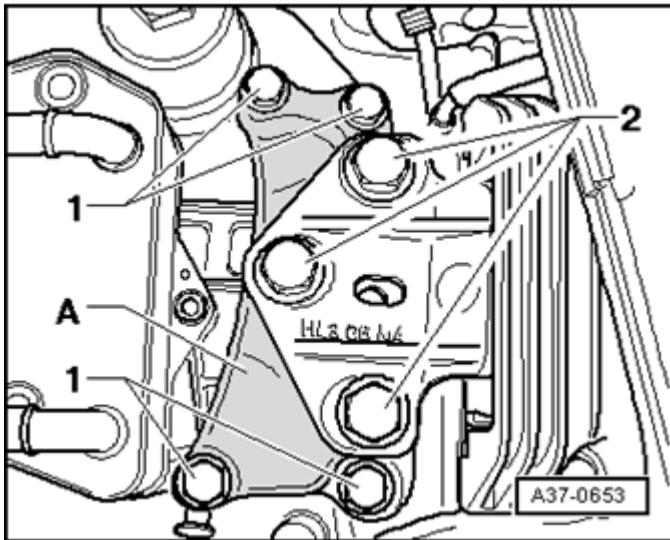
- Align the engine/transmission assembly without tension.
- Install the left transmission mount as follows:
 - Replace all the bolts <1 and 2>.
 - Install the new bolt first hand-tight.
 - Install the bolts <1> in the transmission bracket <A>.
- Align the engine/transmission in its installation position. To do so, lift it until the transmission bracket is completely touching the transmission mount.
- Pry the transmission bracket <A> into the seat using a screwdriver while tightening the bolts <2>.
- Tighten the bolts <2> to 60 Nm + 90° turn. Tighten the bolts <1> to 40 Nm + 90° turn.

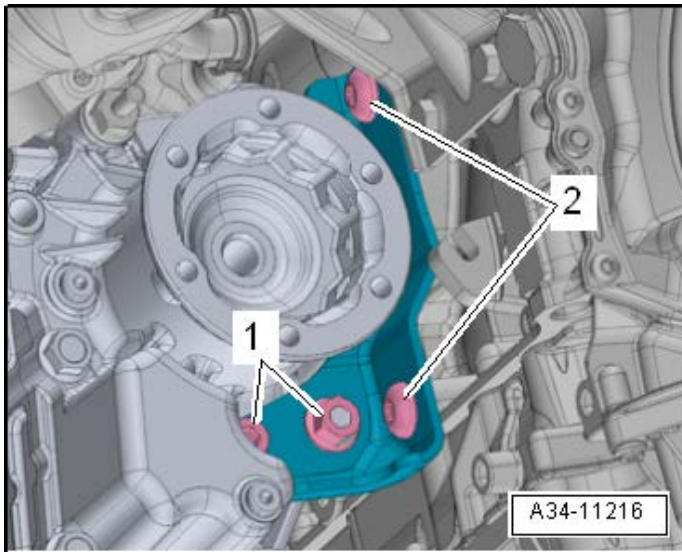
- New bolts <1 and 2> should be installed.
- Hand-tighten all bolts first, starting with bolts <1>, then bolts <2>, in sequence.
- Follow the installation and tightening sequence:
 - First hand tighten bolts <1>: Tighten the bolts to 40 Nm.
 - Then hand tighten bolts <2>: Tighten the bolts to 40 Nm.

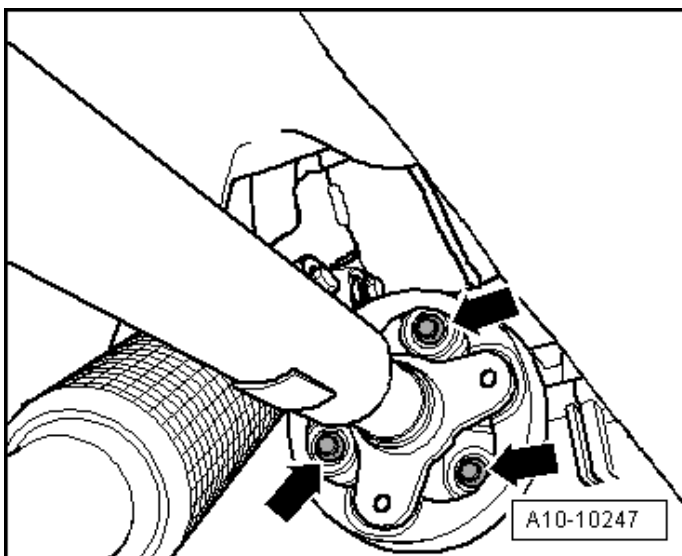
- Attach the driveshaft to the bevel box flange and install the bolts <arrows>. Tighten the bolts to 50 Nm + 90°.

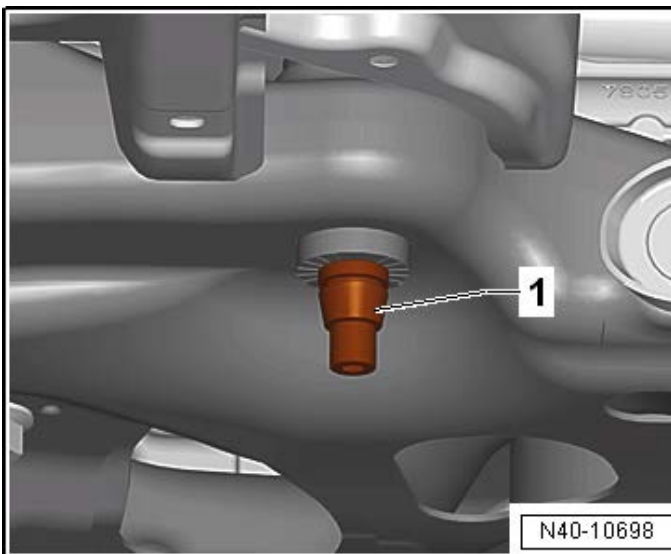
- Lift the subframe further and carefully install the subframe onto the locating pins <1>.
- Make certain that the locating pins do not move during the reinstallation of the subframe or the vehicle alignment may be compromised.

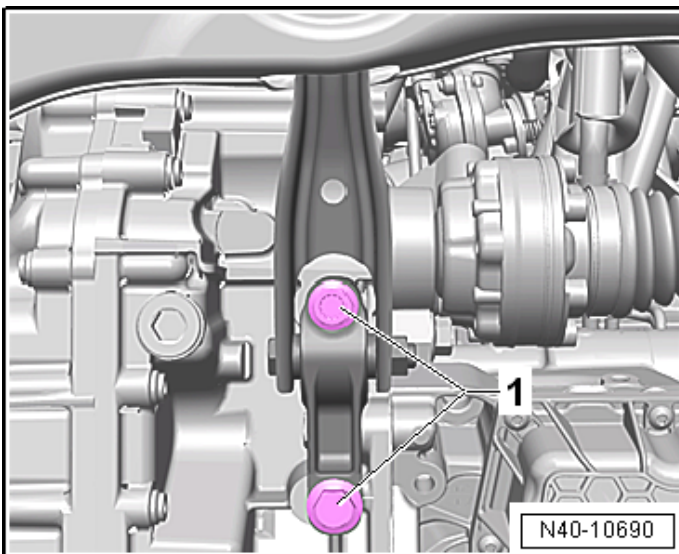
- Install the pendulum support with new bolts <1> on the transmission.
- Tighten the new bolts to 50Nm + 90°.

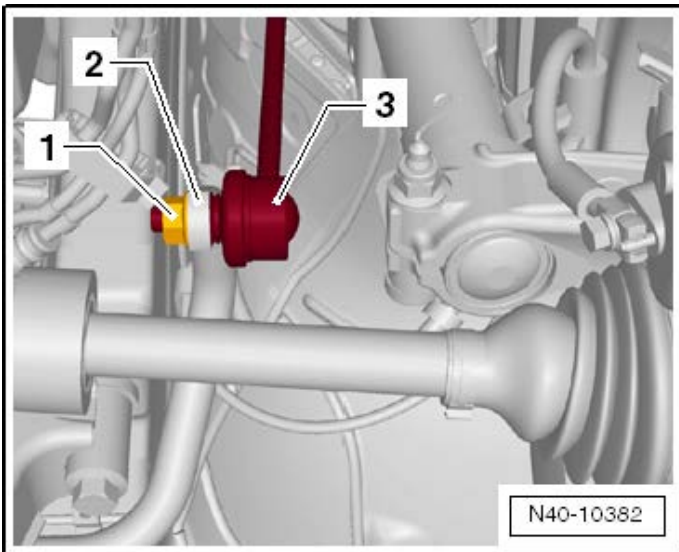
- Install new hex nuts <1> onto the right and left coupling rod <3>.
- Tighten the coupling rod nuts to 65 Nm.

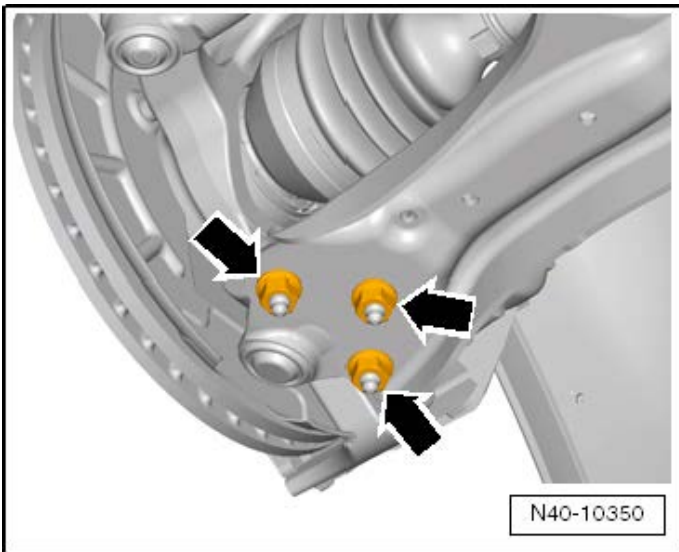
- Install the new ball joint nuts <arrows> on the left and right side of the vehicle.
- Tighten the nuts to 40 Nm + 45 Deg.

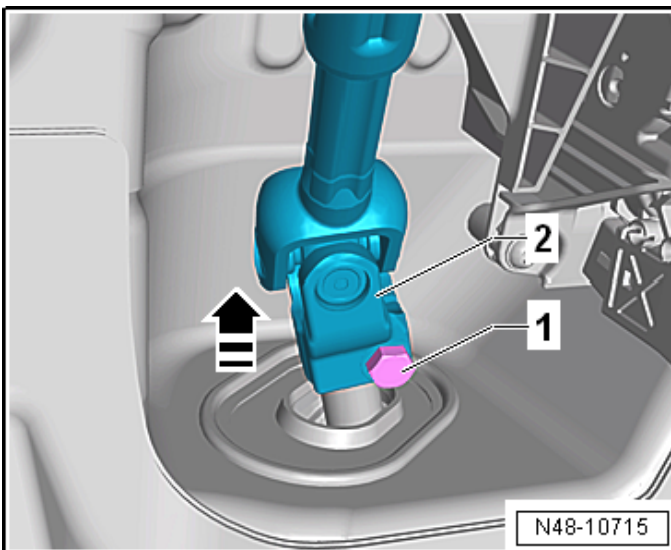
- Install a new bolt <1> for the universal joint <2> and tighten the bolt to 20 Nm + 90°.

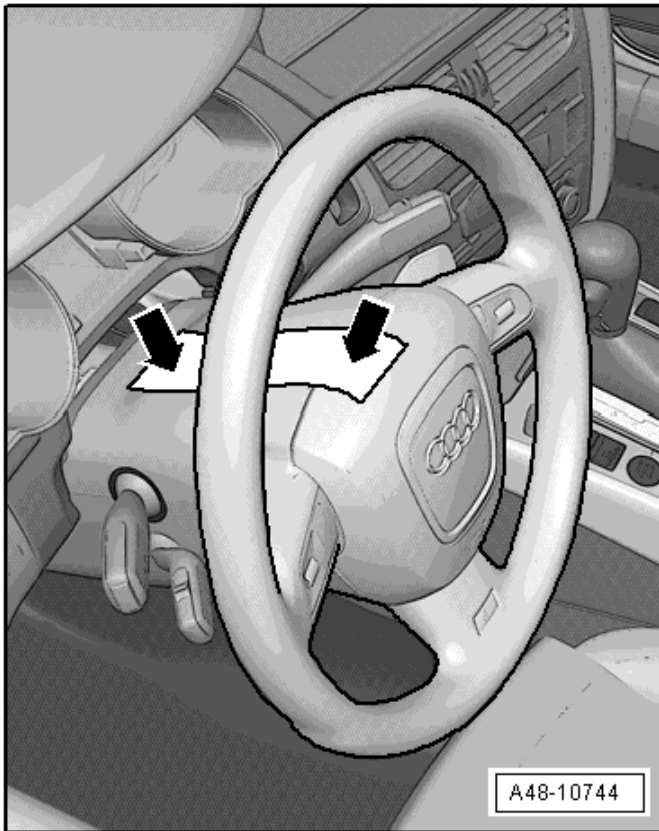
- Remove the securing tape from the steering column <arrow> and verify no residue was left. If tape residue exists, clean the surface with a suitable cleaner.
