Service Action **Code: 34H7**

DSG Gearbox

Over time, affected vehicles may develop gearbox noise due to an insufficient supply of oil within the gearbox.

Replace the DSG gearbox.

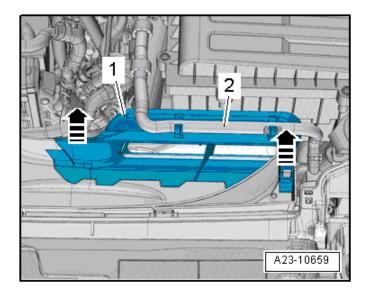
- Free up the coolant hose <2>.
- Release the locking mechanism in direction of <arrows> and remove the air guide upper section <1>.

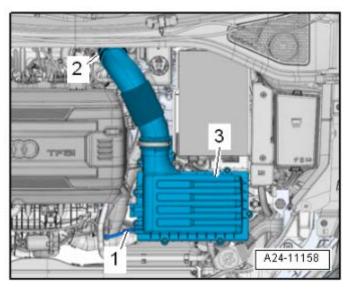
- Disconnect the vacuum hose <1>.
- Loosen the clamp <2> and remove the air guide hose.
- Carefully remove the air filter housing <3>.

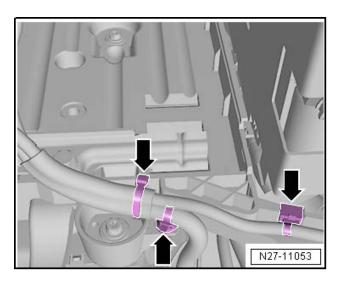
Free up the wiring harness from the battery tray <arrows>.

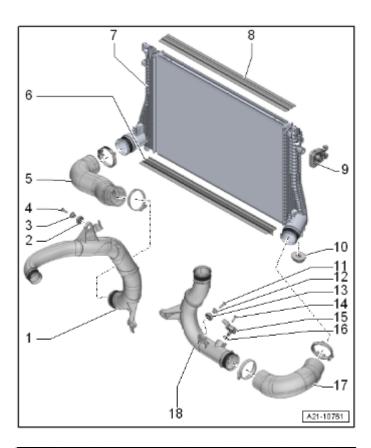
Remove the charge air pipe with the charge air hose <1 and 5> by disconnecting the fastener <4> and removing the clamps.

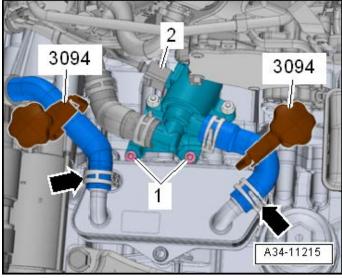
- Clamp the coolant hoses going to the transmission oil cooler with the -3094- hose clamps.
- Loosen the hose clamps <arrows> and remove the coolant hoses from the transmission fluid cooler.
- Remove the bolts <1> and move the Transmission Coolant Valve -N488- to the side.
- Seal off the transmission fluid cooler connections with suitable sealing plugs taken from the -VAS6122-.

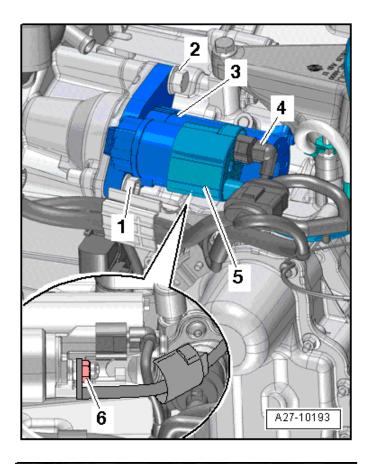
- Disconnect the connector <4>.
- Remove the cap <5>.
- Remove the nut <6> and terminal 30/B+.
- Remove the starter bolts <1 and 2>. Remove the lower bolt <1> first.
- Remove the starter <3> upward.

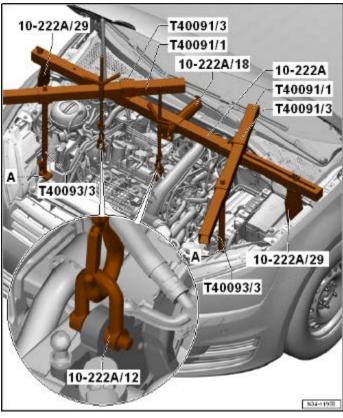
For Golf Models (Criteria 17, 18, 19, and 27):

- Attach the -10-222A- Engine Support Brace as shown.
- See ELSA for additional details.

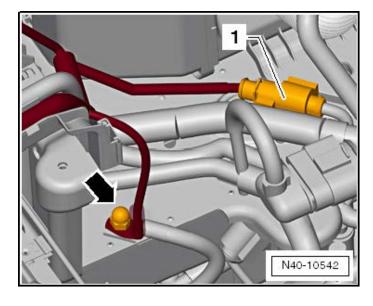
For Passat and Jetta Models (Criteria 05 and 08):

- Disconnect the connector <1>.
- Remove the cap nut <arrow> and disconnect the ground wire.
- Remove the wiring harness from the bracket on the longitudinal member so that it can be removed together with the steering gear.

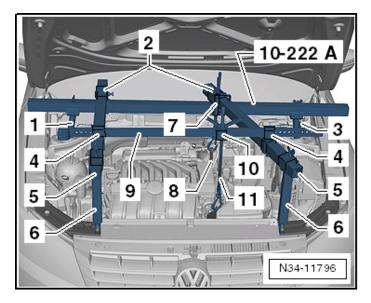
For Passat Models (Criteria 05):

- Attach the -10-222A- Engine Support Brace as shown.
- See ELSA for additional details.

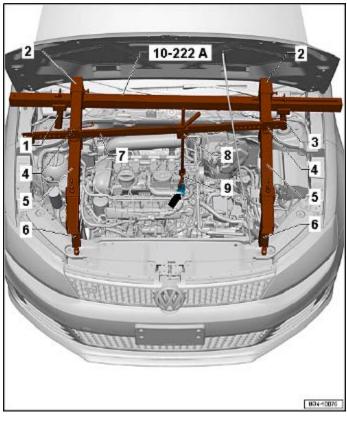
For Jetta Models (Criteria 08):

- Attach the -10-222A- Engine Support Brace as shown.
- · See ELSA for additional details.

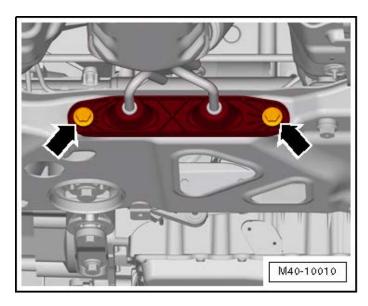
• Remove the exhaust system bracket from the subframe <arrows>.

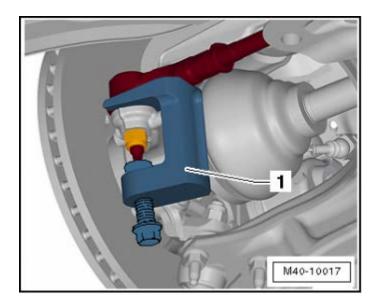
- · Remove tie rod end nut.
- Remove the tie rod end from the wheel bearing housing using tool -T10187-.

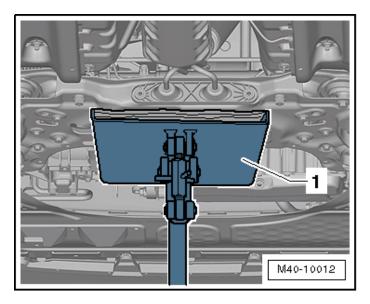
Position the -VAS6931- Engine and Gearbox Jack under the subframe.

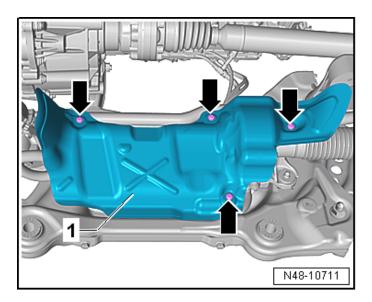
For Golf Models (Criteria 17, 18, 19, and 27):

Remove the bolts <arrows> and remove the heat shield <1> from the steering gear.

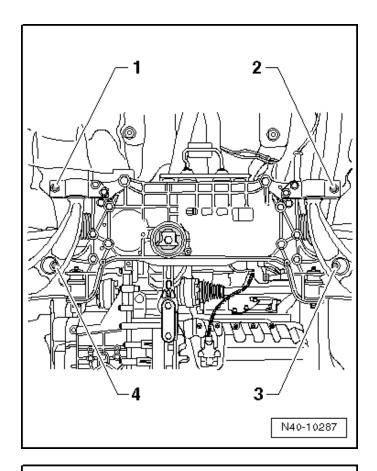
For CC Models (Criteria 06):

- When locating the subframe, the locating pins (-T10096-) must be installed one at a time. Do not remove the next subframe bolt until the locating pin is installed.
- The -T10096- may only be tightened to a maximum of 20 Nm, otherwise the threads of the locating bolts will be damaged.
 - Remove bolt <3> and install -T10096-.
 - Remove bolt <4> and install -T10096-.
 - Remove bolt <1> and install -T10096-.
 - Remove bolt <2> and install -T10096-.

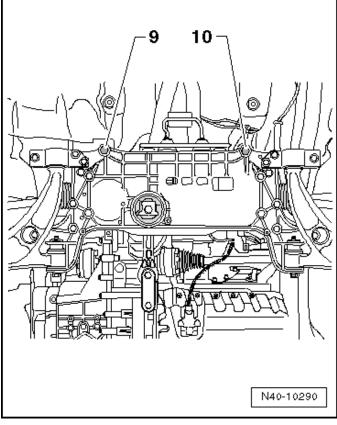
For CC Models (Criteria 06):

• Remove bolts <9 and 10> and slowly lower the subframe using the -VAS6931-.

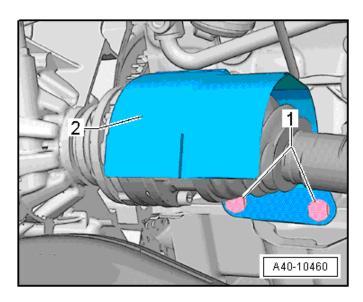
• If installed remove the bolts <1> and the heat shield <2>.

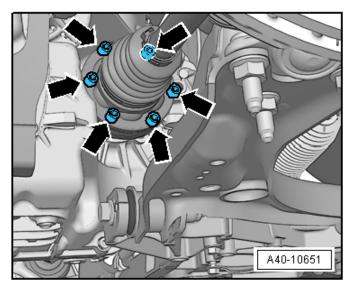
Loosen the bolts <arrows> and remove the drive axles from the transmission flange on both sides.

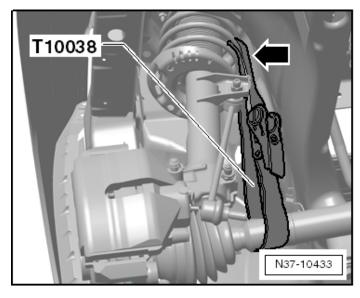
Secure the drive axles to the suspension strut using a -T10038-.

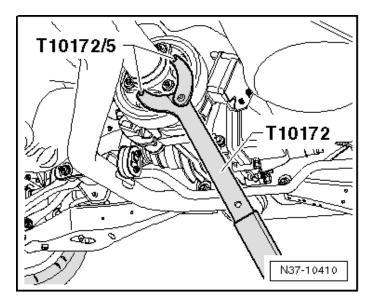
For vehicles with all-wheel drive:

To loosen or tighten, counterhold the driveshaft on the rear final drive using -T10172-.

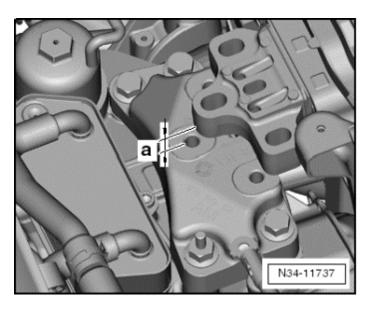
• Lower the engine/transmission approximately 50 mm using the spindles on the -10-222A-.

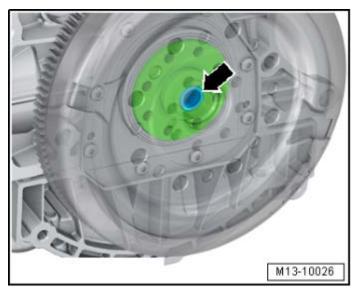
- Always replace the needle bearing in the crankshaft <arrow> after separating the engine and transmission.
- If the needle bearing in the crankshaft is damaged, the gears will no longer shift correctly.
- The front edges of the internal puller must not be broken off.

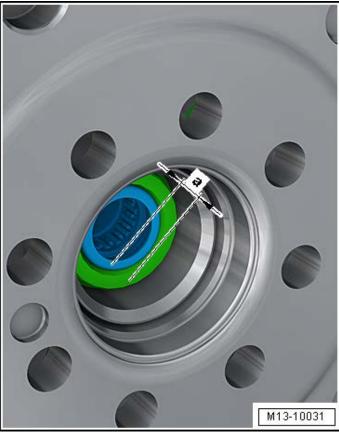
• Installation Depth Dimension <a> = 2.0 mm

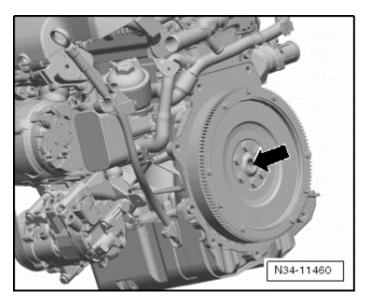
- Transmission pins (not splines) must be lightly lubricated.
- Make sure both alignment sleeves between the engine and the transmission are correctly seated.
- Make sure the intermediate plate is seated correctly.

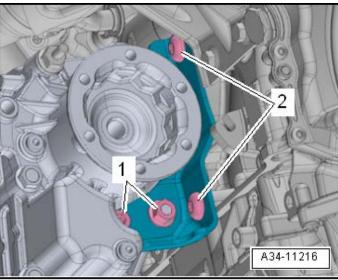
- If equipped, remove the transmission support bracket from the old transmission and install it on the new transmission.
- Replace the bolts with new. Install the new bolts a few turns and leave the bracket loose to allow freedom of movement of the bracket during installation.

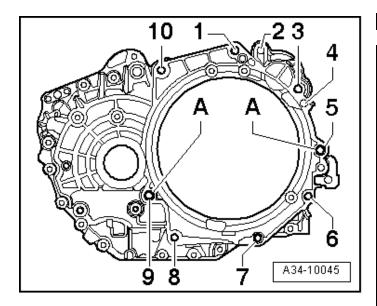
Item	Bolt	Nm
1	M12 x 55	80 Nm (with tool –
		18mm T10179 65
		Nm)
2	M10 x 45	40 Nm
	(Starter to	
	Transmission)	
3	N12 x 55	80 Nm
	(is accessible only	
	through opening in	
	the removed starter	
4	M10 x 45 (or) M10 x	40 Nm
	40	
	(Starter to	
	Transmission)	
5	M12 x65 (or) M12 x	80 Nm
	70	
6	M10 x 50	40 Nm
7	M10 x 50	40 Nm
8	M10 x 50	40 Nm
9	M12 x 65 (or) M12 x	80 Nm
	70 (or) M12 x 80	
10	M12 x 55	80 Nm (with tool –
		18mm T10179 65
		Nm)
Α	Alignment Sleeves for Centering

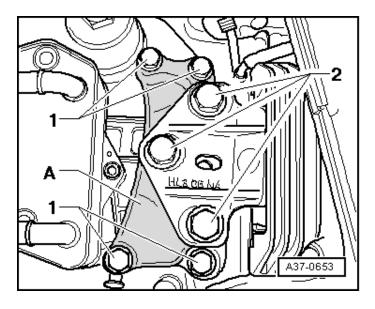
- Align the engine/transmission assembly without tension.
- Install the left transmission mount as follows:
 - Replace all the bolts <1 and 2>.
 - Install the new bolt first hand-tight.
 - Install the bolts <1> in the transmission bracket <A>.
- Align the engine/transmission in its installation position. To do so, lift it until the transmission bracket is completely touching the transmission mount.
- Pry the transmission bracket <A> into the seat using a screwdriver while tightening the bolts <2>.
- Tighten the bolts <2> to 60 Nm + 90° turn. Tighten the bolts <1> to 40 Nm + 90° turn.

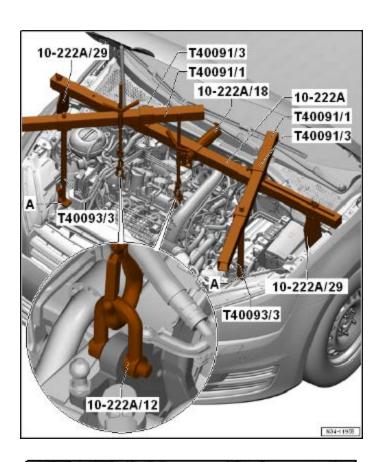
Remove the -10-222A- engine support brace for all vehicles. (Golf shown)

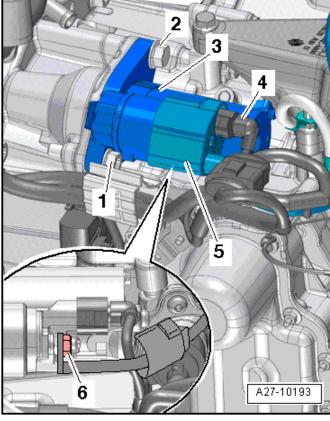
Reinstall the starter <3>. Tighten the bolts <1 and 2> to 40Nm, and reconnect electrical connections <4 and 6> to the starter.

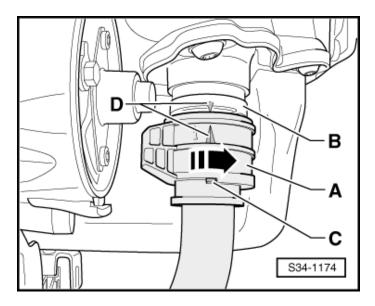
- Connect the connector <A> from the DSG Transmission Mechatronic -J743- as follows:
 - The arrow <D> on the Mechatronic
 B> must line up with the connector
 A> as well as with the tab <C>.
 - Connect the connector <A> carefully all the way and then turn the lock clockwise in the direction of <arrow>.

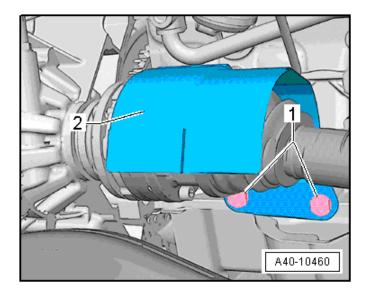
- If equipped, reinstall the bolts <1> and the heat shield <2>.
- Tighten the heat shield bolts <1> to 25 Nm.

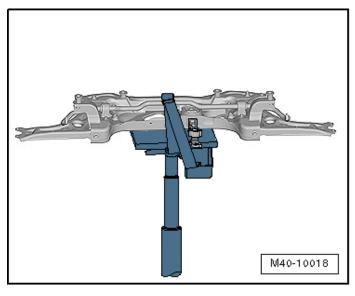
- Reinstall the subframe.
- The removal of the locating pins is reverse of installation, noting the following:
 - Only remove one locating pin at a time and replace each with a new bolt.

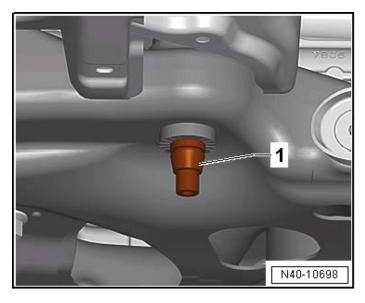
- Carefully install the subframe onto the locating pins <1>.
- Make certain that the locating pins do not move during the reinstallation of the subframe or the vehicle alignment may be compromised.

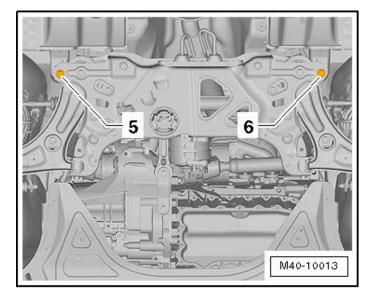
For Passat and Jetta Models (Criteria 05 and 08):

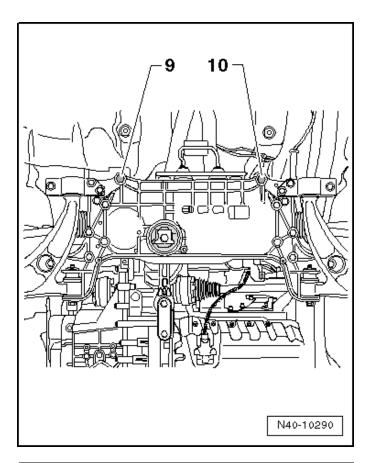
For CC Models (Criteria 06):

Install new subframe bolts <9 and 10> and tighten to 70Nm + 180° turn.

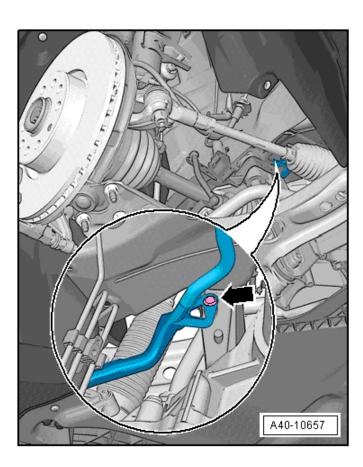
Reinstall the steering gear electrical harness fastener.

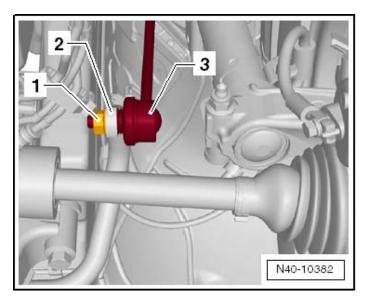
- Install new hex nuts <1> onto the right and left coupling rod <3>.
- Tighten the coupling rod nuts to 65 Nm.

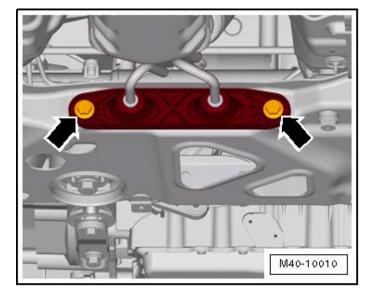
Reinstall the exhaust system bracket onto the subframe <arrows> and tighten the bolts to 23 Nm.

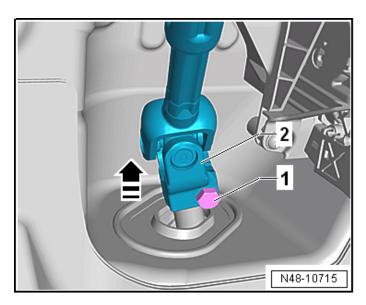
• Install a new bolt <1> for the universal joint <2> and tighten the bolt to 20 Nm + 90°.

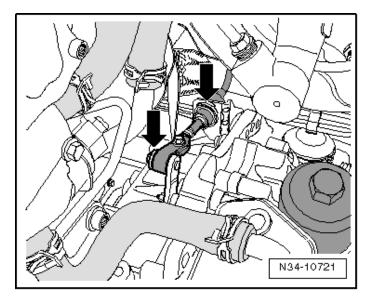
- Reinstall the selector lever cable.
- The selector lever cable lock washers and Orings <arrows> must be replaced. Install new cable lock washers.
- Adjust the selector lever cable if necessary.

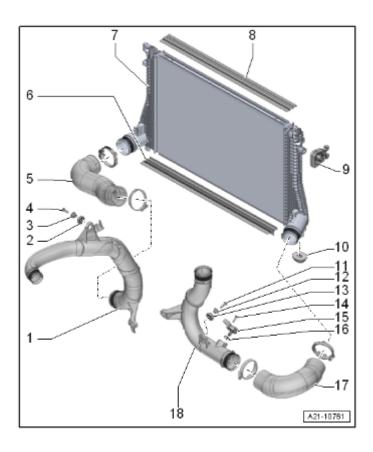
- Reconnect the charge air hose <5 and 1> and reconnect the clamps.
- Reinstall the charge air pipe and tighten the bolt <4> to 7 Nm.

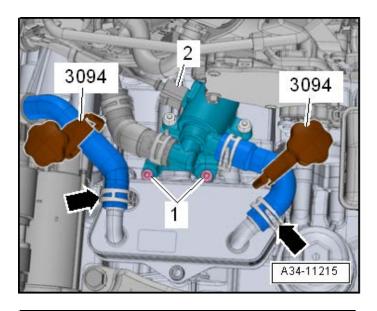
- Reinstall the transmission coolant valve and tighten the bolts <1> to 9 Nm.
- Reinstall the electrical connector <2>
- Reinstall the coolant hoses and reconnect the clamps <arrows>.
- Remove the -3094- coolant hose clamps.

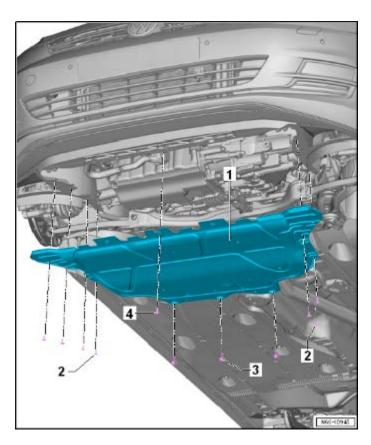
Reinstall the underbody noise installation and tighten the fasteners <2> to 2 Nm. Tighten the fasteners <3> to 6 Nm.

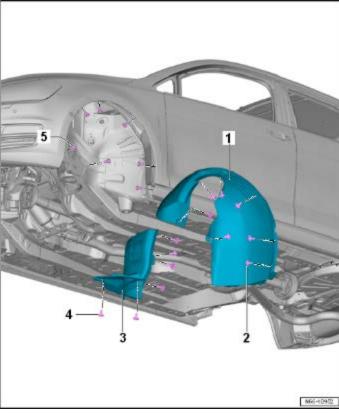
• Reinstall the left front fender liner <1> and tighten the fasteners <2 and 4> to 2 Nm.

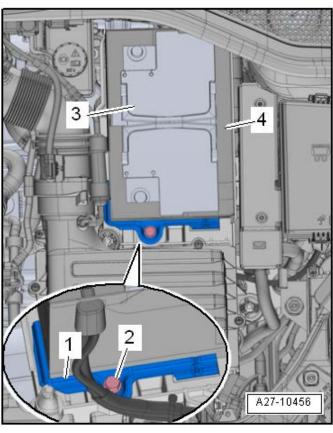
- Reinstall the battery, reinstall the hold down clamp <1> and tighten the hold down clamp bolt <2> to 15 Nm.
- Reconnect the positive battery cable terminal and tighten the nut to 6 Nm.
- Reconnect the negative battery cable and tighten the nut to 6 Nm.

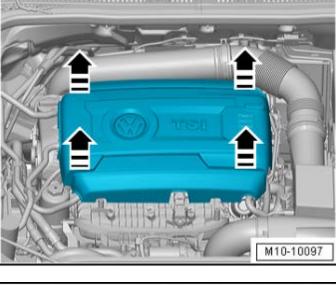
- Reinstall the engine cover.
- In order to prevent causing damage, do not hit the engine cover with your fist or tool.
- Position the engine cover while paying attention to the oil filler tube and oil dipstick.
- Press the engine cover into the rubber grommets on the left side first, then into the ones on the right side.

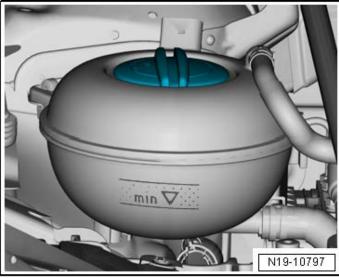
- Top off the coolant reservoir to account for any coolant lost during removal of the transmission cooler lines.
- Verify the DSG transmission fluid level using ODIS test plan. Add fluid as necessary.
- Recheck coolant level after the engine is warm.
