**87-18-05 Air Conditioning Does Not Cool and / or Compressor is Noisy**

Release date: 5/7/2019

The condition may be caused by a faulty **-N280-** A/C Compressor Regulator Valve (Sanden). The internal components of the valve can be obstructed and incapable of full function. This loss of refrigerant regulation from **-N280-** A/C Compressor Regulator Valve can cause noise from the air conditioning compressor and/or affect the HVAC cooling.

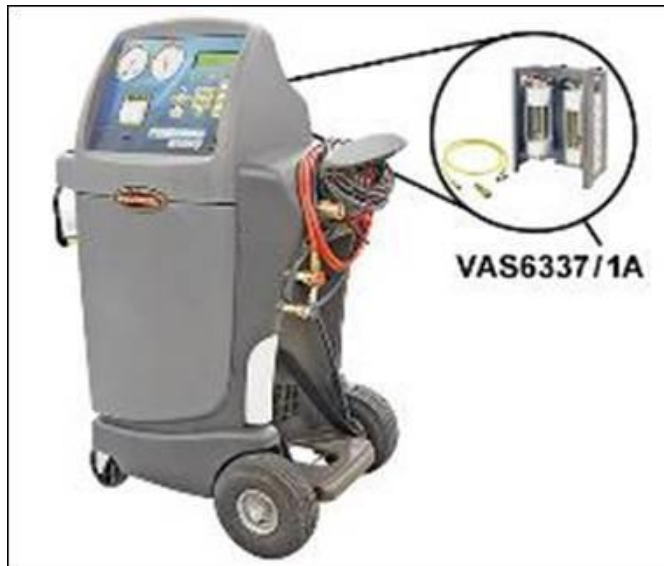
**Figure 4.** Robinair A/C Service Unit.

Connect both the Refrigerant Service Station (Figure 4) and the diagnostic tester to the vehicle.

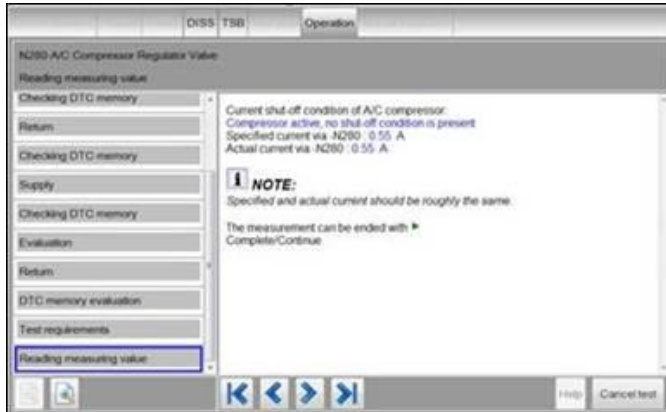
Figure 5. Checking N280 signal value Measuring Value Block.

- Monitor the measuring value for the A/C Compressor - **N280**- A/C Compressor Regulator Valve signal (Figure 5).
- The actual and specified values will be plausible and will show a normal regulating range of current for cooling request (0.400 A – 0.820 A).

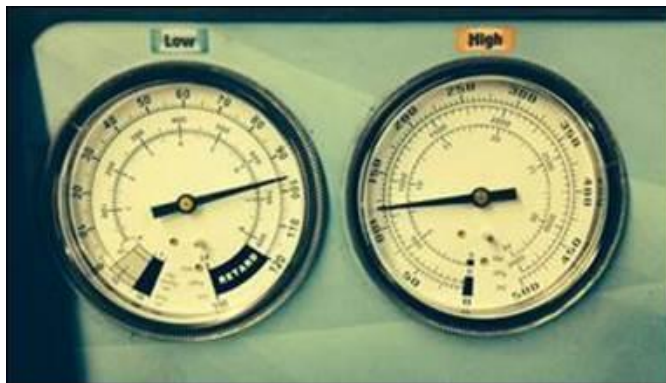
Figure 6. Equalized pressure condition. No pressure generated from compressor.

- Check the gauge readings on the Robinair® service station.
- If the gauges show no pressure generation from the compressor continue to the next step.

An example of no pressure generation is when the pressure readings on the high and low sides are equalized in Figure 6.

If the gauge readings are showing normal A/C Compressor operation per the Elsa Repair Manual, this bulletin does not apply and further diagnosis is required.

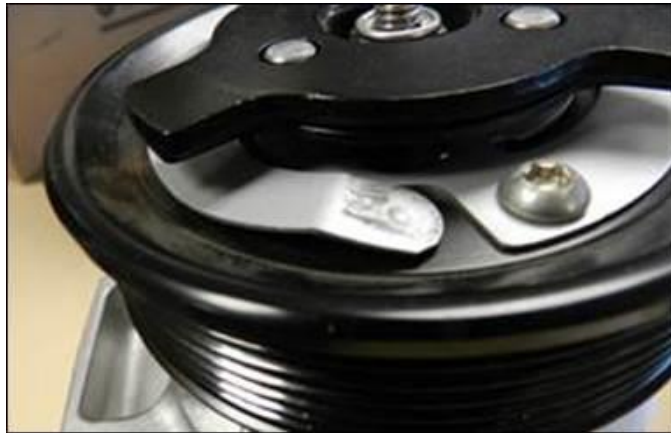
**Figure 7a.** Example of torque limiter over load protection activated.

- Check that the A/C Compressor torque limiter has not been activated (Figures 7a and 7b).

If the torque limiter has been released the - **N280**- A/C Compressor Regulator Valve is not at fault. The A/C Compressor needs to be replaced.

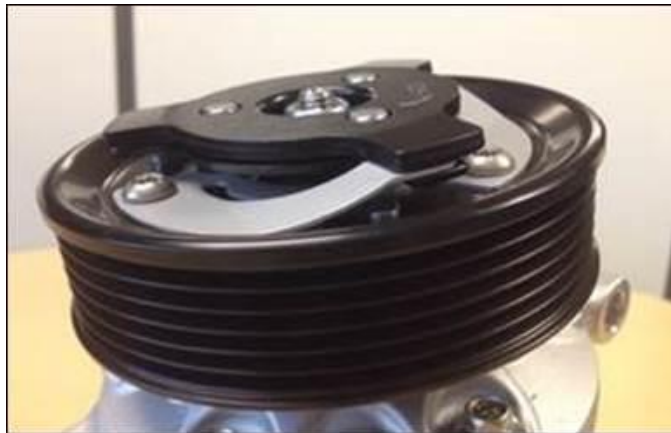
**Figure 7b.** Example of torque limiter over load protection still intact.

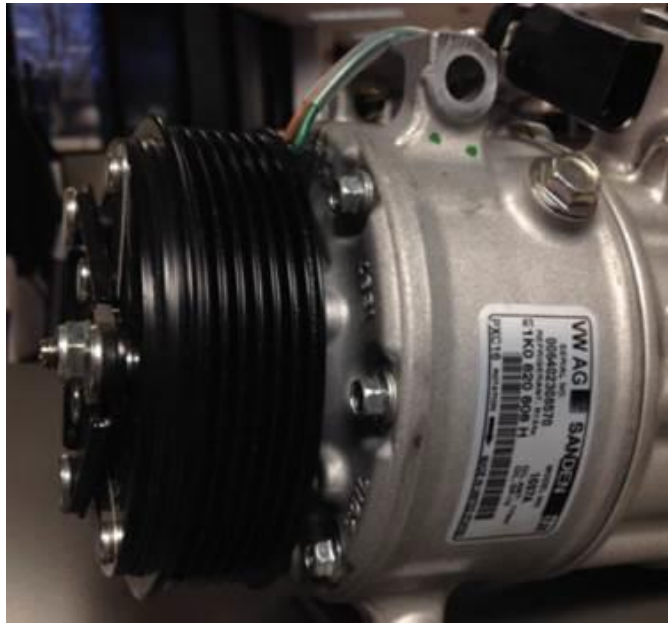
**Figure 8.** MY2016 AC compressor with clutch (Sanden)

- For MY2016 vehicles with Sanden A/C Compressor 1K0820808H make sure the Compressor Clutch is engaged when the A/C is switched ON.
- If clutch is not engaging perform diagnosis of the compressor clutch -**J44**- test.

If the A/C Compressor Clutch is not engaging this bulletin does not apply.

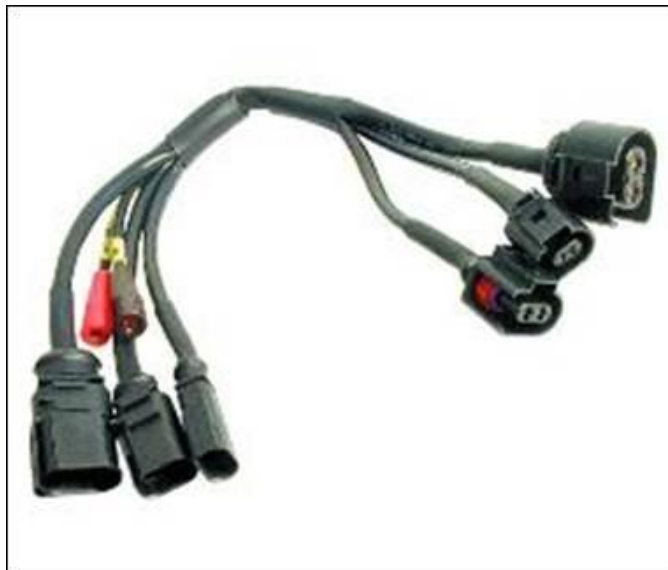
**Figure 9.** VAS 5256 breakout harness.

- Shut off the engine.
- Connect the breakout harness VAS 5256 (Figure 9) between the -**N280**- A/C Compressor Regulator Valve and its connector.

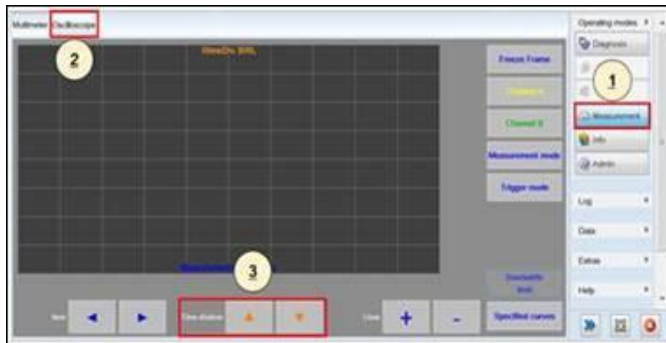
- Go to: Operating Mode “Measurements” to check the -N280- A/C Compressor Regulator Valve signal from the control module.
- Select Measurements.
- Select oscilloscope.
- Change time division to 2ms/Div (Figure 10).

Figure 10. Select Measurements from operating mode menu”.

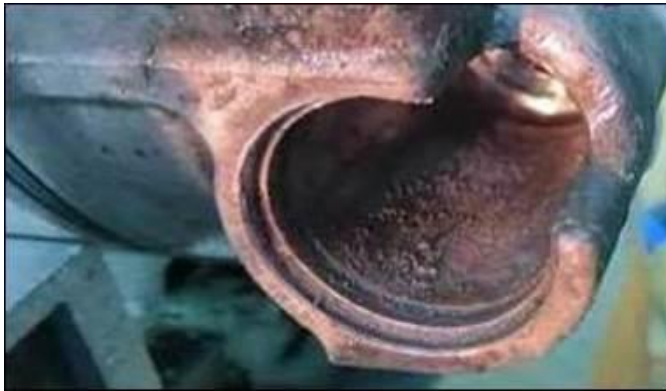
**Figure 14.** Corrosion in the **-N280-** A/C Compressor Regulator Valve bore.

- Assess the condition of the **-N280-** A/C Compressor Regulator Valve bore and the valve filter screen (Figure 14). If severe contamination is found in valve bore there is a risk of damaging the replacement valve on installation. In these cases the A/C Compressor must be replaced.

A slight amount of debris or corrosion does not present a risk and does not justify replacement of the AC Compressor.

- If little or no corrosion or contamination is found perform Repair Procedure A: Replacing the **-N280-** A/C Compressor Regulator Valve.
- If corrosion and contamination is found, perform Repair Procedure B: A/C Compressor replacement.
- Document the all workshop findings of this procedure on the repair order.

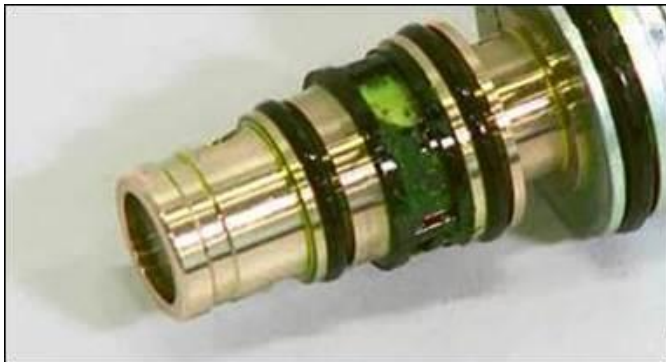
**Figure 15:** Severe contamination at the **-N280-** A/C Compressor Regulator Valve filter screen.

- Should severe contamination be found at the valve filter screen (Figure 15) and A/C Compressor replacement becomes necessary, ensure that the refrigerant circuit is flushed in the course of repair.

Small random particles on the filter screen does not constitute "severe" contamination and does not justify replacement of the A/C Compressor or A/C refrigerant circuit flush.

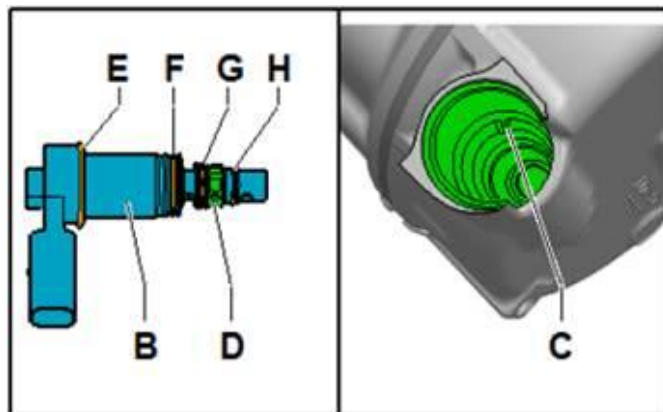
**Figure 17.** Check and prepare N280 O-rings

- Check the O-rings -F-, -G-, -H- and -E- (if applicable) of the -**N280**- A/C Compressor Regulator Valve -B- for damage.
- Coat the O-rings -F-, -G-, -H- and -E- (if applicable) of the -**N280**- A/C Compressor Regulator Valve -B- lightly with refrigerant oil and check for proper seating (Figure 17).

- Insert the -**N280**- A/C Compressor Regulator Valve -B- until the stop in the A/C compressor mount -C-.
- Re install circlip -A-.
- Install the removed parts in the opposite order.
- Evacuate and refill the refrigerant circuit.

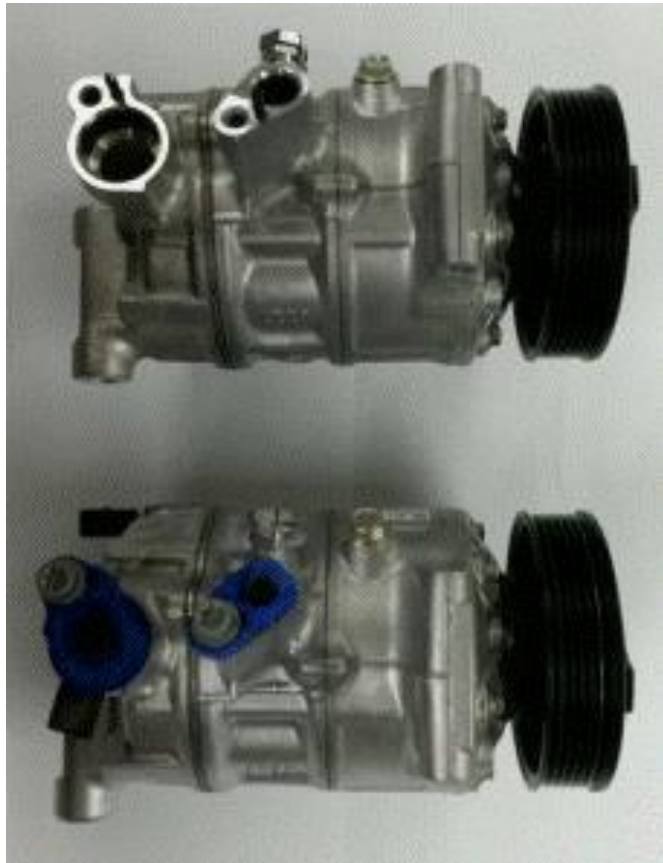
**Figure 18**

When installing a new A/C Compressor transfer the Compressor shipping caps to the original Compressor as shown in Fig 18.

All replaced compressors must have the shipping caps re-installed before being returned to the WPRC.

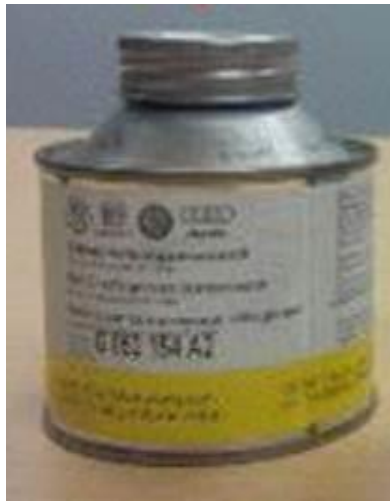
The replacement Sanden A/C Compressor will come with the specified type of PAG oil G 052 154 A2 (Figure 19).

**Figure 19:** Sanden compressor manufacturer PAG oil G 052 154 A2.

The A/C Compressor comes with a full charge of oil for the entire refrigerant circuit. However the amount of PAG oil supplied with the replacement A/C Compressor may not be the exact amount to replenish the refrigerant circuit. Drain and measure the PAG oil in the replacement A/C Compressor to determine the required amount. If the amount needs to be adjusted, do so using the correct type of PAG oil specified in ETKA. Refer to Elsa for the correct oil capacity for the compressor being installed.
