Highland
RIDGE RV

Prevent water intrusion to Rear Blind Spot Monitors

Bulletin Type:	Technical Service Bulletin TSB	Publication Date:	March 2019 Revision April 12, 2019
Bulletin #:	19-018	Make:	Entegra
Job Code(s):	9801428	Model:	Anthem Cornerstone
Flat Rate(s):	1 hour	Model Year(s):	2017-2019

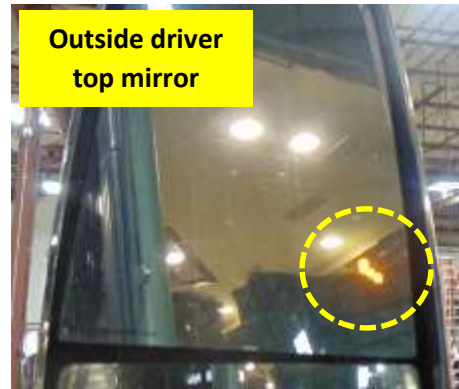
Blind spot mirror indicator

A yellow blind spot indicator will light up in the lower right portion of the top mirror (circled in the photo at the right).

The indicator should flash 5 times, turn off and stay off.

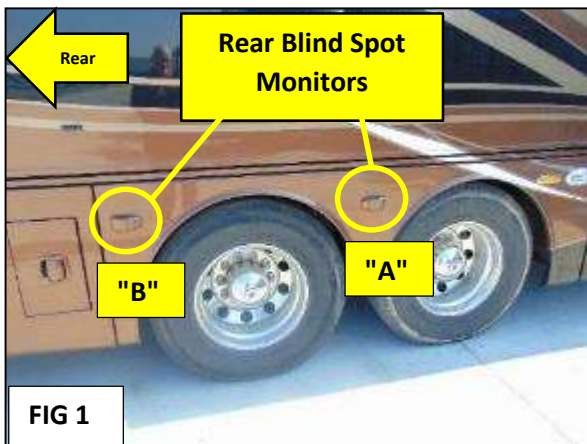
FIG 1:

- Rear blind spot monitors (2 on each side toward the rear of the coach)
- For purposes of this repair, the rear monitors are labeled A & B to differentiate between them in the repair instructions that follow.

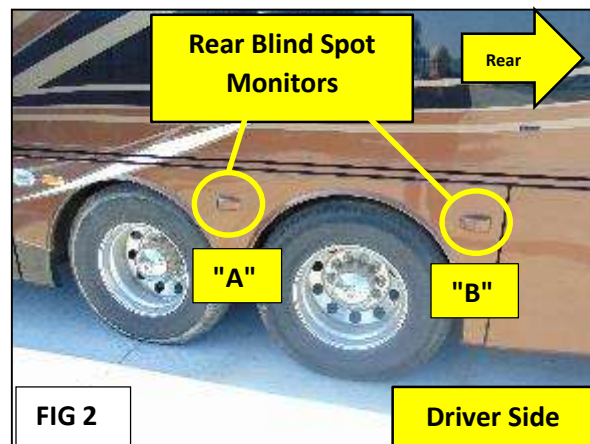
FIG 2

Driver Side

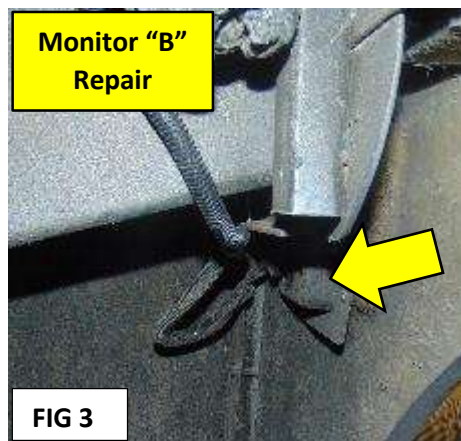
FIG 3: Repairing the driver side rear-most blind spot monitor (arrow).

- Rear most blind spot monitor (driver side Monitor "B" in Fig 2).

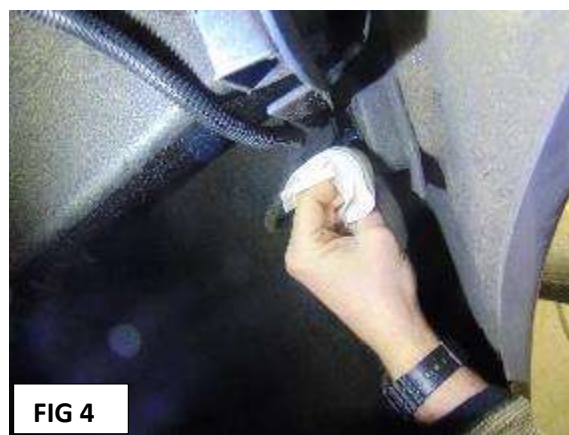
FIG 4

FIG 4: Use isopropyl alcohol and a clean rag and clean all around the blind spot monitor.

- The back of the monitor must be as clean as possible so sealant will adhere to it.
- Let the area dry completely before attempting to seal the monitor and wiring.

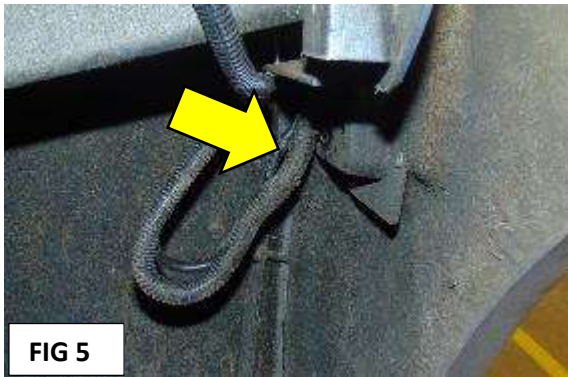
FIG 5

FIG 5: Carefully separate the monitor wire from the loom at the back of the sensor (arrow).

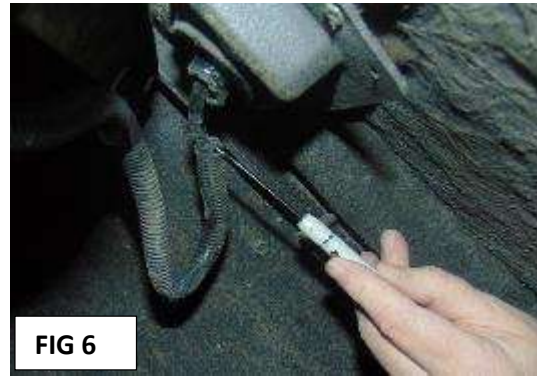
FIG 6

- Use trim shears to cut the loom back approximately 1" from the back of the monitor. (pointed to with screwdriver)
- **DO NOT CUT THE MONITOR WIRING!**
- Re-insert the wiring back into the plastic loom.

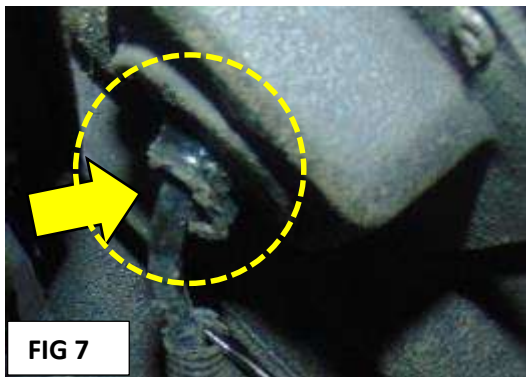
FIG 7

- The sealant will be applied all around the back of the sensor where the wiring goes into the sensor body, and the whole general area around that wire connection.

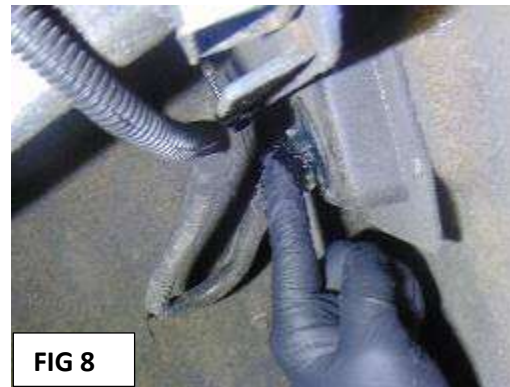
FIG 8

- The caulk gun won't fit up in this tight area, so sealant will need to be put on a paper napkin or towel, and then apply the sealant by hand as shown here.
- Seal the back of the blind spot monitor completely including the wiring going into the back of the monitor using Sika 268 black sealant supplied in the kit.
- **NOTE: Warming the tube of sealant will help the sealant flow easier out of the tube.**

- Seal the back of the blind spot monitor completely including the wiring going into the back of the monitor using Sika 268 black sealant supplied in the kit.
- Sealant will need to be applied by hand as shown in (Fig 8) previously.

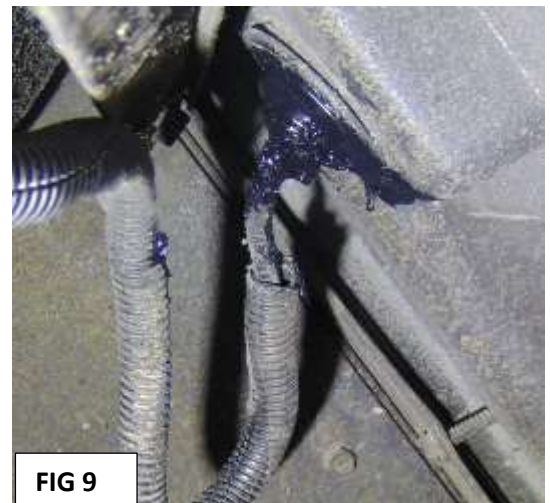
FIG 9

- Coat the entire area around the back of the sensor and the wire going into the sensor.

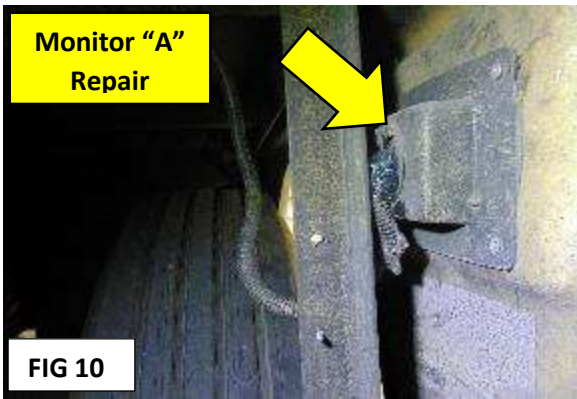
FIG 10:

- Repairing the driver side forward-most blind spot monitor (arrow).
- Forward most blind spot monitor between rear dual wheels (driver side) Monitor "A" in Fig 2.

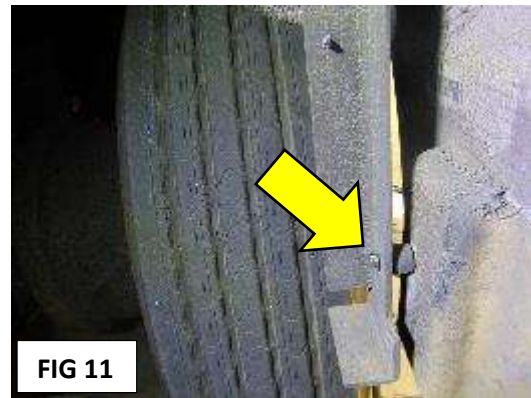
FIG 11:

- To gain some additional room to work, remove the screw holding the spacer at the bottom of the support.

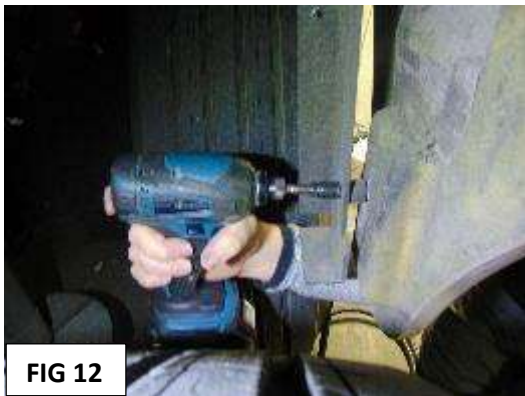
FIG 12:

- Use the screw gun with the 3/8" nutsetter bit.

Replace the screw in the spacer on the steel support (Fig 12).

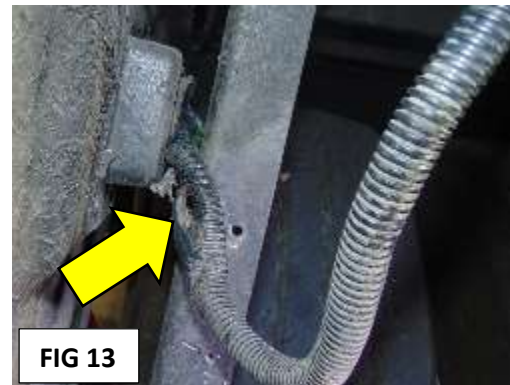
FIG 13:

- Separate the monitor wire from the loom at the back of the sensor (arrow).

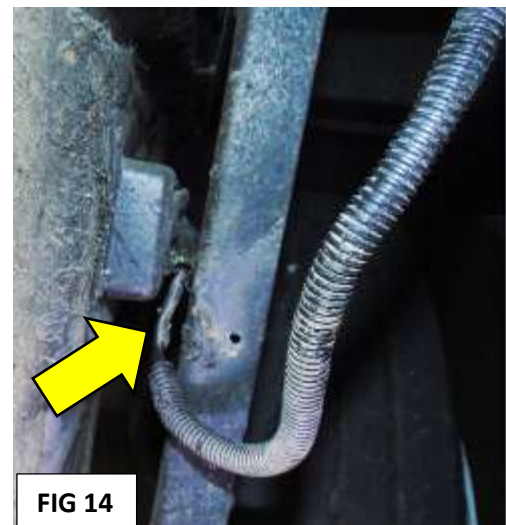
FIG 14:

- Use trim shears and cut off the plastic loom approximately 1 inch behind the blind spot monitor.
- **DO NOT CUT THE MONITOR WIRING!**
- Re-insert the wiring back into the plastic loom.

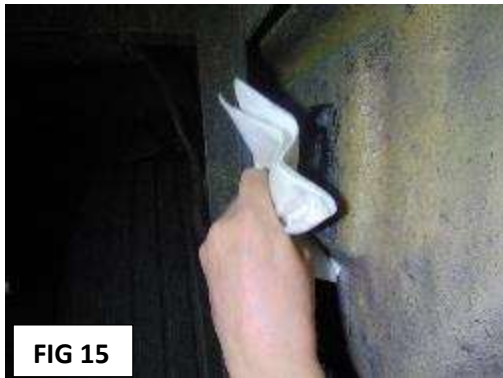
FIG 15

- Use isopropyl alcohol and a clean rag and clean all around the blind spot monitor.
- The back of the monitor must be as clean as possible so sealant will adhere to it.
- Let the area dry completely before attempting to seal the monitor and wiring.

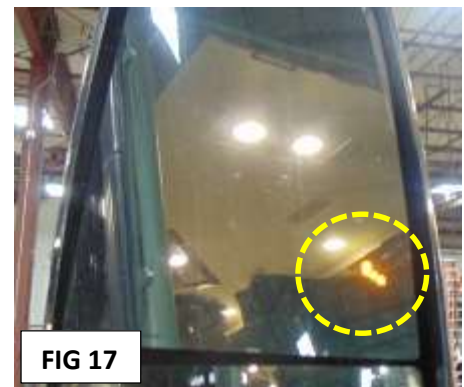
FIG 17

- The yellow warning indicator for the blind spot monitors will show up in the driver side top outside mirror lower right corner (circled).

Yellow indicator should light up in lower right portion of the mirror and flash 5 times and turn off (Fig 17).
