# SERVICE BULLETIN

EM19-002

## 2017 – 2018 ROGUE SPORT; AIR DUCT REPLACEMENT

**APPLIED VEHICLES** 2017 Rogue Sport (J11) - ALL  
**AND DATES:** 2018 Rogue Sport (J11); Built before September 15, 2018

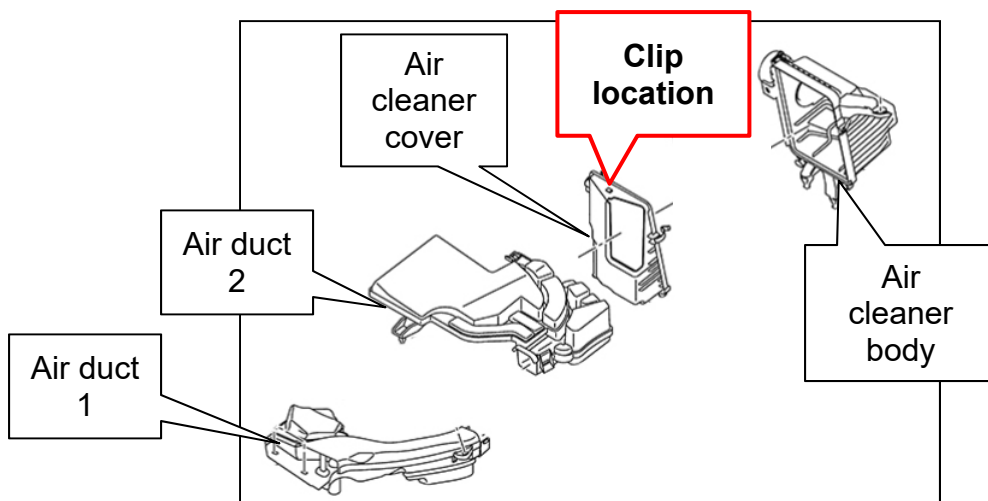
If air duct 1, air duct 2, or air cleaner cover shown in Figure 1 need to be replaced

Inspect for a clip in the location shown in Figure 1 and Figure 2.

- If a clip is present, then the vehicle **IS** equipped with the updated parts; no further action is needed. Individual parts may be replaced as needed.
- If a clip is **NOT** present, then the vehicle is equipped with older parts. See **SERVICE PROCEDURE** on the next page.
