## **SERVICE BULLETIN**

**Service Bulletin No.:** 2019-0031

Goshen Impulse 2016MY and prior

Eliminate water in steel tube and remove bulges in sidewall due to steel tube expansion.

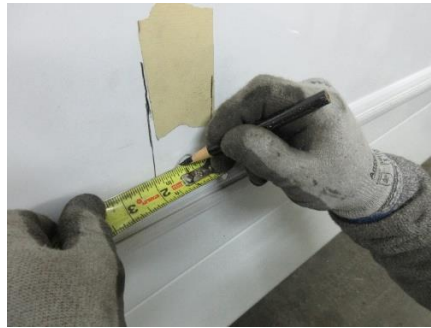
Photo #1

1. Locate bulging area(s) on exterior sidewall.
2. Using a magnet, locate the vertical tube in the area where the wall bulges.
3. Using a grease pencil, mark the outer edges of the 2.00 inch tube. Reference Photo #1.

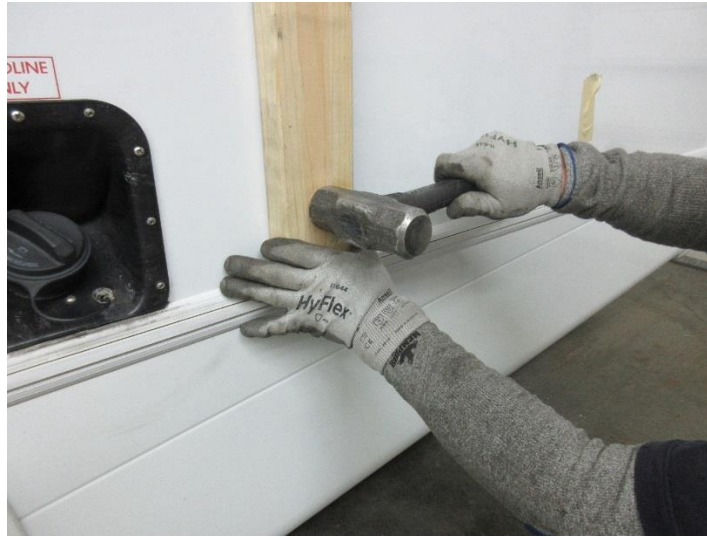
Photo #3

1. Use the piece of 2X4 lumber and a hammer to reshape the bulged tube back to a flat state.

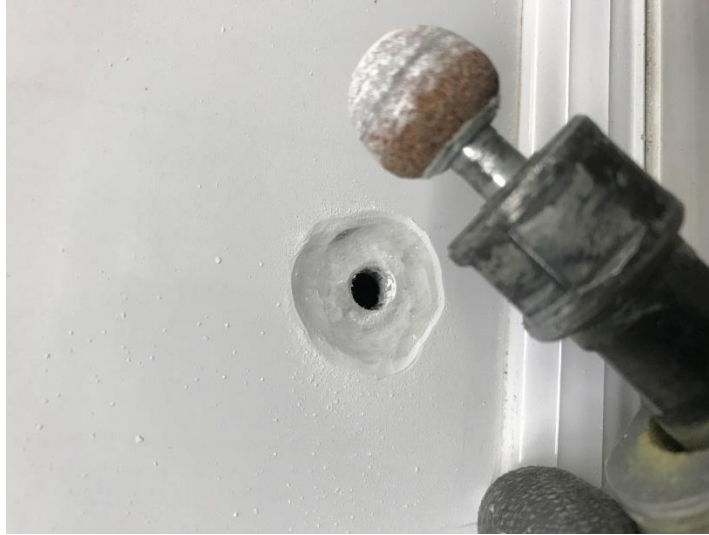
Photo #4

1. Use a Dremel tool with ball-type sanding bit to taper the hole. Reference Photo #4.

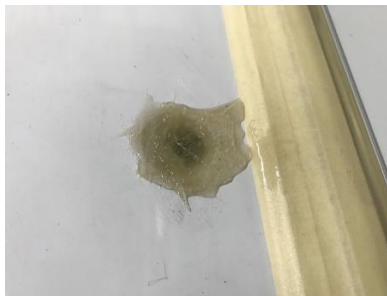
Photo #5

2. Fiberglass in the hole or back face.
3. Fill the larger hole with fiberglass resin soaked glass mat, then apply fiberglass mat to fill large hole. Reference Photo #5.

Apply tape over filled hole to prevent resin from dripping down the exterior surface of the side wall.

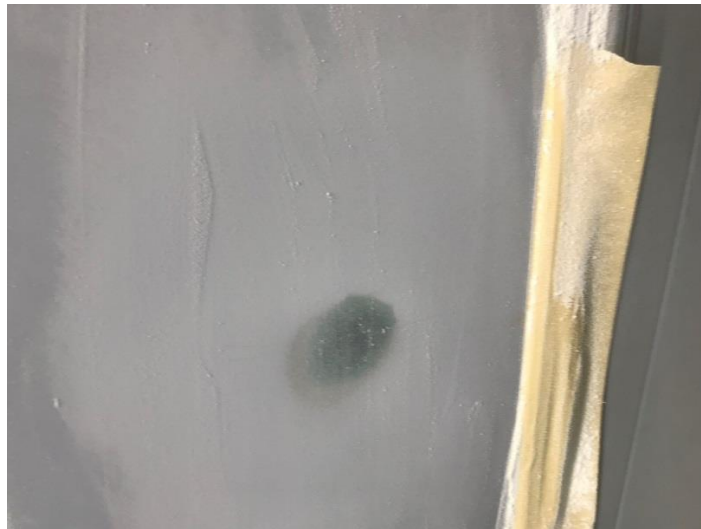
Photo #7

5. Sand the Everglass using 180 grit sandpaper.

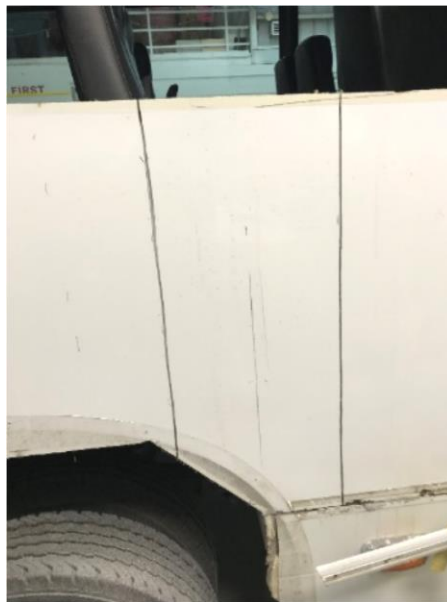
Photo #10

1. Remove the window directly above the fiberglass sidewall panel area to be cutout and removed.
2. Remove fender flare, as necessary, that is attached to the fiberglass sidewall panel area to be cutout and removed.
3. Removed the rub rail that is attached to the fiberglass sidewall panel area to be cutout and removed.
4. Place a mark on either side of the bulge approximately 7.00 inches from the centerline of the 2.00 inch tube. Reference Photo #10.

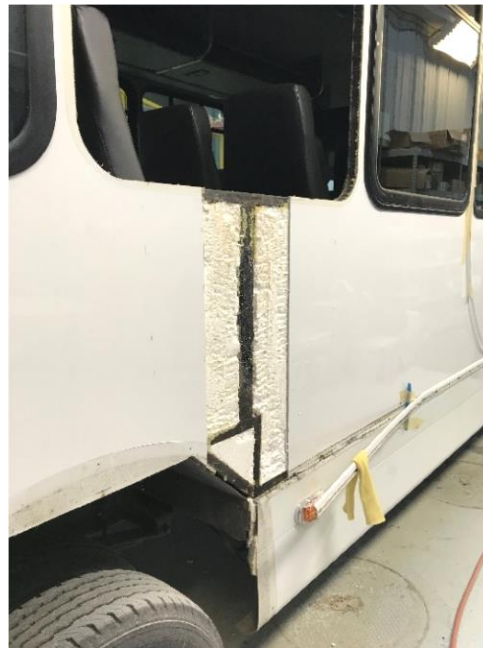
Photo #12

5. Use the piece of 2X4 lumber and a hammer to reshape the bulged tube back to a flat state. Reference Photo #12.

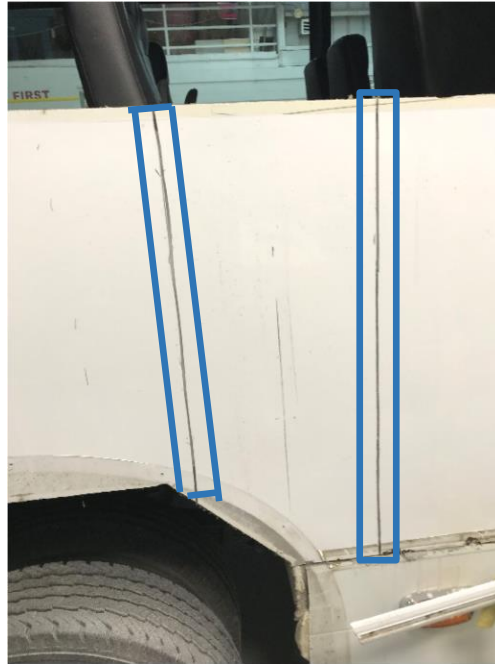
Photo #16

19. Apply Loctite H8100 Adhesive to the wood board exposed area and the exposed steel tubing.
20. Apply the cut-to-shape new fiberglass panel, pressing firmly into place.
21. Secure the panel in place and allow the adhesive time to cure.
22. Bevel the two vertical edges of the new panel and the adjacent sidewall fiberglass edges, approximately half the wall material thickness. Reference Photo #16.

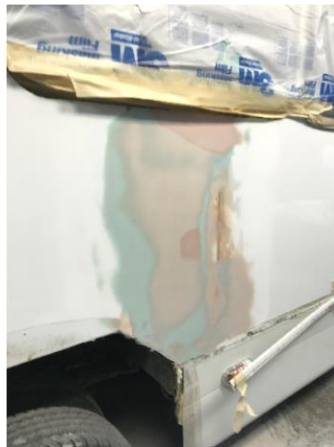
Photo #17

23. Apply Fibral Glass Fibre Repair Paste to the beveled areas. Reference Photo #17.

24. Sand smooth using 120 Grit sandpaper. Reference Photo #17.

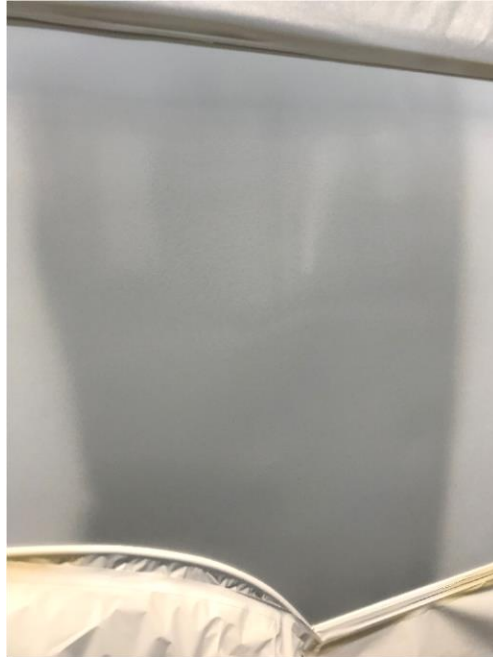
Photo #18

25. Apply Gel Coat to the repaired area of the bodywork. Reference Photo #18.

26. Sand down gel using 400 grit sandpaper in preparation for body paint. Reference Photo #18.

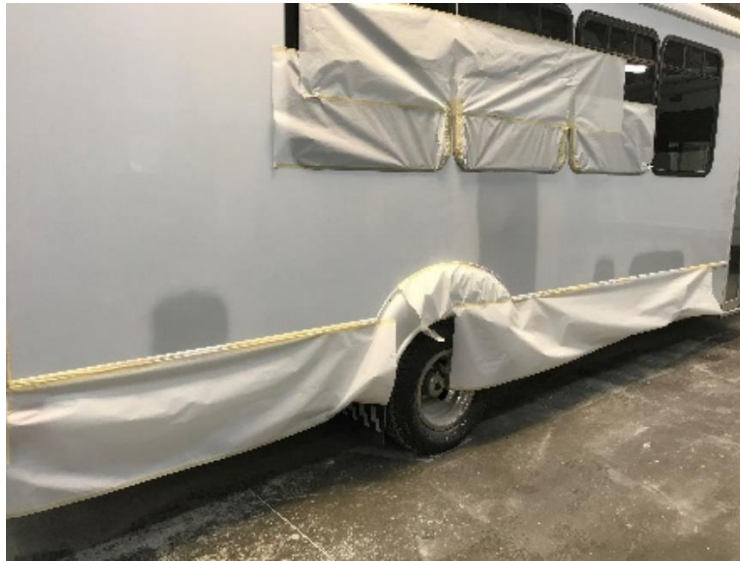
Photo #19

Ensure to protect surrounding area from paint overspray.  
Reference Photo #19.
