SERVICE BULLETIN

Service Bulletin No.: 2019-0032

World Trans (WT) 2xx, 2016MY thru 2019MY

Inspect and repair, as necessary, EV-1 or EV-96 Evaporator installation.

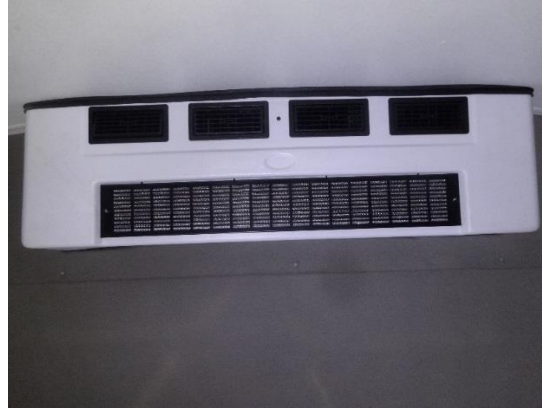
Photo #1
EV-1

1. Locate EV1 Evaporator or EV-96 Evaporator at the rear of vehicle. Reference Photo #1 (EV-1) and Photo #2 (EV-96).

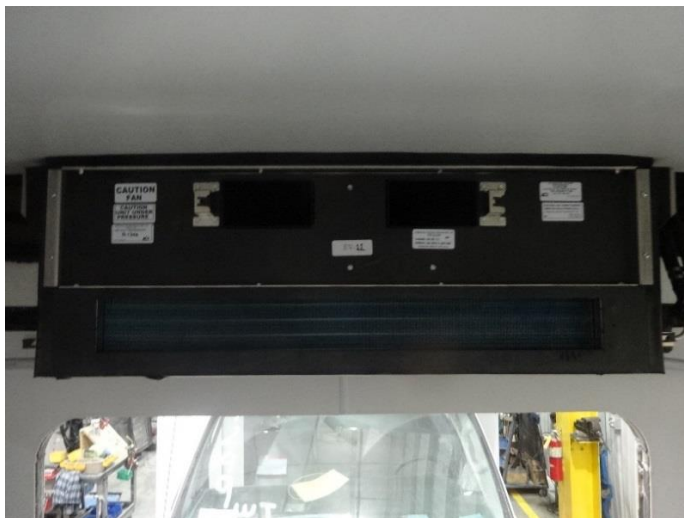
Photo #3
EV-1

2. Remove the evaporator cover from the unit. Reference Photo #3 and Photo #4.

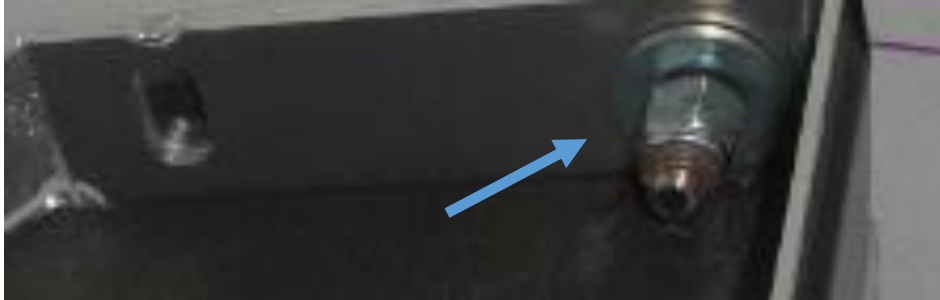
Photo #5
EV-1 or EV-96

3. Inspect EV-1 Evaporator or EV-96 Evaporator to see if there are fasteners securing unit to the ceiling.

If there are fasteners attaching the unit to the ceiling on both sides, reinstall the evaporator cover. No Further Actions Are Required.

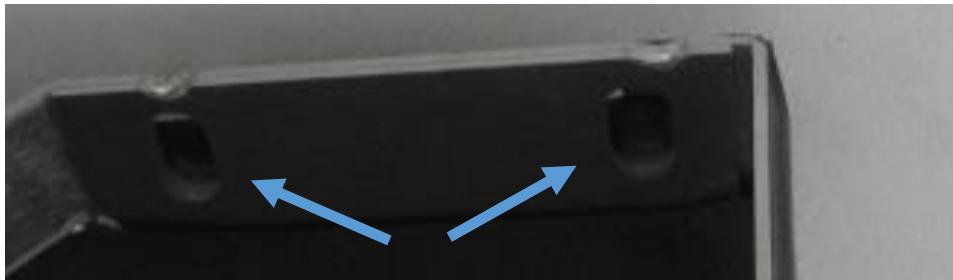
Photo #6
EV-1 or EV-96

If there are no fasteners attaching the evaporator to the ceiling, reference Photo #6, continue with the repair steps below for the appropriate evaporator unit – **EV-1 Repair Instructions** or **EV-96 Repair Instructions**.
