SERVICE BULLETIN

APPLICABILITY: 2015-**2019MY** Legacy and Outback **NUMBER:** **12-253-18R**
SUBJECT: “Squeak” “Creak” or “Pop” -Type Sound from Driver’s Seat **DATE:** 11/13/18
REVISED: **03/27/19**

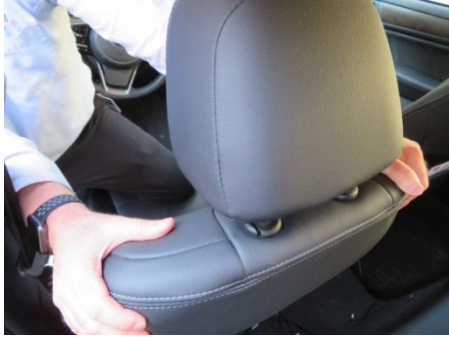
Step 1- Using a knee and body weight applied to the seat cushion, apply pressure towards the rear seat frame mounting bolts from each corner, one corner at a time while listening for the sound to occur.

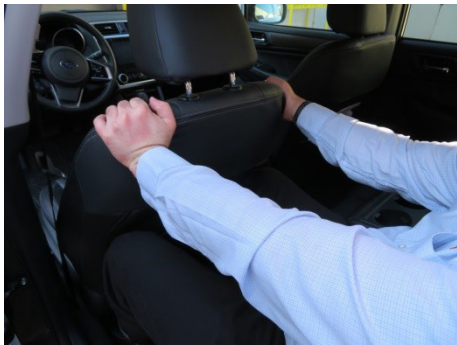
Step 2- While sitting in the rear seat, apply back and forth pressure to the backrest while pushing downward toward the seat frame slide rails. Repeat this step using a twisting motion. This applies pressure to the TORX bolts and will help isolate any squeaks.

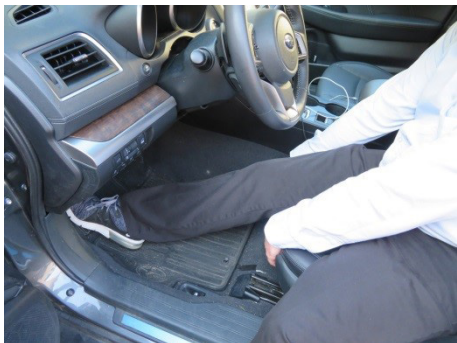
Step 3- While sitting in the driver's seat, apply pressure with feet / legs as shown towards the back of the seat while leaning and shifting body weight towards the four TORX bolts. When complete, raise the seat to the fully lifted position.

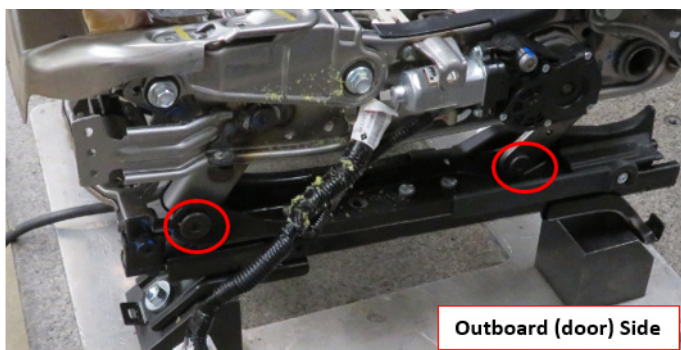
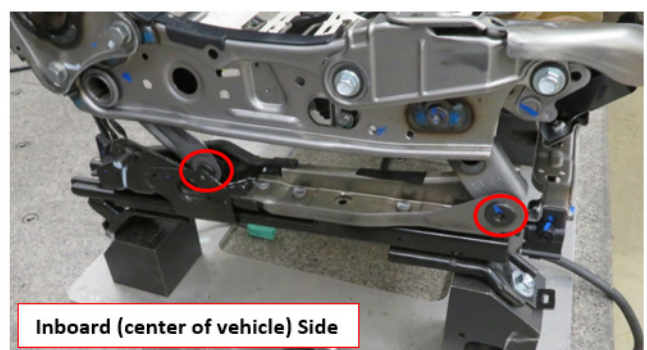
Step 6) Inspect all four of the TORX bolts closely for any signs of wear. The seat must be lifted to see all four of them.

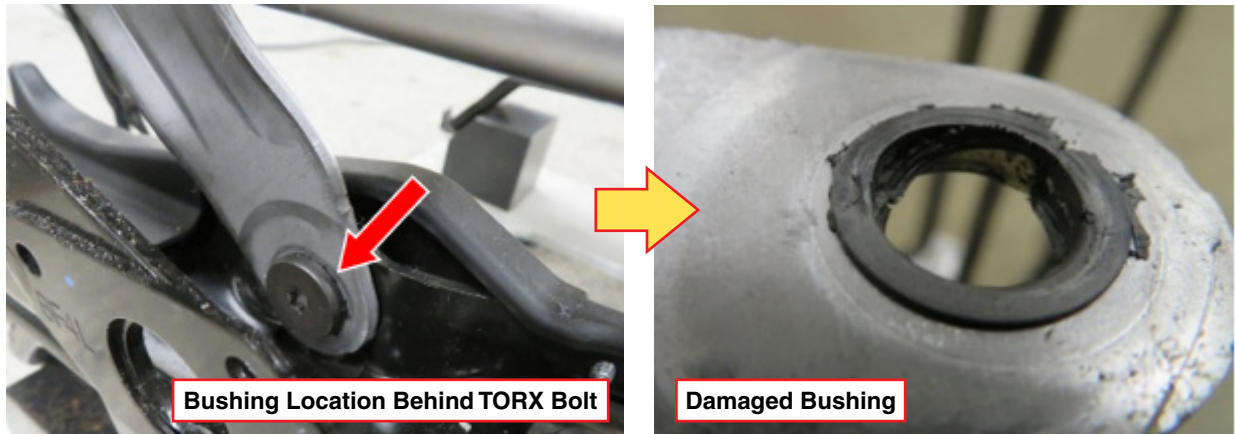
Step 7) Remove the link bolts using a T45 TORX bit to inspect the Teflon bushing underneath for damage.

NOTE: Only inspect one side at a time. If OK, re-install the TORX bolt and retorque to 15 ± 2 Nm (11 ft. lbs.). Most damaged Teflon bushings are found on the inboard side.

If any of the four Teflon bushing(s) are damaged, replace the seat cushion frame assembly following the procedure in the applicable Service Manual.
