RES Screen Image Has a Green Tint?

AFFECTED VEHICLES

Year	Model	Trim
2018-19	Odyssey	EX-L, Touring, Elite
2019	Pilot	EX-L, Touring, Elite

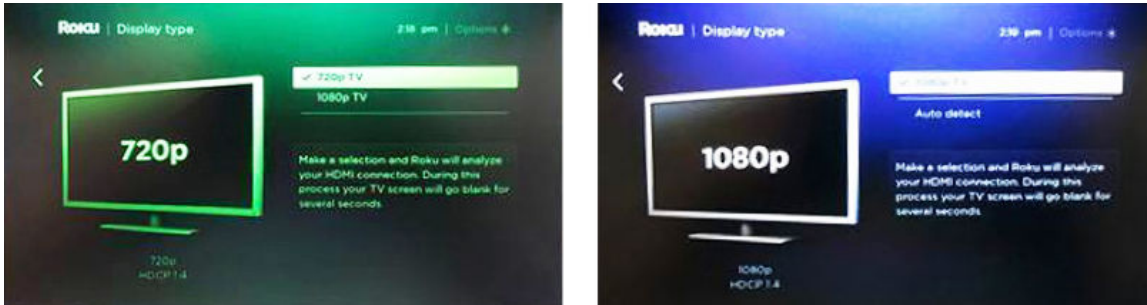
EDITOR'S NOTE: This article is aimed at service advisors. It covers an issue that's easy to handle on the service drive. When plugging in an HDMI device, does the RES screen image have a green tint to it?

This happens because the device resolution setting is set to **720p** instead of **1080p**, which is standard for the RES. To correct this, just have your customer set the resolution to **1080p**.

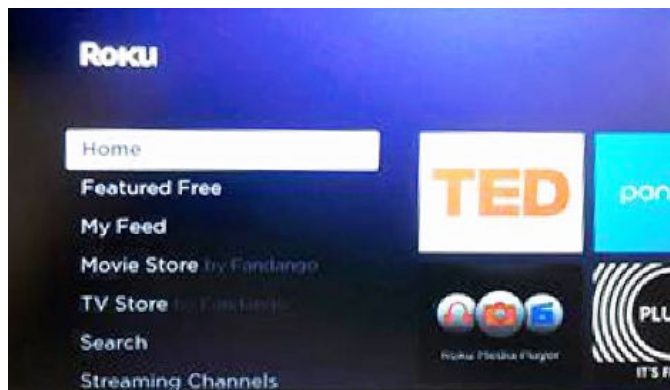
When switching to **1080p**, the screen may expand or stretch. To correct this, just unplug the device and plug it back in.
