<b>Subject:</b>  <b>CHECK ENGINE LIGHT ON WITH DTC P061B, SURGING ON ACCELERATION, TRANSMISSION WON'T SHIFT PAST 4TH GEAR, VARIOUS U CODES SET</b>	<b>Service Alert No.:</b> SA-011/19
	<b>Last Issued:</b> 05/13/2019

2018-2019 CX-5

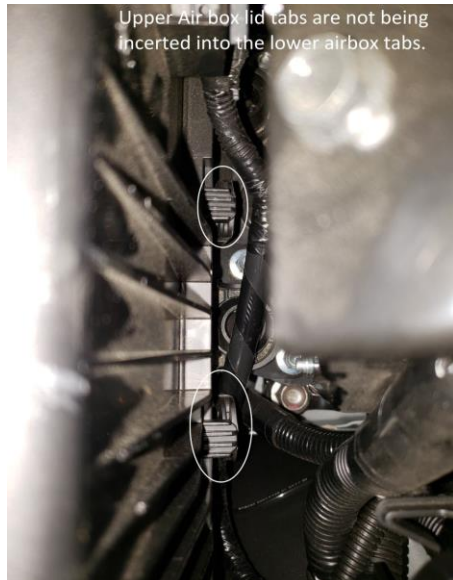
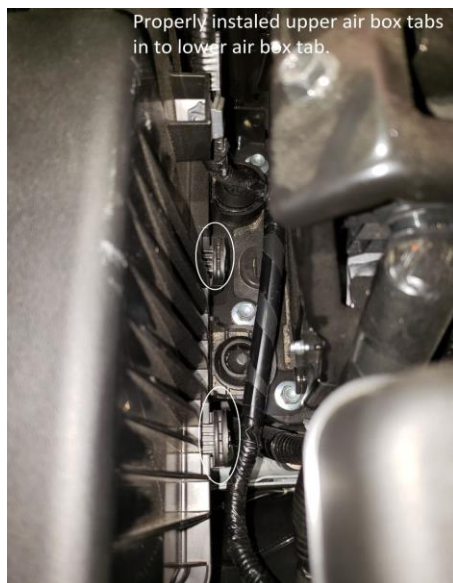
1. Verify the customer concern.
2. Before beginning normal diagnosis, inspect the air cleaner assembly. The three (3) attaching tabs at the lower rear area of the air cleaner assembly may not be properly attached. This could accidentally occur during an air filter inspection or replacement.

1. Open the hood.
2. Grasp the air cleaner assembly by hand and gently pull it toward the front of the vehicle.
  - If the air cleaner assembly moves, inspect the three (3) tabs at the lower rear area of the air cleaner assembly. Ensure that all three (3) tabs are properly attached to the lower air cleaner assembly.

- If the air cleaner assembly is properly attached, perform normal diagnosis according to the instructions on MGSS online.
