<b>Subject:</b> <b>CHECK ENGINE LIGHT COMES ON WHEN DRIVING WITH P3400 STORED IN PCM</b>	<b>Service Alert No.:</b> SA-015/19
	<b>Last Issued:</b> 05/20/2019

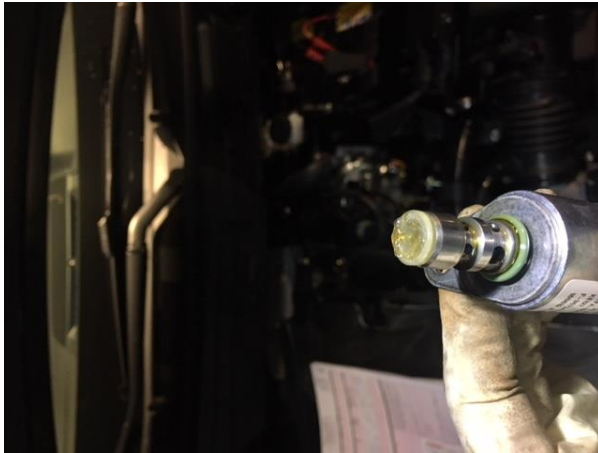
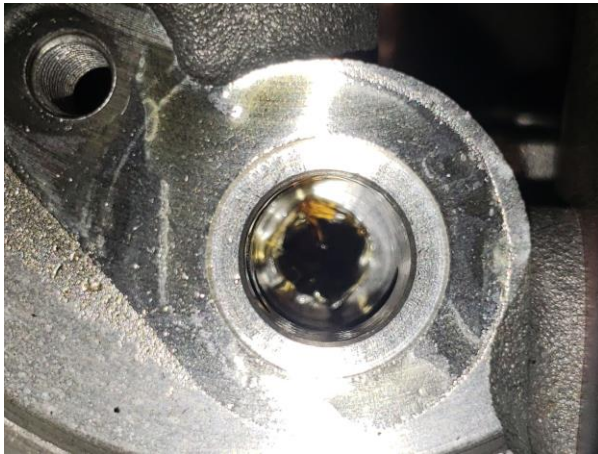
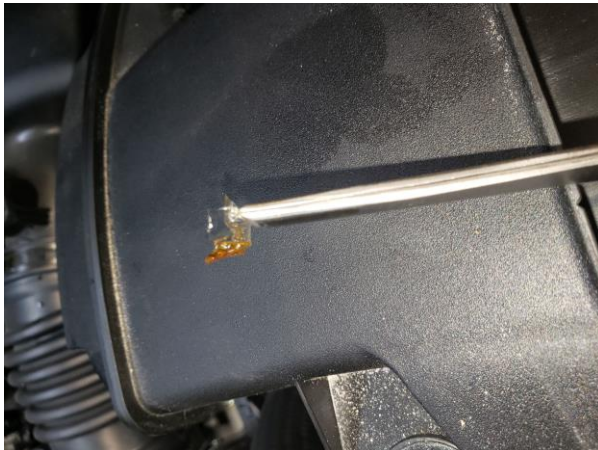
1. Remove the valve cover and inspect for any rocker arms that are broken or have fallen off, especially in the cylinder deactivation area (cylinders 1 and 4). Refer to SA-041/18 if found.
2. Remove the front and rear oil control valves for cylinder deactivation and inspect the oil control valves and cylinder head port for contamination or debris (see photo).
  - If contamination or debris is found:
    - Photograph your findings and place the solenoid and debris in separate plastic bags for collection. Mark on each bag the location where contamination was found.
    - **Remove oil filter and drain the oil from it. Place the oil filter in a separate bag for collection.**
    - Contact Hotline for instructions on creating a case where you can attach the photos. All of the parts will be collected.
  - Collect service history.

- If there is no sign of contamination or debris, proceed with normal diagnosis for DTC P3400 according to the instructions on MGSS.
