Preliminary Information

PIP5636 Air-Filter Showing 0% Life

Brand:	Model:	Model Years:	VIN:		Engine:	Transmissions:
			from	to		
Chevrolet	Silverado 1500 (New Model)	2019	All	All	5.3L 6.2L, L84, L87	All
GMC	Sierra 1500 (New Model)	2019	All	All	5.3L 6.2L, L84, L87	All

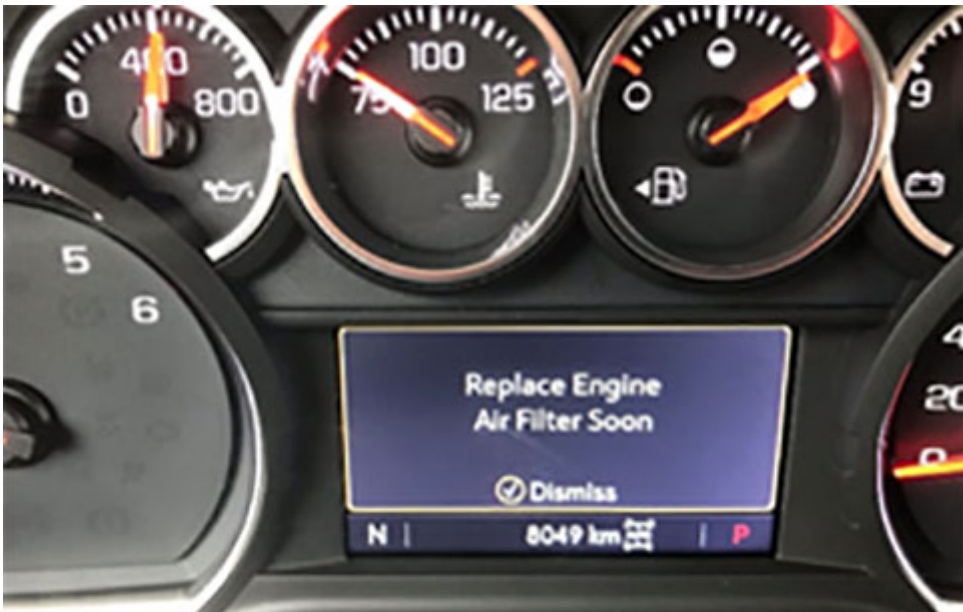
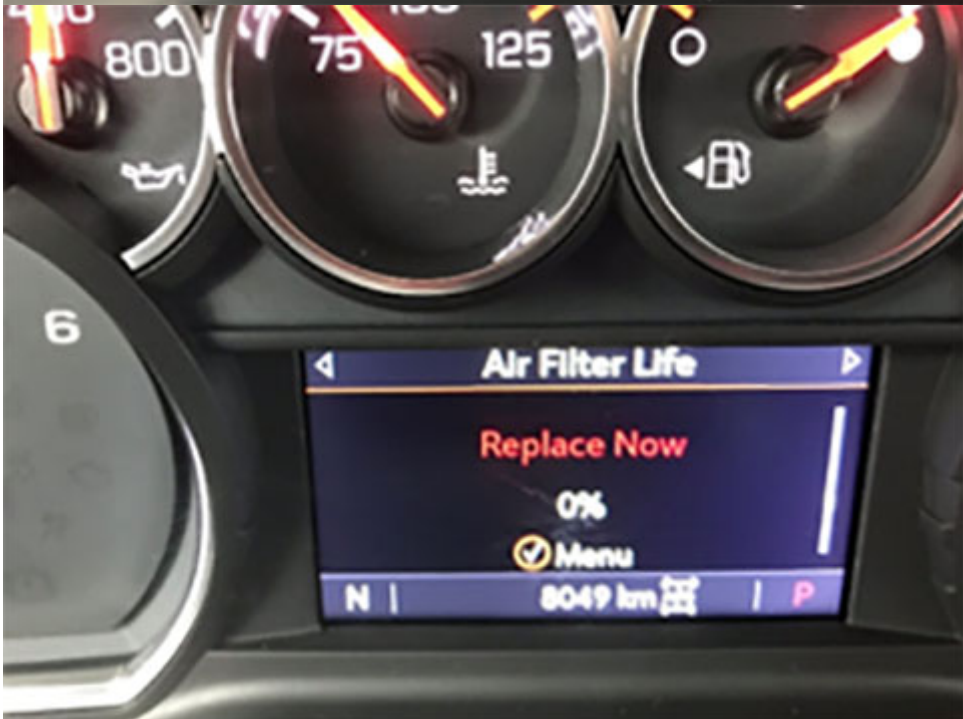
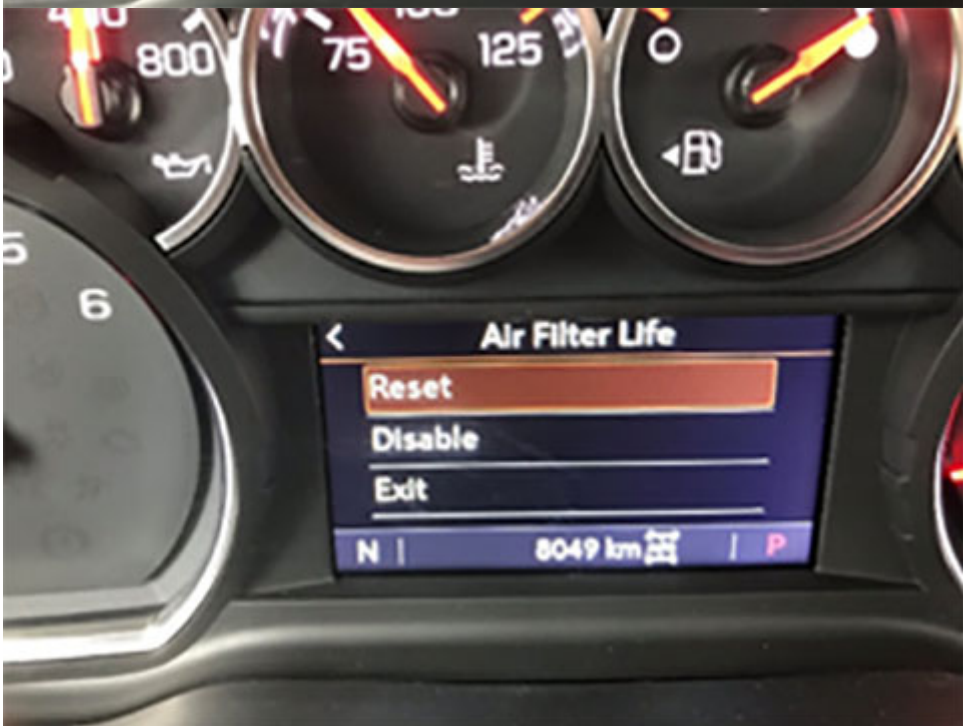
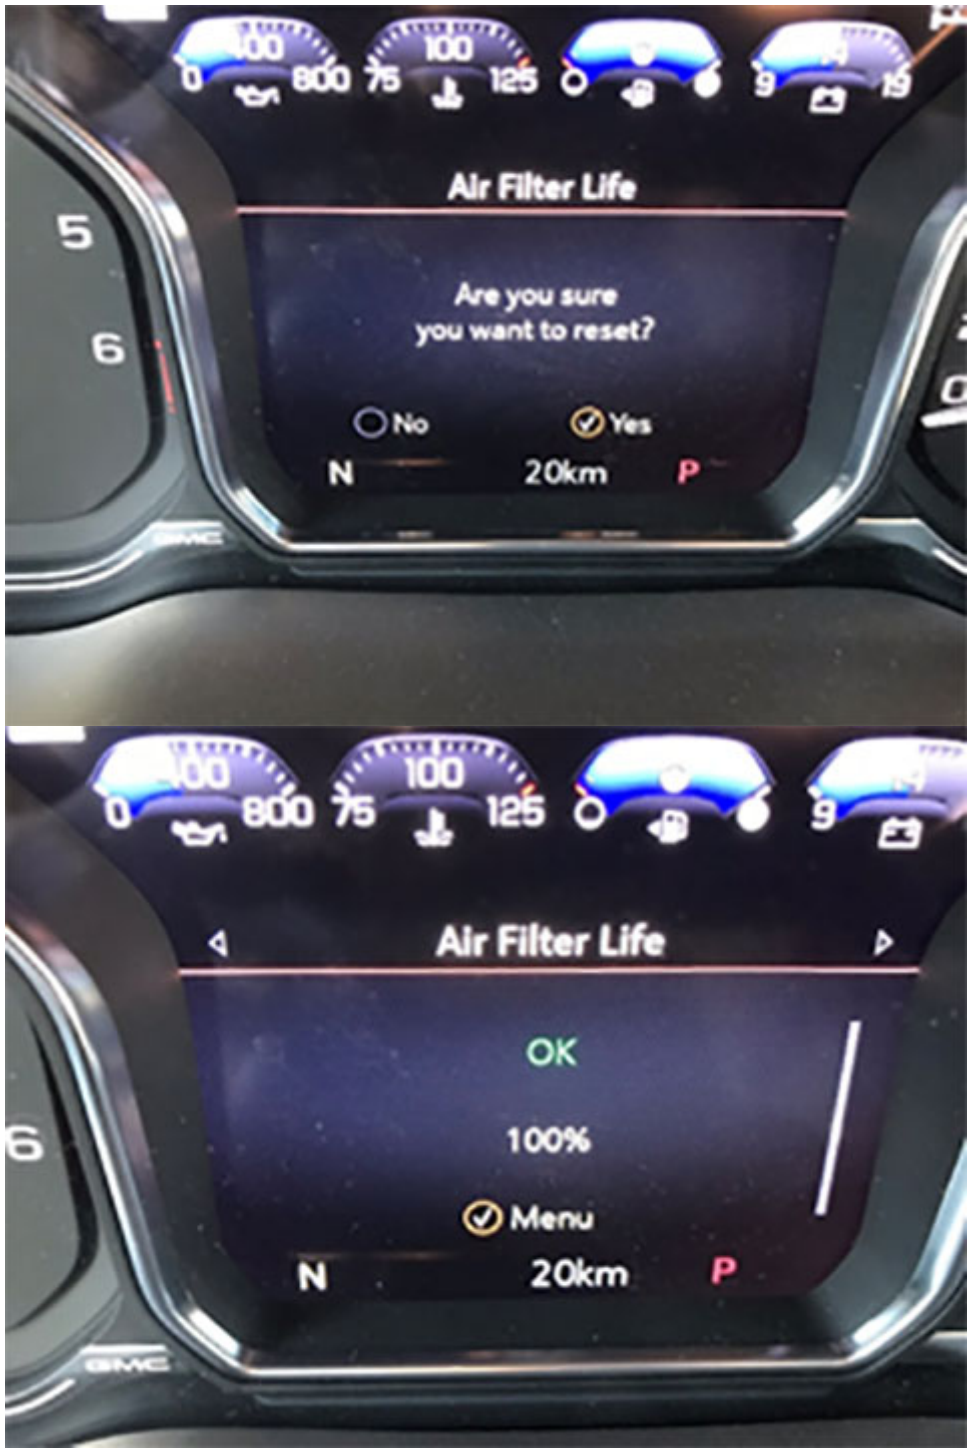
Inspect the air filter, If clean (not restricted) reset the DIC message.

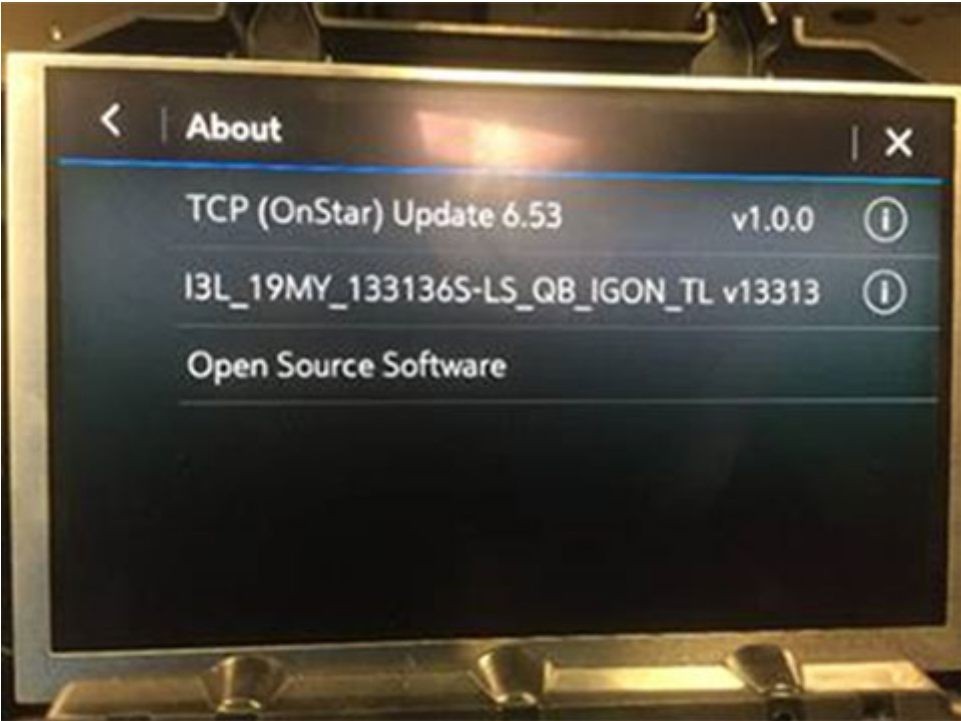
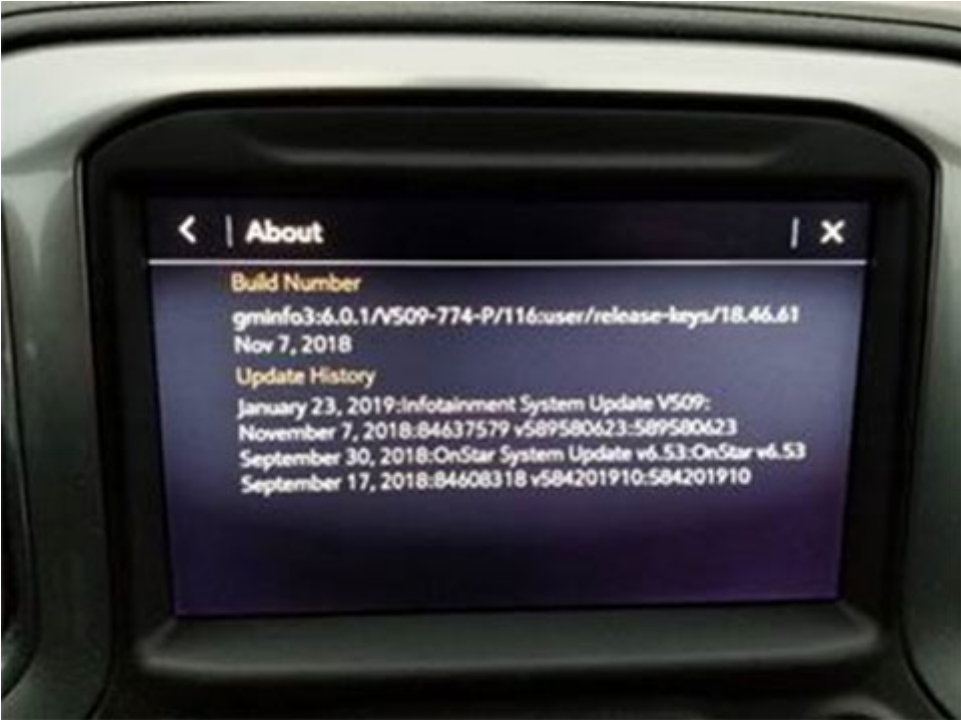
Enter the radio menu on the radio display. Select Home > Settings > About.

On IOR-equipped vehicles this will bring you to the About menu page to view Update History.

On IOS, IOU, or IOT-equipped vehicles, scroll to Build Number and select the lowercase “i” next to Build Number to view Update History.

Look for a line that contains reference to OnStar update “v6.63” or greater in it. The sample illustrations above do not show this specific version but serve to illustrate where to find it. The presence of OnStar v6.63, or any OnStar update greater than v6.63 indicates the firmware has been installed and that the PI does not apply. Refer to SI for further diagnostics.
