## **SERVICE BULLETIN**

**SB-19-003 AIR TANK CRACK**

**GROUP: 0-GENERAL  
BULLETIN NO: SB-19-003  
DATE: 5-8-2019  
REF: HMM-190204-B1**

**SUBJECT VEHICLES:** Certain 14MY-19MY Conventional Trucks equipped with a J08 engine that were assembled at the Williamstown, West Virginia assembly plant before August, 2018.

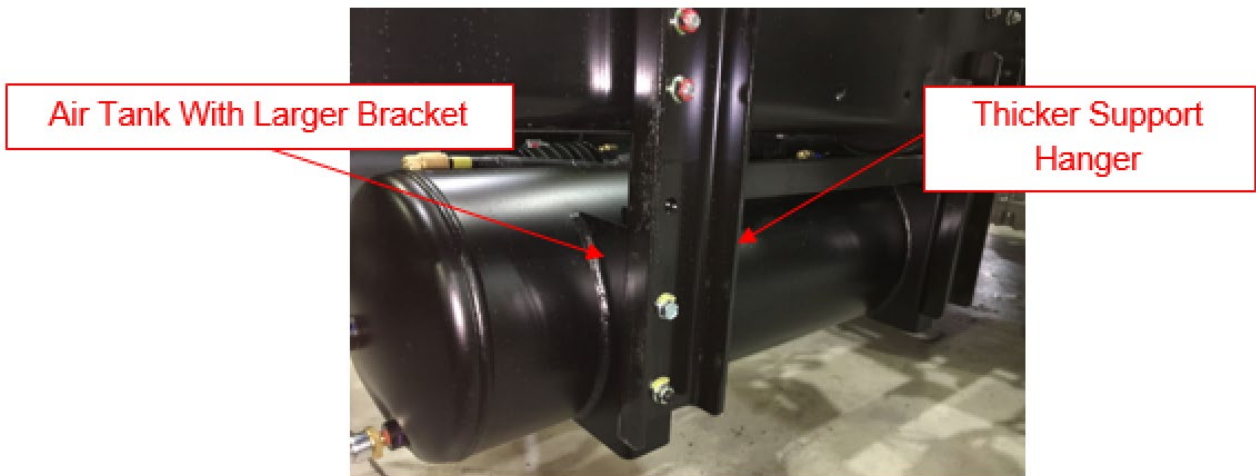
The subject vehicle may experience an air leak from one of the air tanks due to a crack in the tank shell where the tank bracket is welded to the tank shell. An updated air tank that incorporates a larger bracket in conjunction with a thicker support hanger has been made available to address this condition.
