No.: 18 TS-2Rev
Mar 11, 2019

SUBJECT: **Detroit™ DT12™ Split Rod Bushing Repair**

Note: This document supersedes Technical Service Letters 16 TS-22 and 17 TS-10.

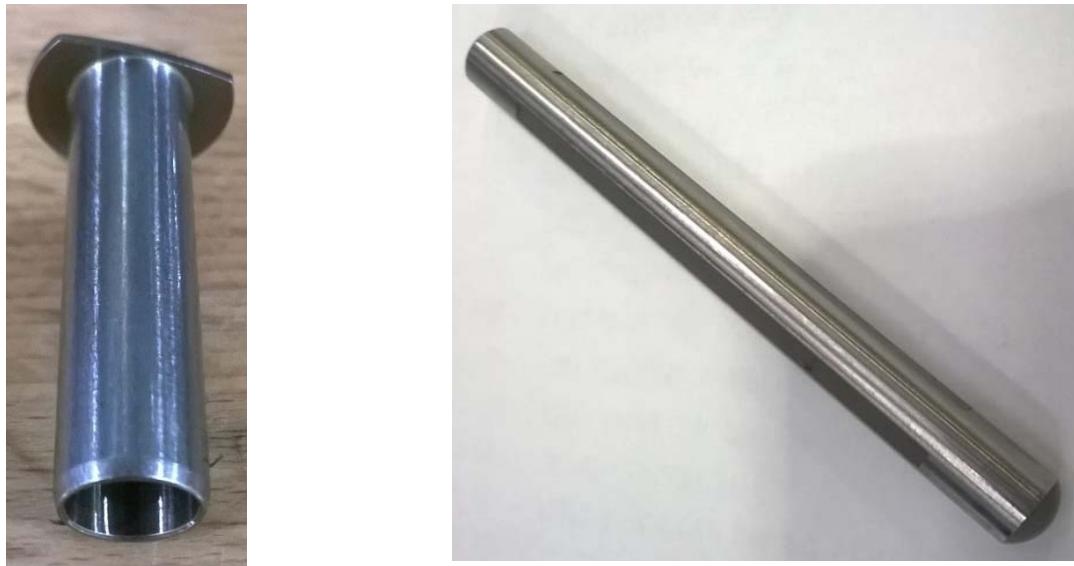
The steel split rod wears on the aluminum transmission housing, causing the split rod to stick. The Shift Controller cannot read the correct position of the split rod and will not shift into gear. To correct this, a hardened steel bushing and new design split rod with three flattened sides were implemented with transmissions built in August, 2016. For Detroit-built transmissions (transmission serial number beginning with 716), the change took place on August 9, 2016, with approximate transmission serial number 716310E0008107. For German-built transmissions (transmission serial number beginning with 715), the change took place on August 29, 2016, with approximate transmission serial number (last seven digits) 1806530. See Figure 1 for the new bushing and split rod.

Figure 1 – New Steel Bushing and Split Rod

The necessary parts to install the new bushing and split rod are contained in service kit P/N: A 960 268 23 74. The new kit is also shown in PartsPro in design group 342.

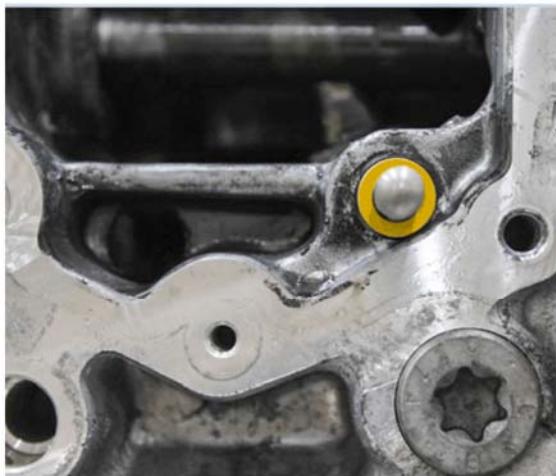
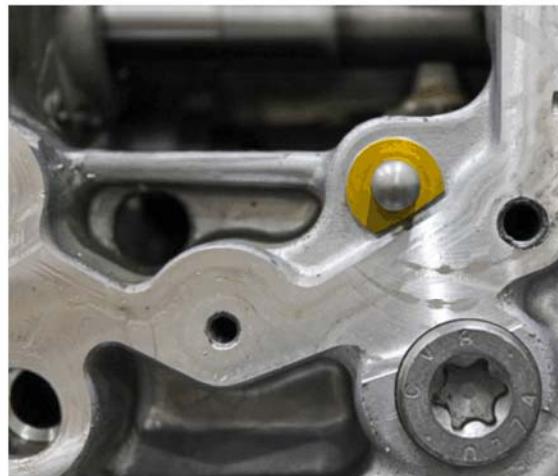
d260185

See Figure 2 below for two different steel bushing designs that were implemented in production of new transmissions. Both styles below are new designs and do not need to be replaced in service.

Figure 2 – New Steel Bushing Installed

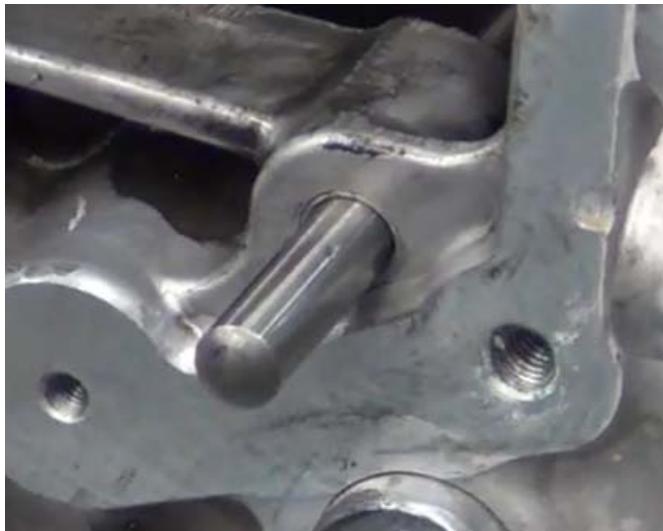
If you have the ream and bushing update, either of the new style steel bushings can be installed into the reamed bushing.

Figure 3 – Old Style ream and bushing
