# Technical Service Bulletin

## 46 Brake pulsation diagnostic guidelines

46 19 12 2022584/9 May 31, 2019. Supersedes Technical Service Bulletin Group 46 number 17-68 dated March 15, 2017 for reasons listed below.

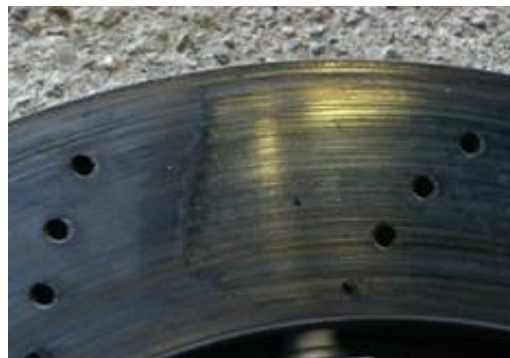
**Figure 2.** Deposits on the brake disc.

**Condition:** Brake pad material smeared on the brake disc (Figure 2). This condition can create DTV.

**Common cause:** An overly-aggressive driving style, which results in frequent sharp braking without proper cooling off periods.

**Service:** Replace the brake discs and pads.

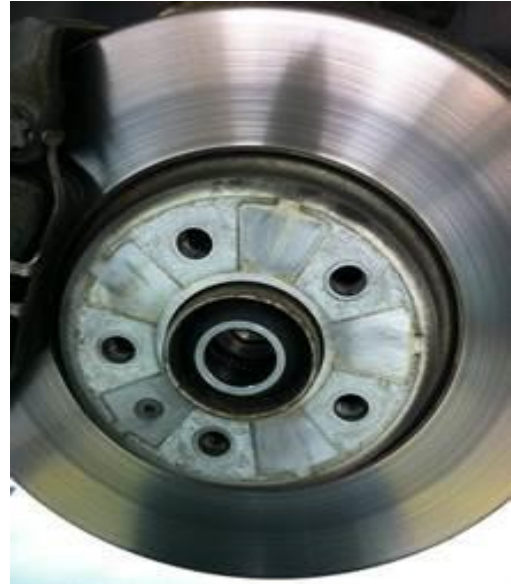
*Figure 3. Brake disc with heat marks.*

**Condition:** Blue-tempered or overheated brake discs (Figure 3).

**Common cause:** Failed component(s) causing constant brake application. This can also be caused by an overly-aggressive driving style, which results in frequent sharp braking without proper cooling off periods.

**Service:** Replace the brake disc and pads.

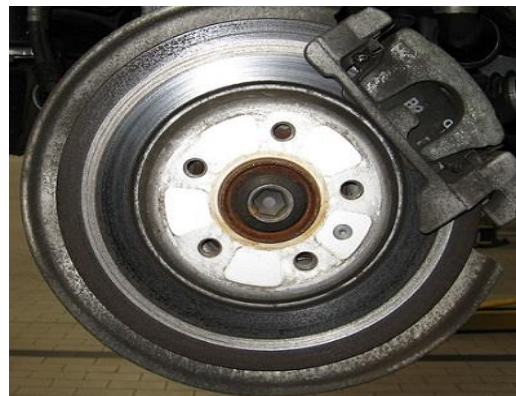
*Figure 4. Corrosion/rust build-up.*

**Condition:** Corrosion/rust build-up on the brake discs (Figure 4). This condition can create DTV.

**Common causes:**

- Exposure to road salt during winter months, high humidity, or moisture.
- Vehicle not being driven for prolonged periods of time.
- A gentle driving style with very light brake application may not be enough to remove build-up (such as rust or corrosion) on the brake discs and pads.

**Service:** With careful consideration of the traffic situation, perform 2-3 ABS stops from speeds above 50mph. Between each stop, allow the brake components to cool by driving the vehicle for more than one minute at speeds greater than 50mph. Do not perform ABS stops if brand new pads and/or discs are installed. Replace brake disc and pads if the condition is not eliminated.

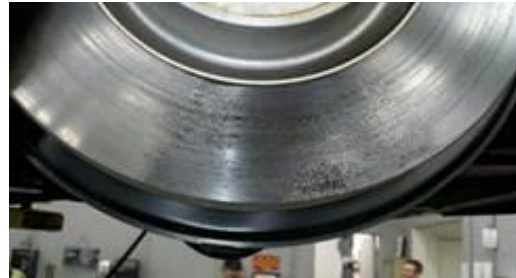
**Figure 5.** Pad marks on the brake disc.

**Condition:** Pad material transfer or corrosion marks from brake pads on the brake disc, also known as “pad marks” (Figure 5). This condition can create DTV.

**Common cause:** These marks can appear if the vehicle has not been driven for a prolonged period of time or if the brakes are exposed to high humidity or moisture.

**Service:** With careful consideration of the traffic situation, perform 2-3 ABS-stops from speeds above 50mph. Between each stop, allow the brake components to cool by driving the vehicle for more than one minute at speeds greater than 50mph. Do not perform ABS stops if brand new pads and/or discs are installed. Replace brake disc and pads if the condition is not eliminated.

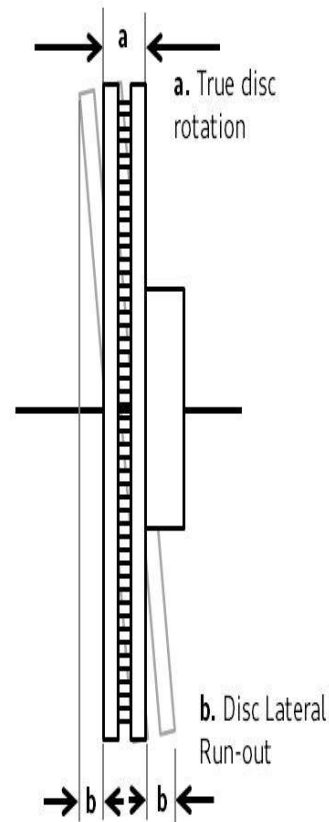
**Figure 6.** True disc rotation (a) and disc lateral run-out (b).

**Condition:** Excessive brake disc or wheel hub run-out (Figure 6). Measure according to the *Run-out Measurement Instructions* listed below.

**Common causes:**

- **Over-torqued or improperly-torqued wheels** (torque sticks, impact gun, etc.) can distort the brake disc and hub, causing a run-out condition. Refer to Elsa for proper torque values and procedures for the VIN.
- **Wheels that are not Audi-approved** may not have the same contact surface on the back of the wheel and may not have the correct center bore dimension, which can distort the brake disc and hub, causing a run-out condition.
- **External impact or rust build-up** between brake disc and hub.

**Service:** Replace brake disc(s) and/or hub(s) if measurements exceed the maximum value listed in the *Run-out Measurement Instructions*.

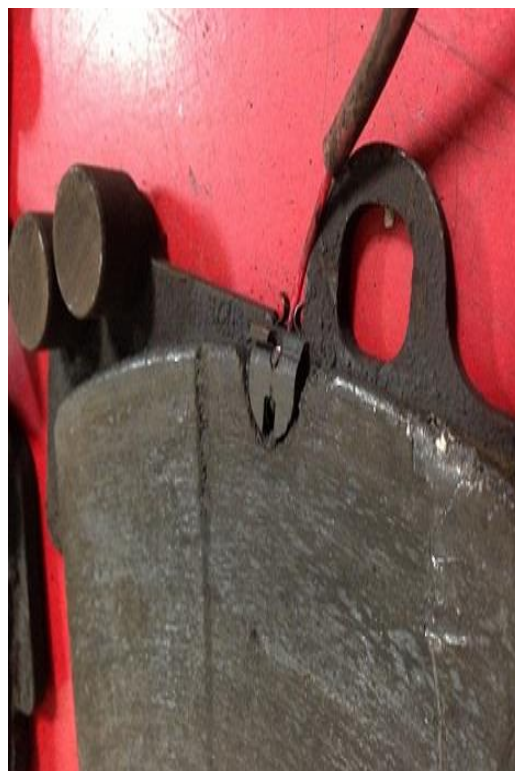
*Figure 7. Worn brake pad.*

**Condition:** Worn brake pads (Figure 7).

**Common cause:** As brake pads and discs reach their wear limit, their dampening characteristics are reduced.

**Service:** Replace worn brake pads and discs.

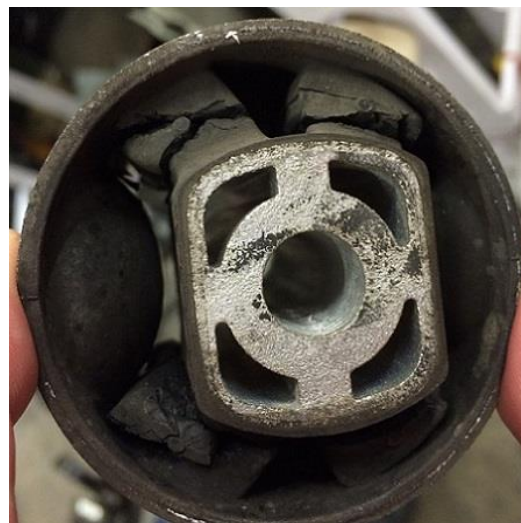
**Figure 8.** Damaged suspension bushing.

**Condition:** Faulty, damaged, or aftermarket suspension components (ball joints, links, tie rods, bushing, etc.) can significantly amplify vibration/pulsation or lead to body vibrations which only become noticeable when braking (Figure 8 and Figure 9).

**Service:** Diagnose these components accordingly.

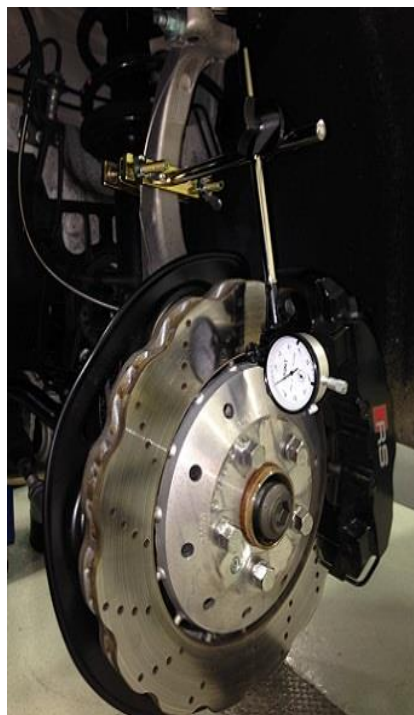
- All surfaces that will be measured must be free of rust/corrosion build-up or pad material transfer.
- VAS6079/1 (or similar measurement tool) is securely attached to the vehicle (Figure 11).
- The brake disc is secured to the hub with 5 bolts.
- Axle bolt/nut is installed and properly torqued.
- Run-out measurements should be taken with all parts installed on the vehicle.

**Figure 11.** Example of the run-out measurement tool VAS6079/1 properly secured to a solid suspension component.

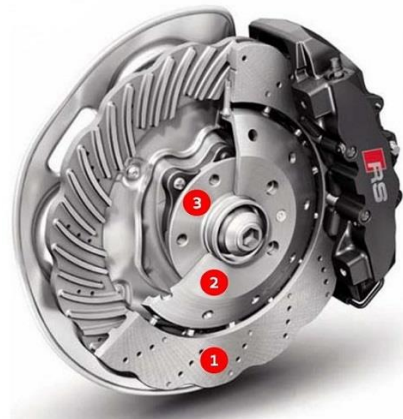
**Disc braking surface** (Figure 12, point 1):

- Disc hub and wheel hub run-out impact this value.
- Maximum run-out: **0.06 mm / 0.002"**.

**Disc hub (center of the brake disc)** (Figure 12, point 2):

- Wheel hub run-out impacts this value.
- Disc hub run-out impacts the disc braking surface run-out.
- Maximum run-out: **0.03 mm / 0.0012"**.

**Wheel hub (without the disc installed)** (Figure 12, point 3):

- This value impacts the disc hub and disc braking surface run-out. High run-out can distort the brake disc.
- Maximum run-out: **0.02 mm / 0.0008"**.

**Figure 12.** Run-out measurement locations: disc braking surface (1), disc hub (2), wheel hub (3).
