May 29, 2019

Product Update: 2017-18 CR-V Shift Knob Button**AFFECTED VEHICLES**

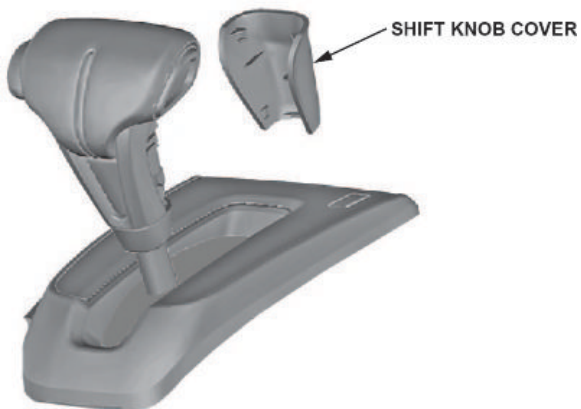
1. Use a plastic trim tool to remove the shift knob cover.

There are four retaining tabs.

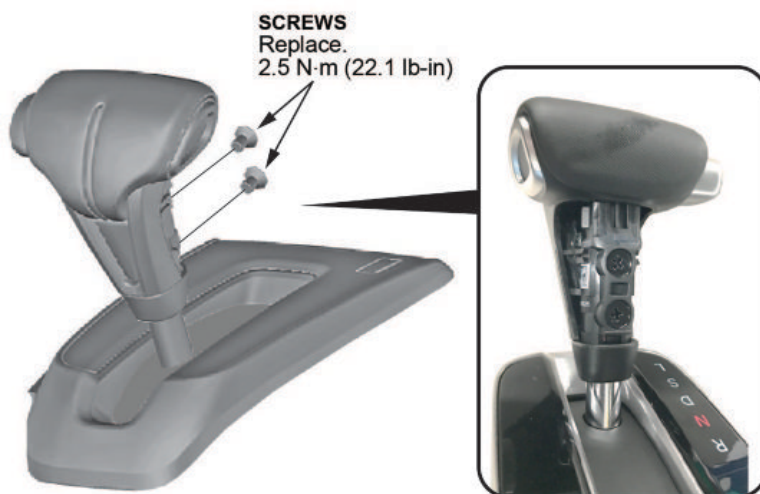
2. Remove the two screws from the shift knob.

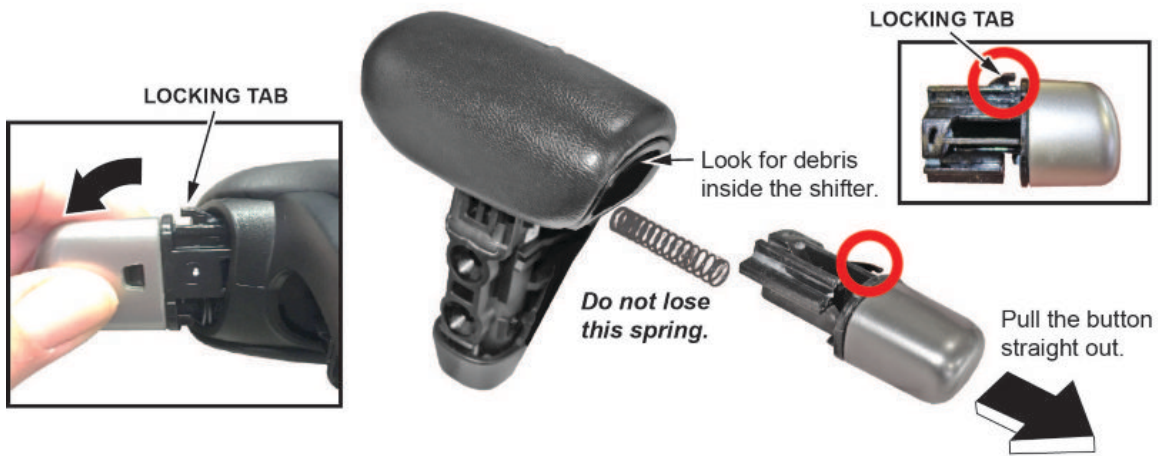
4. Make sure the knob set bushing is still on the lever. If it sticks to the shift knob, remove it with a small screwdriver, then install it back into the lever.
5. Using a small flat-head screwdriver, push in the locking tab on the side of the shift knob button, and gently wiggle it away from the knob.

- Be careful not to lose the spring.
- The tab may break while being removed.
- If the shift knob button is broken, remove it and make sure there is no debris left inside.
- If the shift knob is broken and the spring is gone, install a new spring.

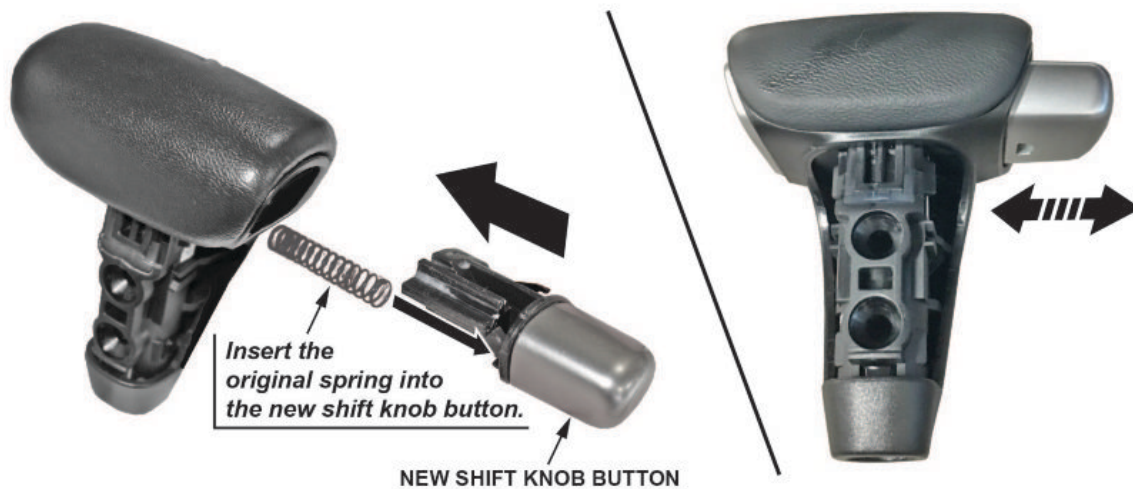
6. Insert the spring into the shift knob button, and slide in the new shift knob button until it clicks into place.

7. Press the shift knob button several times to make sure it works smoothly and returns to its original position.
8. Press the shift knob button half way in, and install the knob onto the shift lever assembly.
9. Install two new flat-head screws, and torque them to **2.5 N·m (22.1 lb-in)**.
10. Install the shift knob cover.
11. Make sure that the lever works normally and you can select every gear.
