**19PBA**

Safety Recall - Mekra Lang Side Mirror Adhesion Issue

Peterbilt Motors Company has determined that a defect, which relates to motor vehicle safety, may exist in certain model year 2020 Model 567 and 579 vehicles manufactured between 2/15/2019 and 3/15/2019.

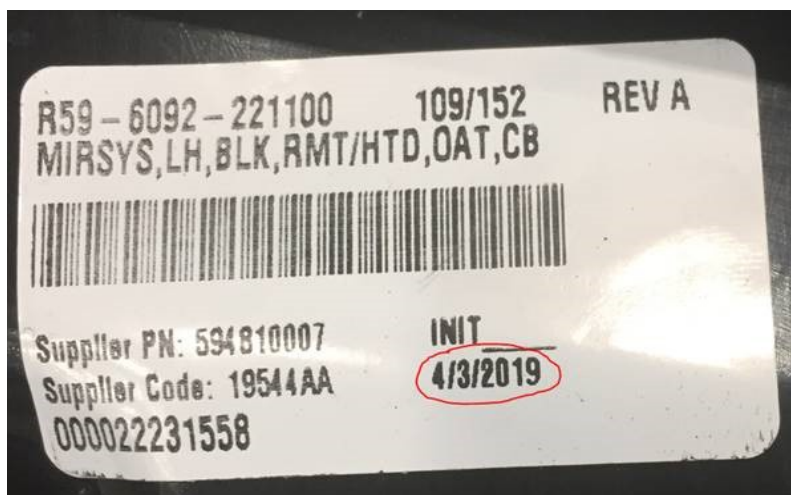
1. Refer to the [Mekra Lang Mirror Service Manual](#), section 2.2, to remove the upper mirror carrier.
2. Locate the white Mekra Lang label on the back of the mirror carrier and note the manufacture date.
  - Mirror manufacture date before 2/14/2019 or after 2/28/2019, no mirror replacement required.
  - Mirror manufacture date from 2/14/2019 through 2/28/2019, replace the defective mirror carrier with a new part.

| Both mirrors must be inspected. Mirror manufacture dates may not be the same on both sides. | |

3. Reassemble the side mirror.
4. Repeat the process for the other side mirror.
