Replace LH Front Drive Unit Clevis Mount and Both Front Halfshafts

| Classification | Repair Bulletin | Section/Group | 39 - Front Drive Unit | Country/Region | All |
| Year | 2014 - 2019 | Model | Model S, Model X | Version | Dual Motor |

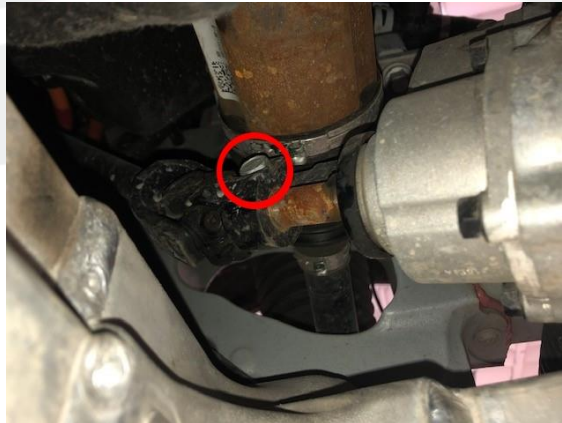
Figure 1

9. If equipped, remove the HEPA filter inlet duct (refer to Service Manual procedure 18105001).
10. If equipped, remove the HEPA filter outlet duct (refer to Service Manual procedure 18105202).
11. Disconnect 12V power (refer to Service Manual procedure 17010200).
12. If equipped, remove the HEPA filter housing (refer to Service Manual procedure 18100202).
13. Remove the front skidplate (refer to Service Manual procedure 30011002).
14. Drain the front gearbox fluid (refer to Service Manual procedure 39300102).
15. Remove the bolt that attaches the lower intermediate shaft to the steering rack (torque 30 Nm) (Figure 1), and then slide the shaft off the steering rack.

36. Position the LH and RH front wheels on the vehicle, and then loosely install the lug nuts.
37. Position the lower intermediate shaft on the steering rack, and then install the bolt that attaches the shaft to the steering rack (torque 30 Nm) (Figure 1).

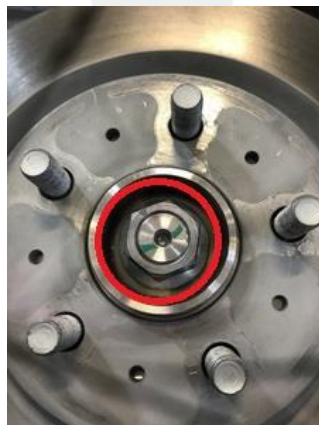
Figure 2

16. Remove the RH front wheel.
17. Remove the nut and discard the washer that attaches the RH halfshaft to the RH front hub assembly (Figure 2).

NOTE: The washer must be discarded and replaced with a new washer. The nut may be reused.

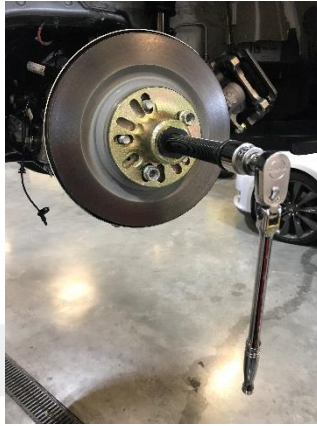
Figure 3

18. Install a hub puller on the RH front hub assembly, and then free the halfshaft from the hub splines (Figure 3).

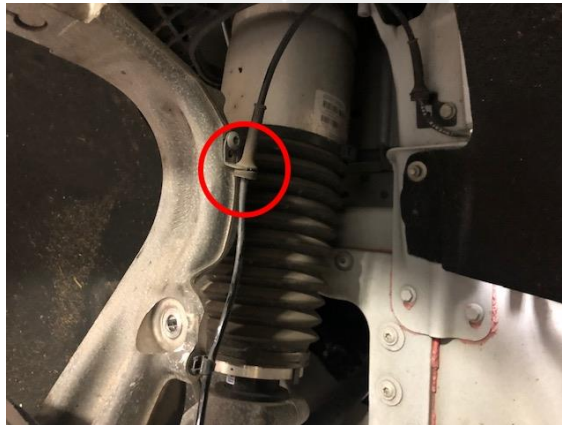
Figure 4

19. Release the grommet that attaches the RH wheel speed sensor to the RH front knuckle (Figure 4).

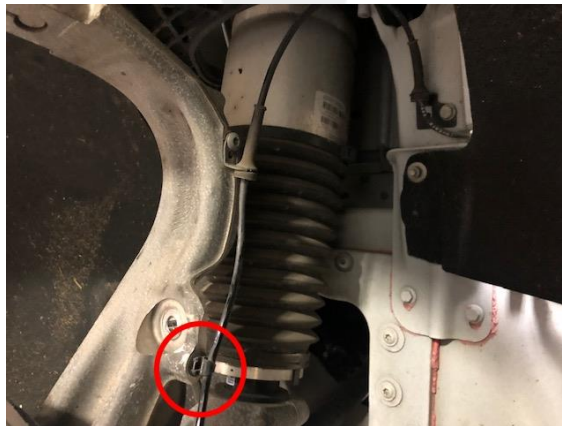
Figure 5

20. Release the clip that attaches the RH wheel speed sensor to the RH front knuckle (Figure 5).

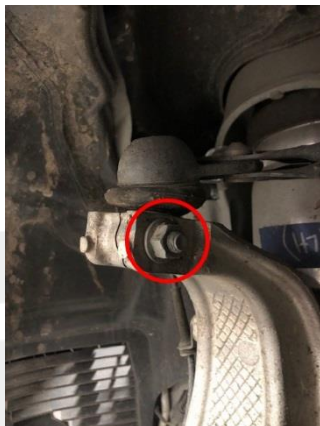
Figure 6

21. Remove the bolt and discard the nut that attaches the RH front knuckle to the RH front upper control arm (torque 60 Nm) (Figure 6).

NOTE: The nut must be discarded and replaced with a new nut. The bolt may be reused.

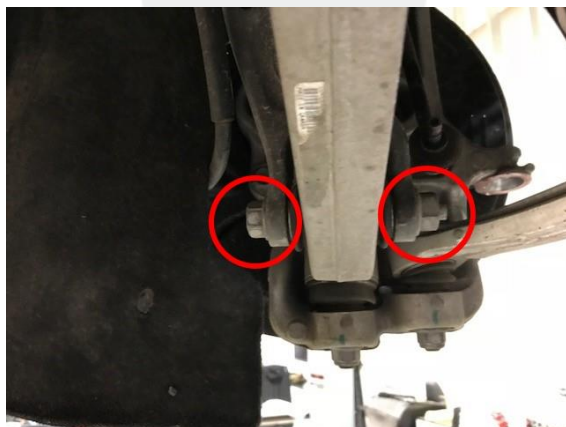
Figure 7

22. Remove the bolt and nut that attach the RH front shock absorber to the RH front lower aft link (torque 140 Nm) (Figure 7).

NOTE: When performing step 22, only loosely install the bolt and nut that attach the LH front shock absorber to the LH front lower aft link (Figure 7).

NOTE: When performing step 22, only loosely install the bolt and nut that attach the RH front shock absorber to the RH front lower aft link (Figure 7).

51. Set the vehicle to Standard height (**air suspension only**).
52. Move the vehicle to a 4 post lift and chock the wheels.
53. Tighten the bolts and nuts that attach the LH and RH front shock absorbers to the LH and RH front lower aft links (torque 140 Nm) (Figure 7), and then mark each nut with a paint pen.

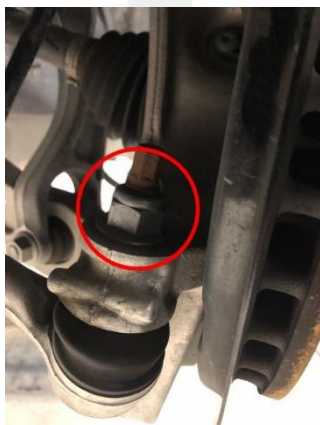
Figure 8

23. Remove and discard the nut that attaches the RH tie rod end to the RH front knuckle (torque 103 Nm), and then swing the tie rod end away from the knuckle (Figure 8).

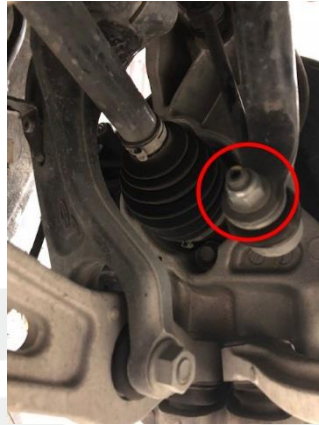
Figure 9

24. Remove and discard the nut that attaches the stabilizer bar to the stabilizer bar end link (torque 70 Nm), and then swing the end link away from the stabilizer bar (Figure 9).

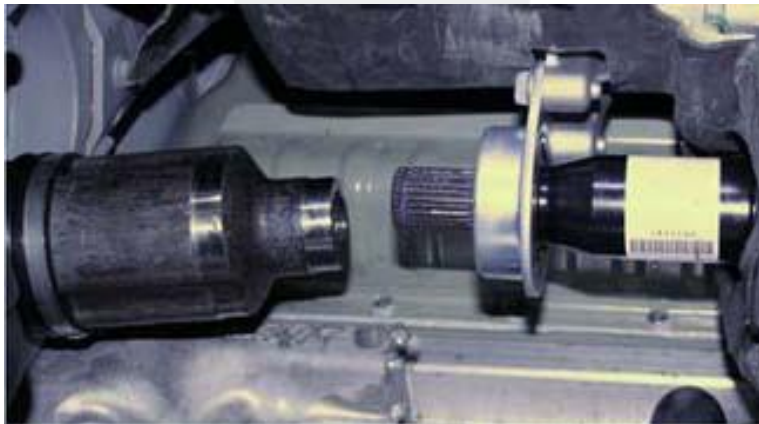
Figure 10

25. Remove the RH front halfshaft from the RH front hub assembly.
26. Use the cable axle remover to remove the RH front halfshaft from the RH front jackshaft (Figure 10).

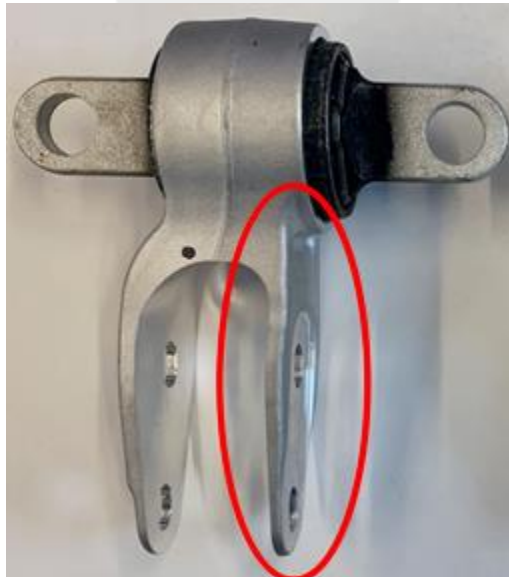
Figure 14

NOTE: The flat side of the clevis mount (Figure 14, circled) faces the rear of the vehicle.
