June 1, 2019

Version 1

Warranty Extension: White Diamond Pearl Paint

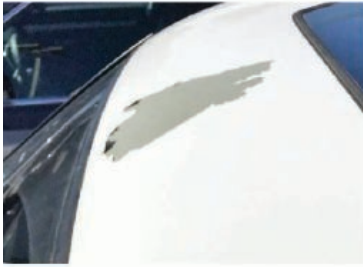
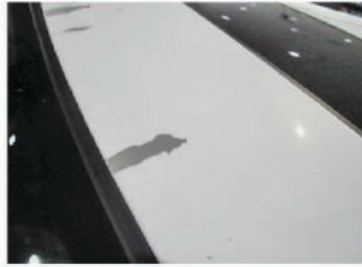
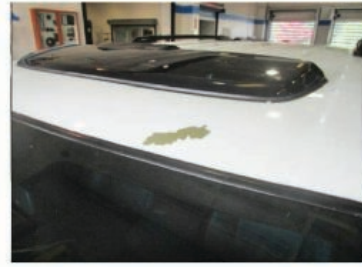
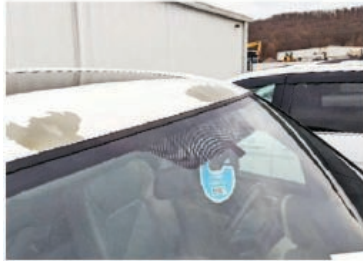
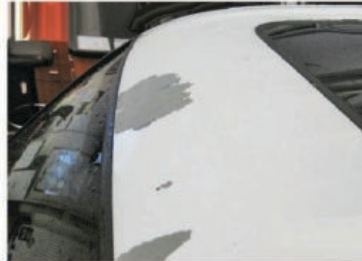
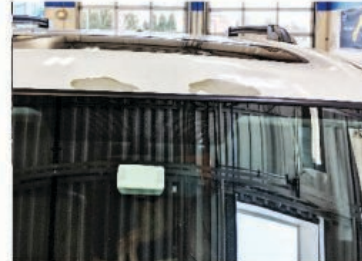
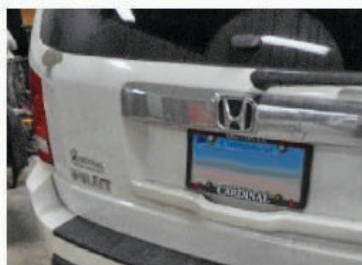
The exterior paint on the roof and/or tailgate may peel off. American Honda is extending the warranty on the paint of the affected vehicles to 7 years from the original date of purchase with no mileage limit. This warranty extension does not apply to other paint issues like rock chips, scratches, bird droppings, sap, etc.

3. Inspect the roof and tailgate areas for damage.
 - If the paint on the vehicle appears similar to the images below, go to REPAIR PROCEDURE.
 - If the paint looks different from the images below, the damage is not covered because it may be caused by sap, bird droppings, stone chips, etc. This bulletin does not apply.

Inspect the vehicle and, if necessary, have a ProFirst Certified Body Shop repaint the entire affected panel(s) with a tri-coat color, mid (mica) , and clear coat paint after obtaining DPSM approval.

1. Make sure you have DPSM authorization to repaint the vehicle.
2. Using iN/SIS instructions, remove vehicle components as required to insure proper paint adhesion and coverage of all affected areas:
 - 2.1. **Roof** - remove the following as needed: the windshield, roof rails, moldings, and XM Antenna which requires carefully dropping the roof liner to access the antenna nut. If the vehicle is equipped with a moonroof, it does not need to be removed. Open it and tape off the open area.
 - 2.2. **Tailgate** - remove the following as needed: lid lights, emblems, license plate trim, spoiler, high mount brake light, and glass. If needed, the entire tailgate may be removed from the vehicle.
