SERVICE BULLETIN

Classification: EL17-030b	Reference: NTB18-036b	Date: May 30, 2019
------------------------------	--------------------------	-----------------------

2015-2017 MURANO; BACK DOOR WARNING CHIME OPERATES CONSTANTLY WITH IGNITION ON

APPLIED VEHICLES: 2015-2017 Murano (Z52)
2016 Murano Hybrid (Z52)

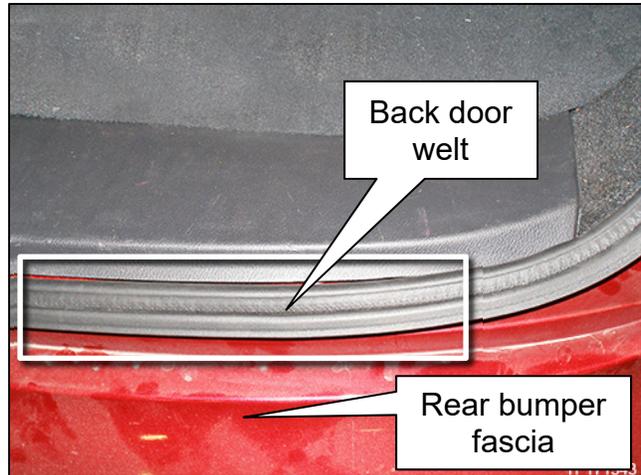
Figure 1

1. Open the back door to access the back door welt.
2. Remove the back door welt from the area shown in Figure 1.

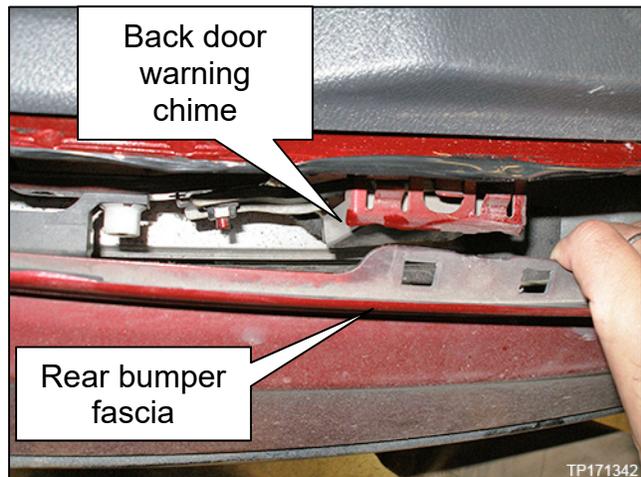
Figure 2

3. To unclip the rear bumper fascia, carefully pull the rear bumper fascia away from the body.
4. Locate the back door warning chime.

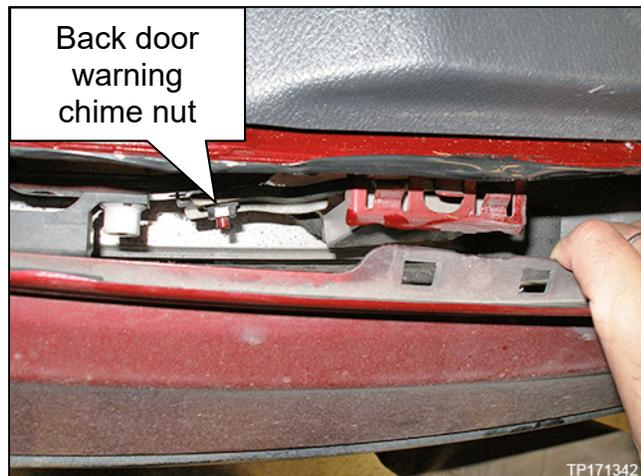
Figure 3

5. Remove the back door warning chime nut.

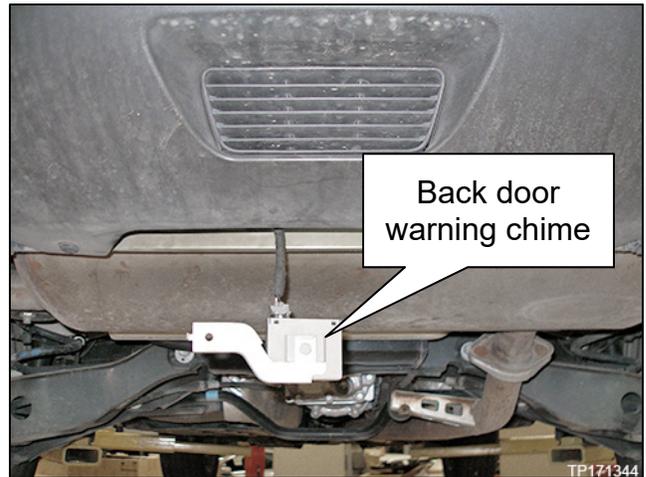
Figure 4

6. Lower the back door warning chime between the muffler and the rear bumper fascia.

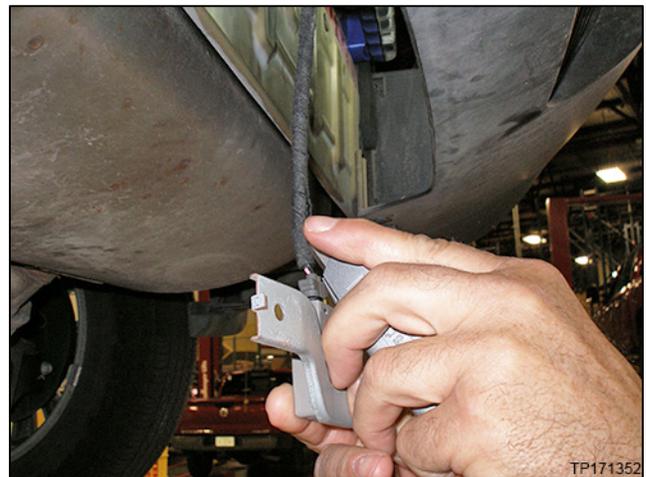
Figure 5

7. Remove about 4 inches of the felt tape from the back door warning chime harness.

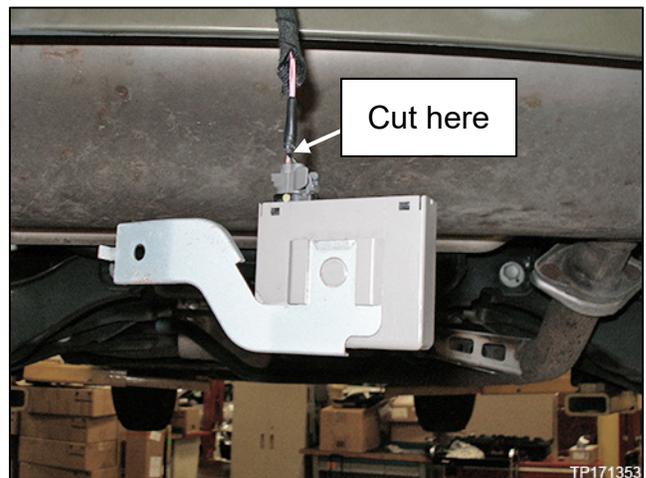
Figure 6

8. Cut the harness at the back door warning chime connector.

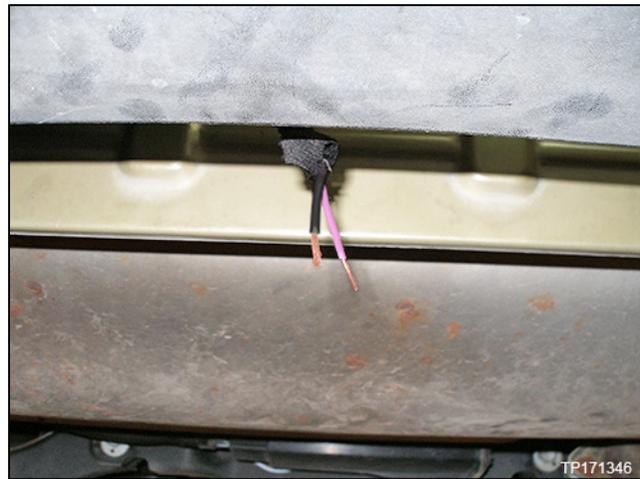
Figure 7

9. Strip the insulation from the vehicle side harness as shown in Figure 7.

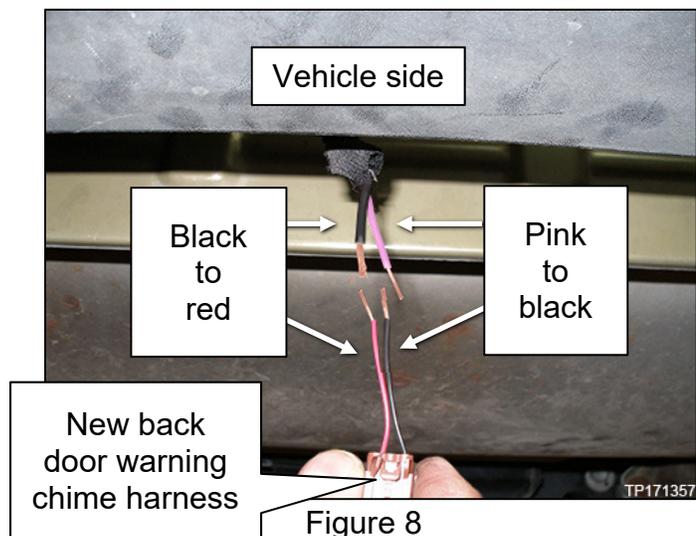
Figure 8

10. Align the new back door warning chime harness.

Wire connections:

<u>Vehicle Wire</u>		<u>Harness Wire</u>
Pink	→	Black
Black	→	Red

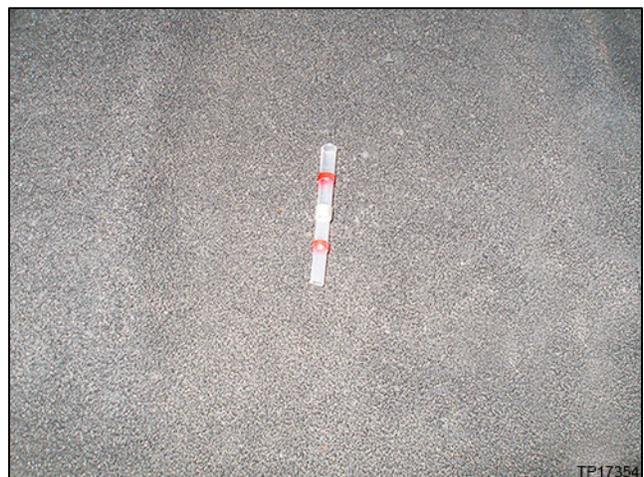
Figure 9

11. Install the solder sleeve connectors.
 - Solder sleeve connectors are included in the kit listed in the **PARTS INFORMATION** section of this bulletin.

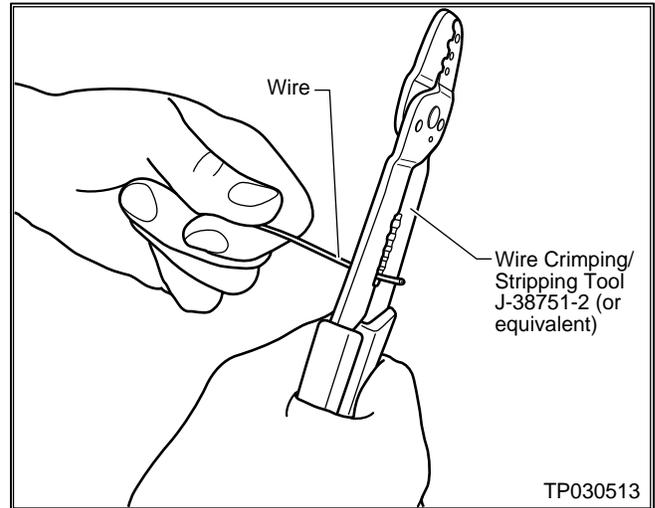
Figure 10

- Strip about 10 mm of insulation from the ends of the wires.

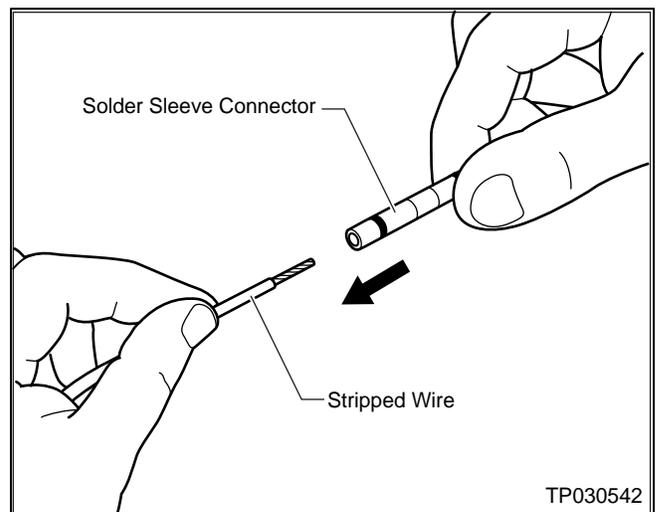
Figure 11

- Slide a solder sleeve connector over the wire.

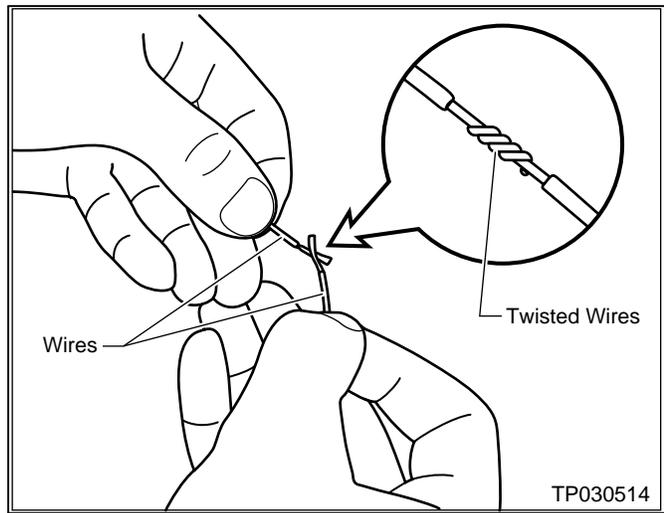
Figure 12

14. Make sure the wires are securely twisted together.

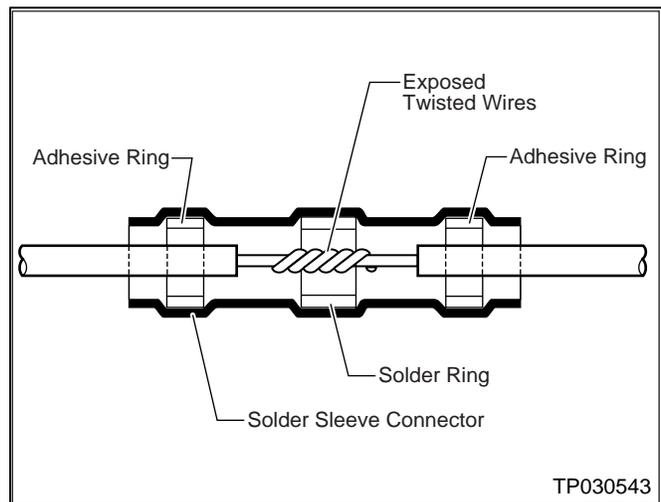
Figure 13

15. Position the solder sleeve connector so that the solder ring (in the connector) is centered around the exposed twisted wire area (see Figure 13).

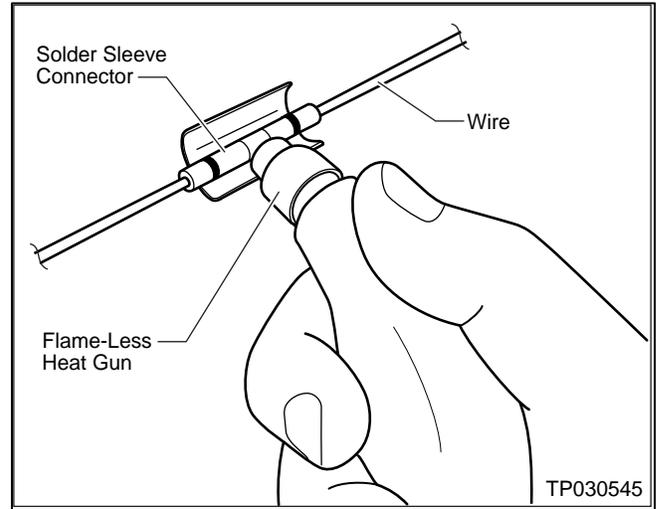
Figure 14

16. Use the special Flameless Heat Gun—J-46538 to heat the solder connector.

This operation will:

- Melt the solder (silver ring inside the solder sleeve connector) into the exposed twisted wire area.
- Melt the sealant (red rings inside the solder sleeve connector) onto the wires.
- Shrink the plastic sleeve onto the wires.

- Position the solder connector in the middle of the heat shield (of the heat gun).
- Start heating the connector from the center and move back and forth (side to side) and around to allow even distribution of the heat to the entire connector.
- Make sure the solder completely flows into the exposed twisted wires and the adhesive properly seals the wire insulation to the connector sleeve. Stop applying the heat immediately after this happens.

- Be careful not to damage the connector or wires with the heat gun:
- Do NOT apply heat for more than about 40 seconds.
- Do NOT overheat the connector or wires (i.e., severe darkening of connector sleeve or wire insulation).

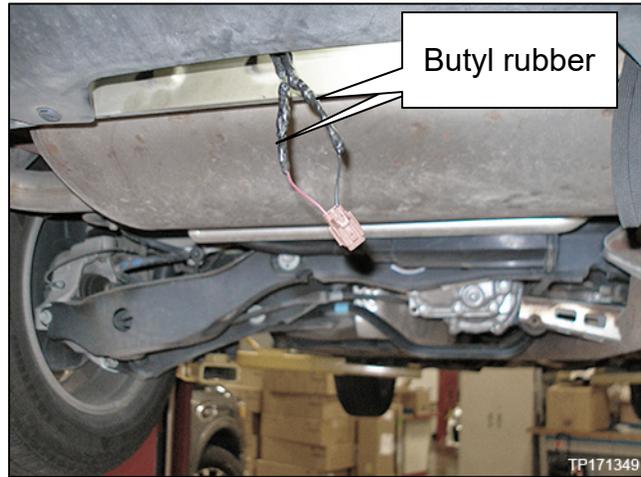
Figure 15

17. Use butyl rubber to wrap the individual solder sleeve connectors.

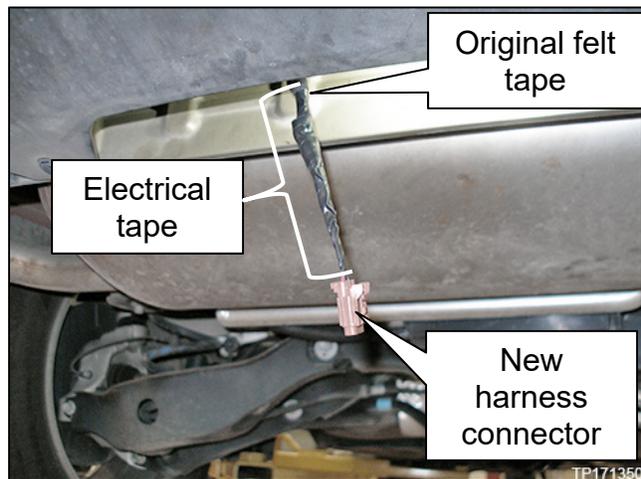
Figure 16

18. Starting at the new harness connector, use electrical tape to cover both wires and butyl rubber to just past the original felt tape.

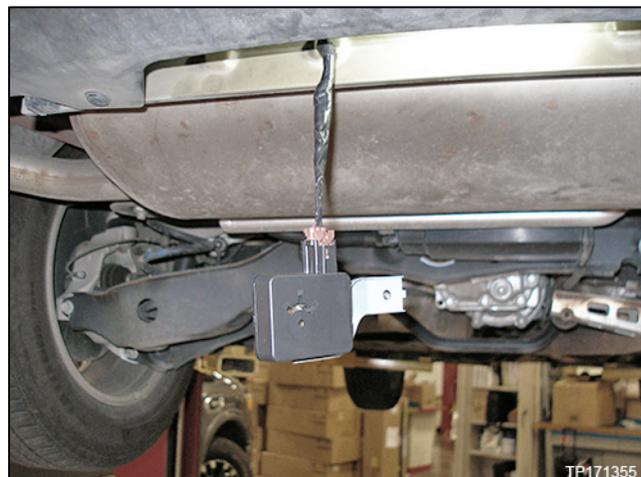
Figure 17

19. Connect the new back door warning chime harness connector to the new back door warning chime.
