SERVICE BULLETIN

Classification: BT19-006	Reference: NTB19-038	Date: May 13, 2019
-----------------------------	-------------------------	-----------------------

DEAD PEDAL REPLACEMENT

APPLIED VEHICLES: 2013 – 2019 Pathfinder (R52)
2014 Pathfinder Hybrid (R52)

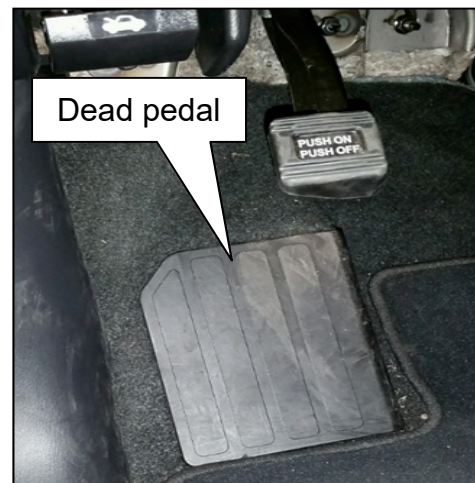
Figure 1

If the dead pedal needs to be replaced for any reason, it is no longer necessary to replace the front floor trim (carpet).

The dead pedal is now available as a service part.

NOTE: Do not replace the carpet if only the dead pedal is needed.
