Parking Brake Adjustment / Calibration Difficult or Not Possible

Vehicles Affected

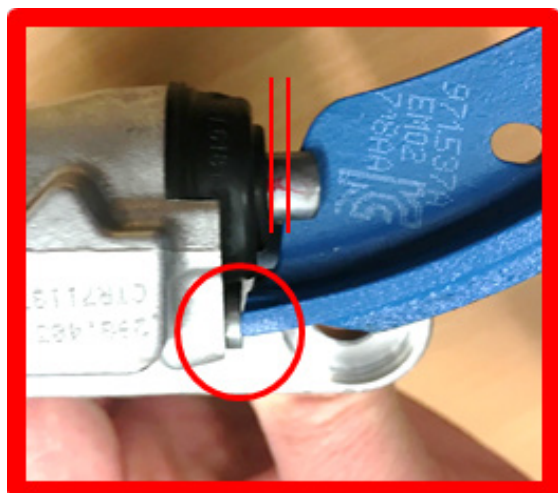
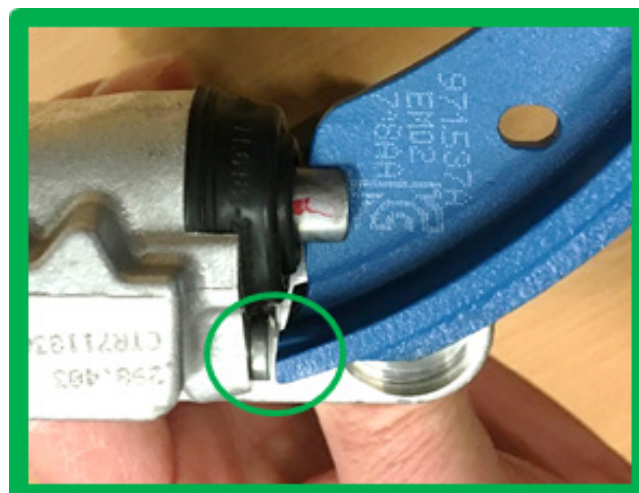
Parking brake shoes were manufactured that were too long on one end. This resulted in not enough clearance for the shoe. A visible gap will exist with the new improved shoe, as seen in the photo on the right.

Replace the parking brake shoes with new shoes, Part Number 971.698.533.C
Parts stock was purged earlier last year. All parts in stock are known good parts.

If the parking brake actuator has been damaged, replace it as well.
