LTB01287NAS2

TECHNICAL BULLETIN

Vibration Felt In Passenger Compartment When Starting and/or Idling Engine

MODEL:	MODEL YEAR:	VIN:	ASSEMBLY PLANT:	APPLICABILITY:
Range Rover Velar (LY)	2018-2019	700000-799996	Solihull	INGENIUM I4 2.0L Petrol/INGENIUM I4 2.0L Diesel
Range Rover Velar (LY)	2019 Onwards	200017 Onwards	Solihull	INGENIUM I4 2.0L Petrol/INGENIUM I4 2.0L Diesel

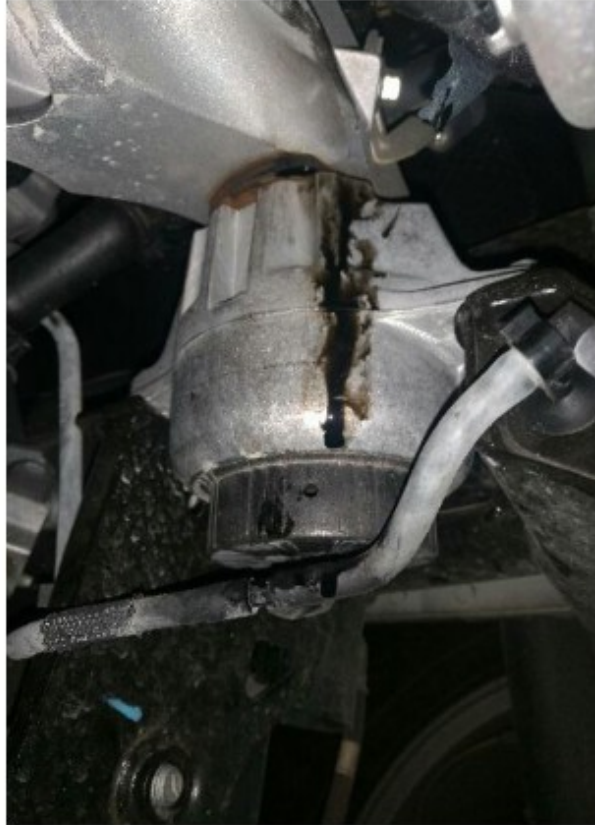
E246391

Excessively worn and/or leaking active engine mount.

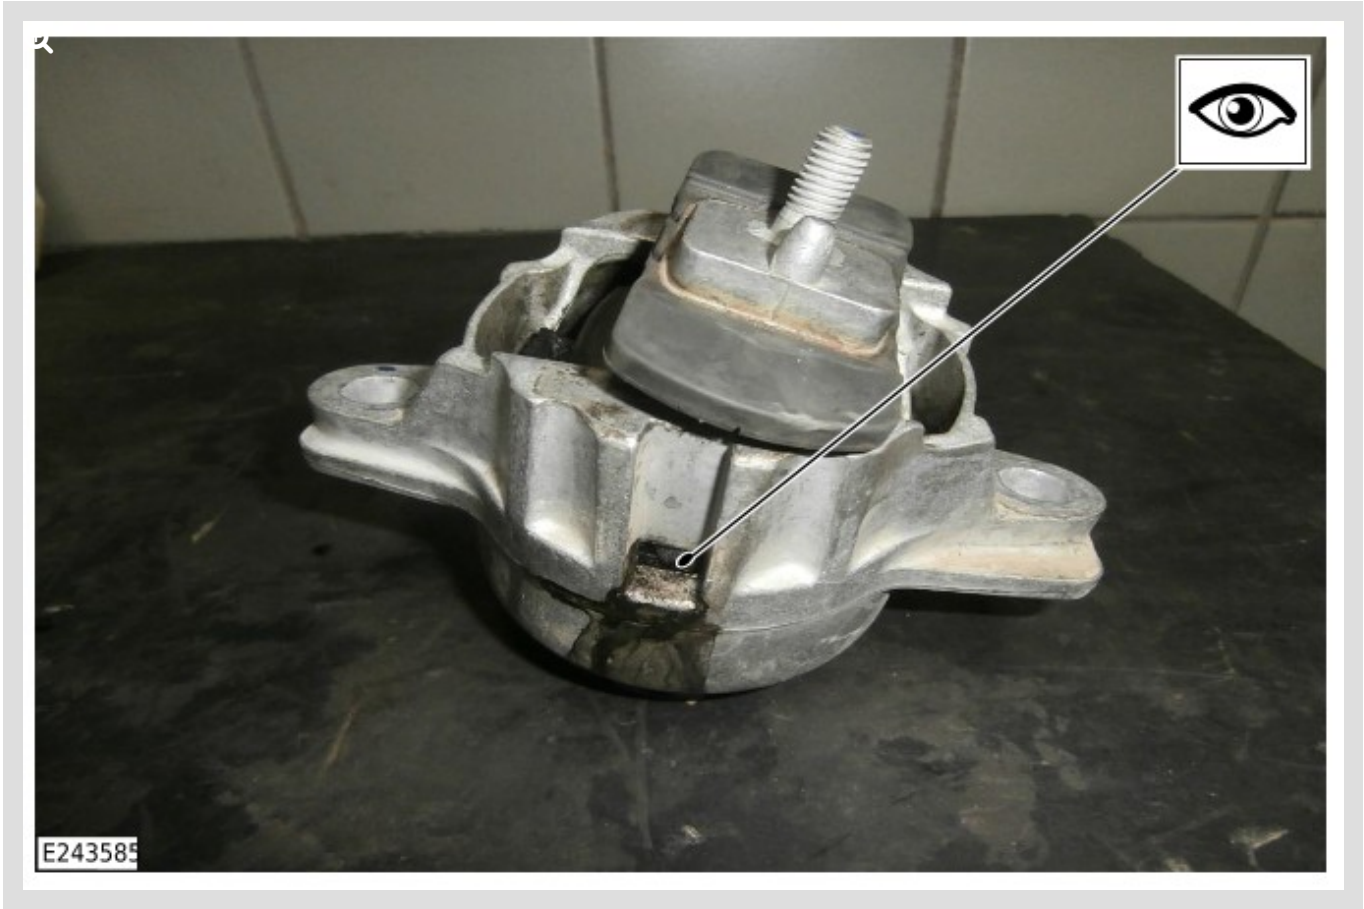
2

Excessively worn and/or leaking active engine mount.

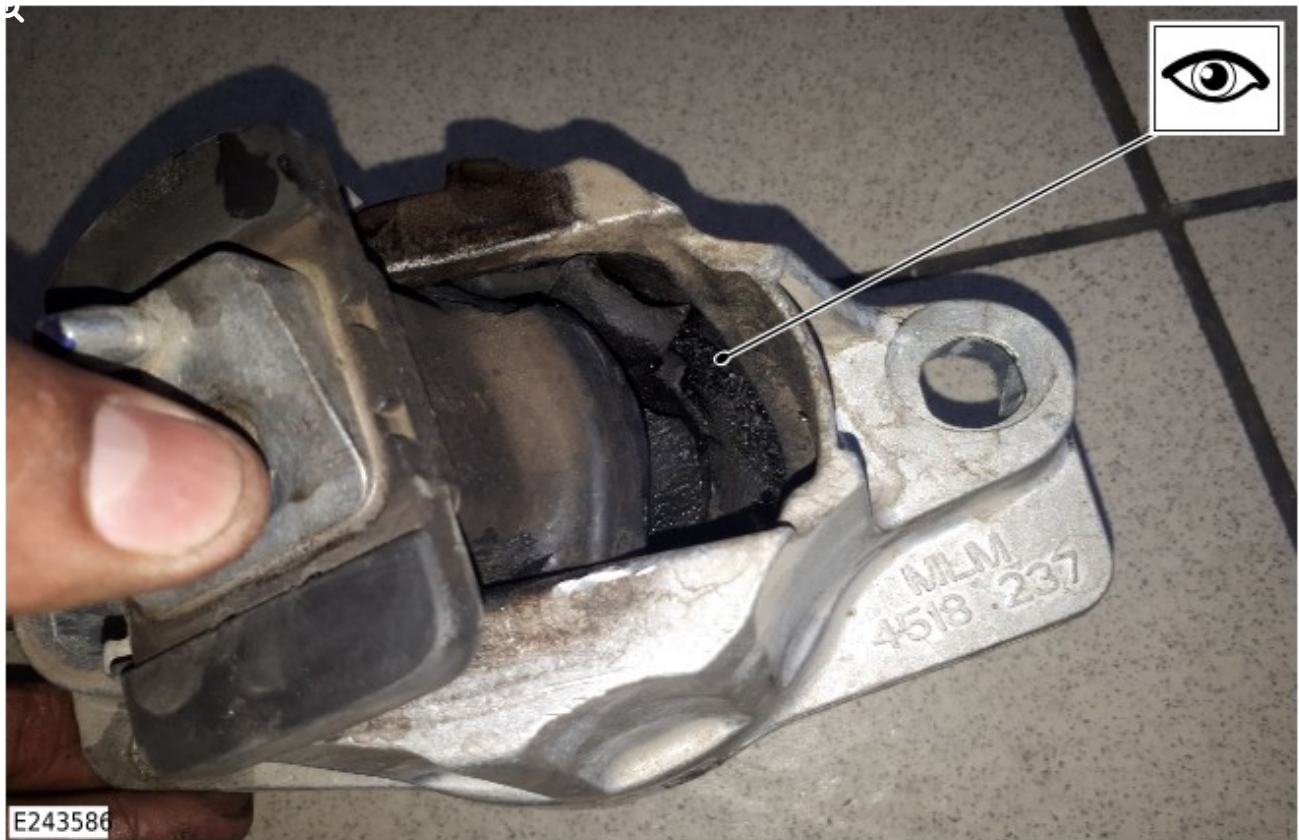
3

Excessively worn and/or leaking active engine mount.

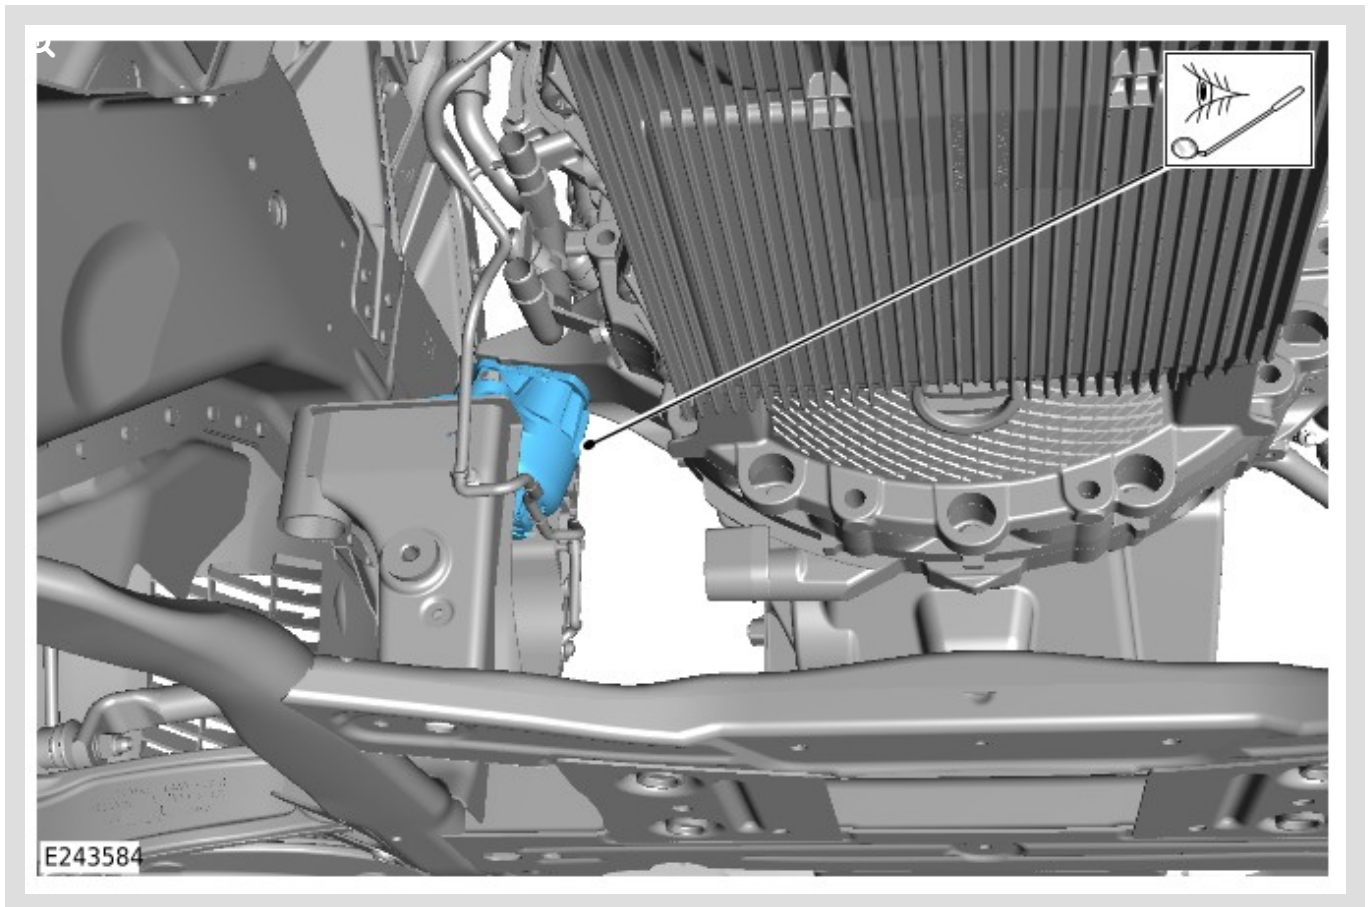
2

Inspect the left and right active engine mounts for signs of excessive wear and/or leaking fluid.

- If the left and right active engine mounts do not show signs of excessive wear and/or leaking fluid, do not continue with this Technical Bulletin. The content of this technical bulletin does not directly relate to the customer's concern.
 - Continue to diagnose the vehicle (see TOPIx Workshop Manual section 303-00: Diagnosis and Testing - Engine).
- If the left and right active engine mounts do show signs of excessive wear and/or leaking fluid, go to Step 3.

3 Renew the left and right active engine mounts (see TOPIx Workshop Manual section 303-01: Removal and Installation - Left/Right Engine mount).

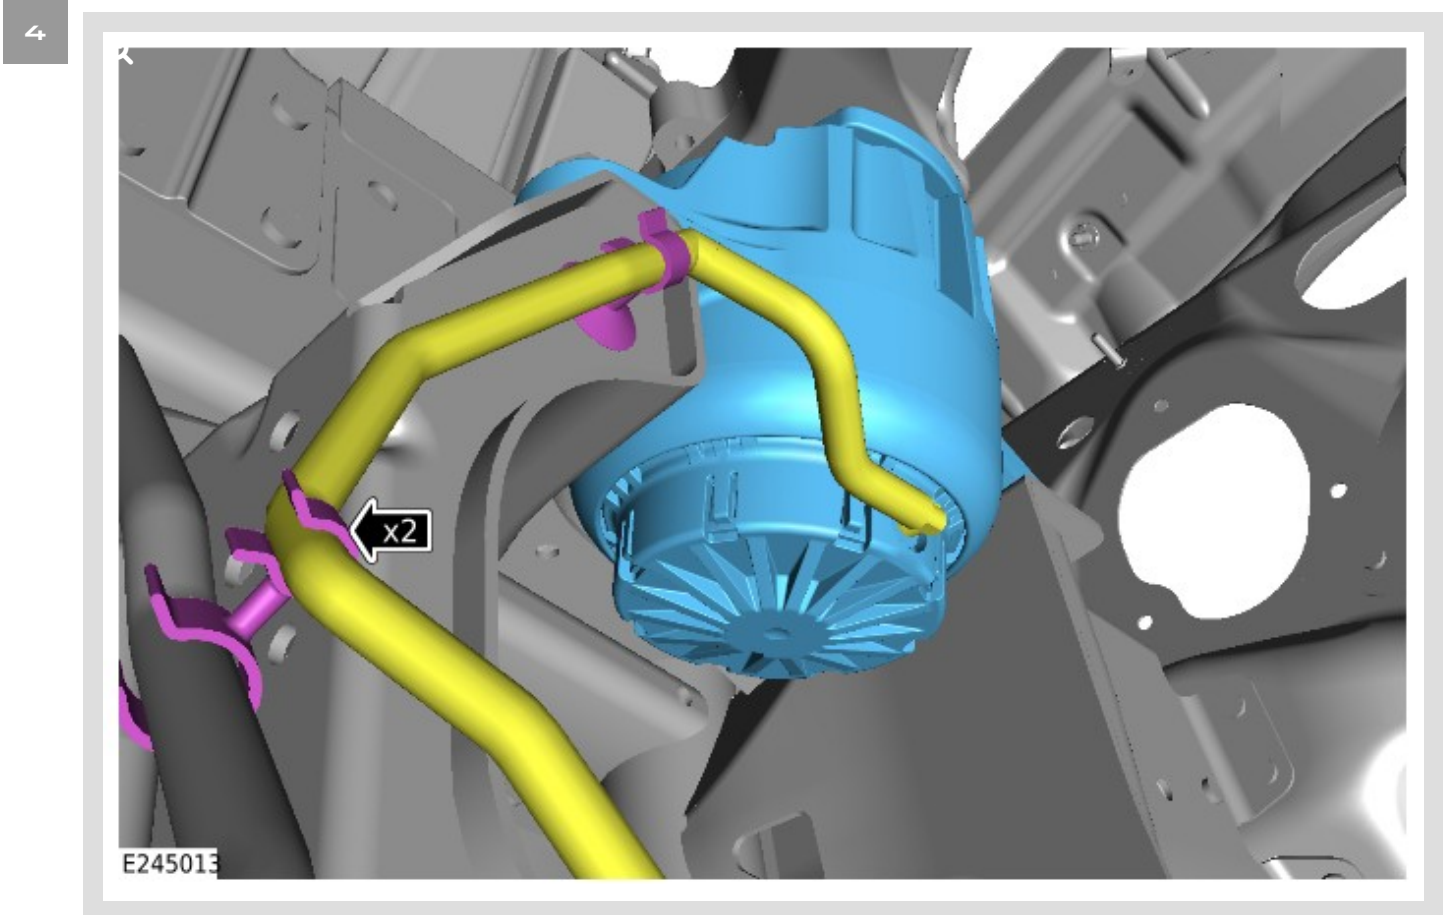
Disconnect the active engine mount vacuum hose from the fastener(s).

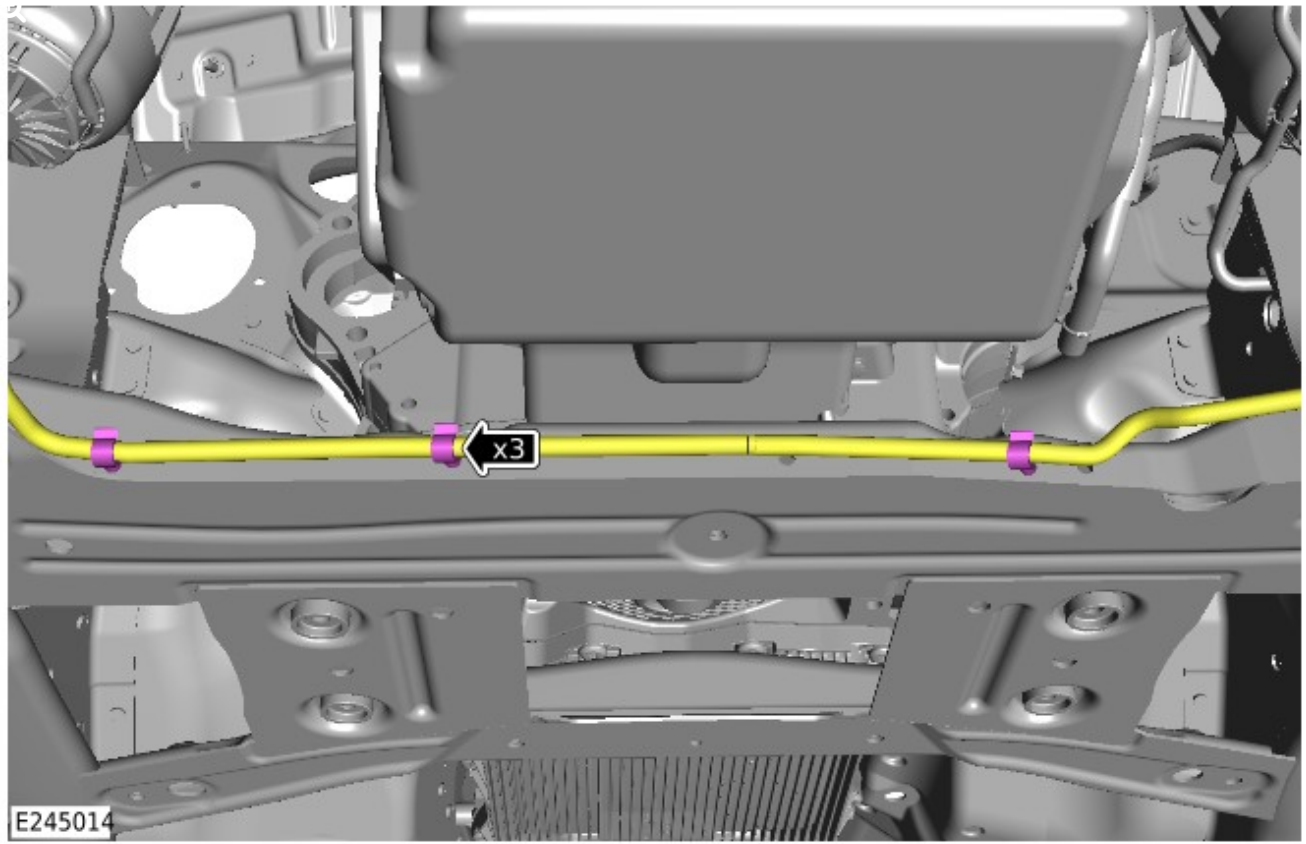
Disconnect the active engine mount vacuum hose from the fastener(s).

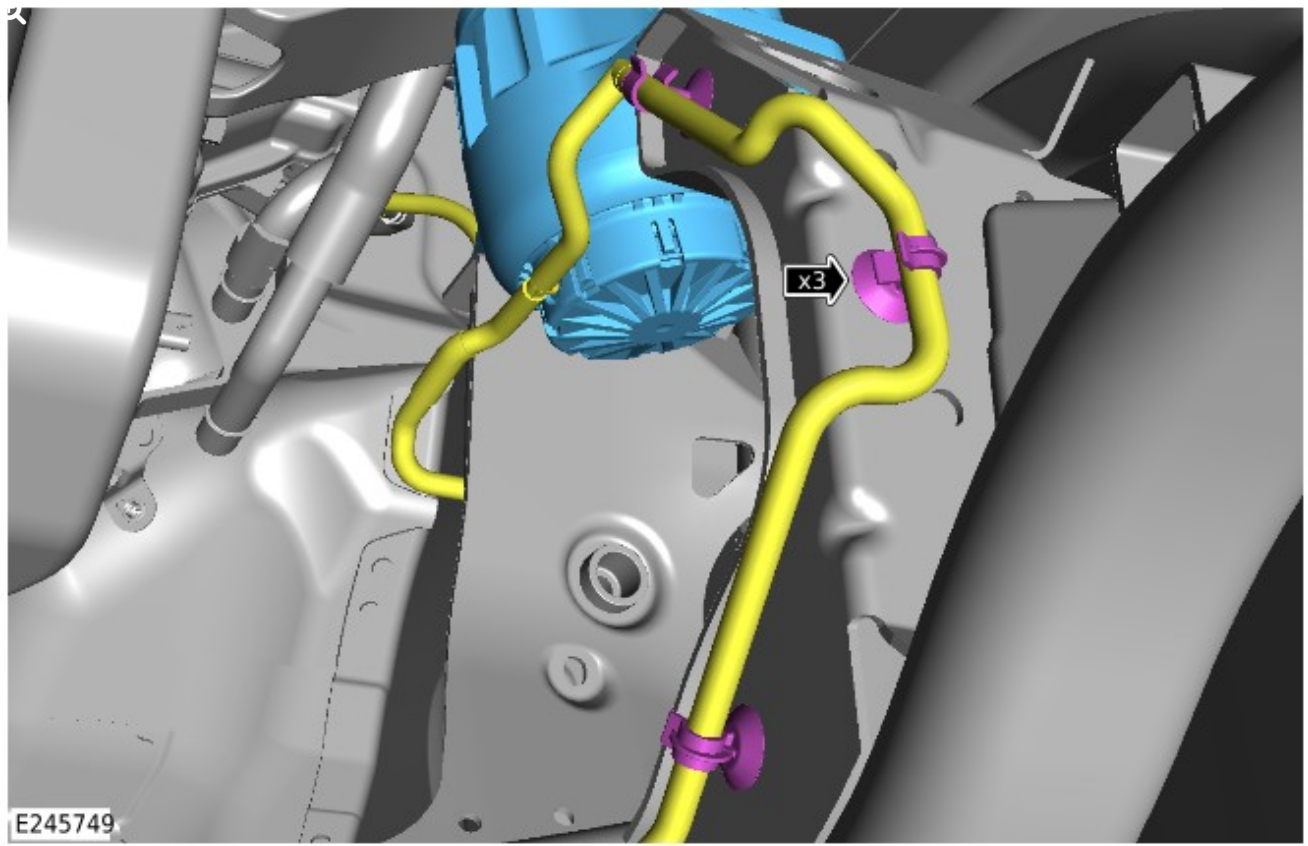
6

Disconnect the active engine mount vacuum hose from the fastener(s).

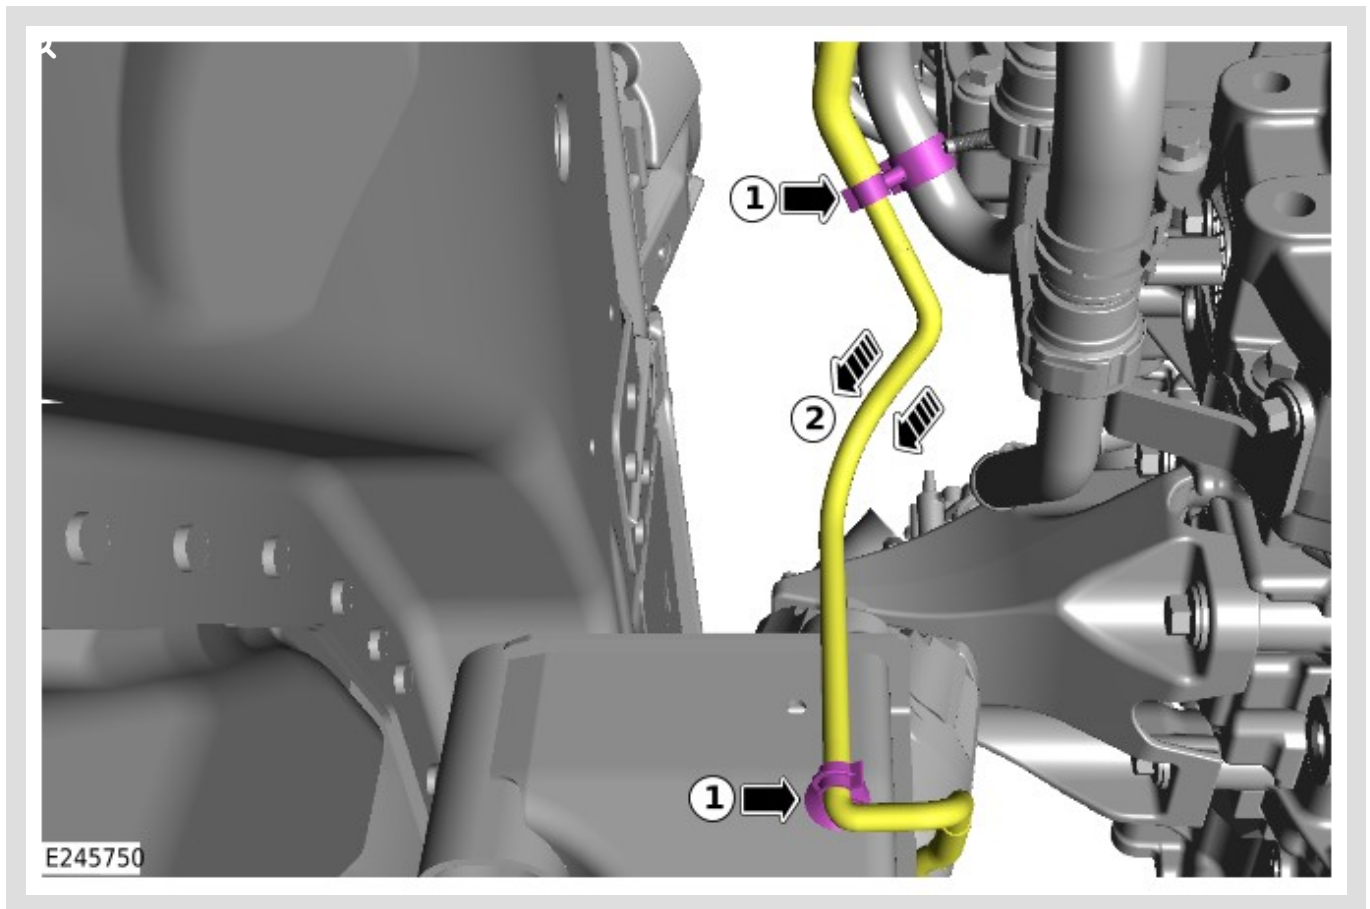
Disconnect the active engine mount vacuum hose from the fastener(s) and let the active engine mount vacuum hose reposition downward.

Do not pull on the active engine mount vacuum hose.

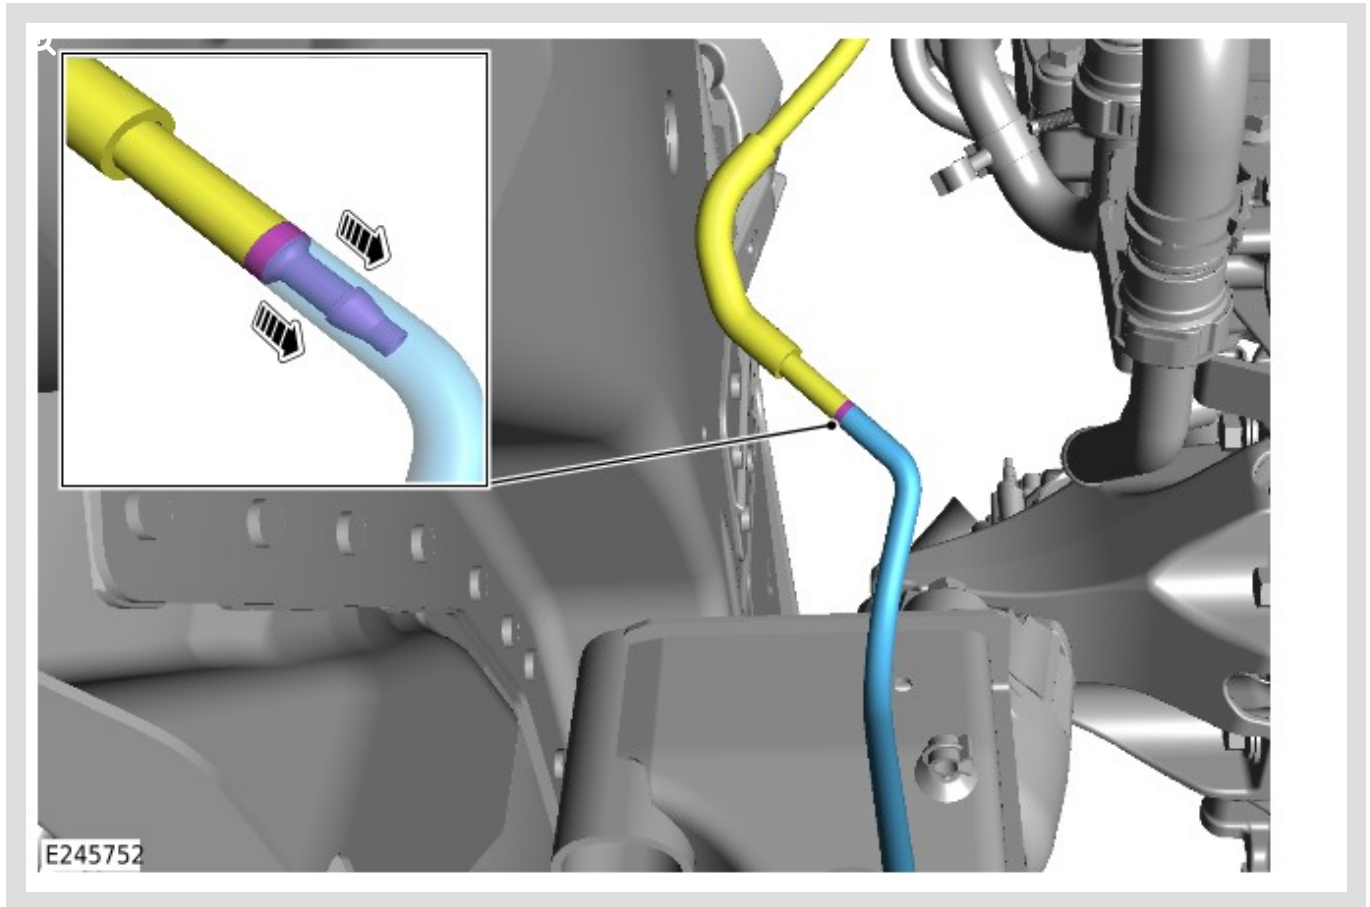
Separate the active engine mount vacuum hose at the connector shown.

- Remove the active engine mount vacuum hose from the vehicle.

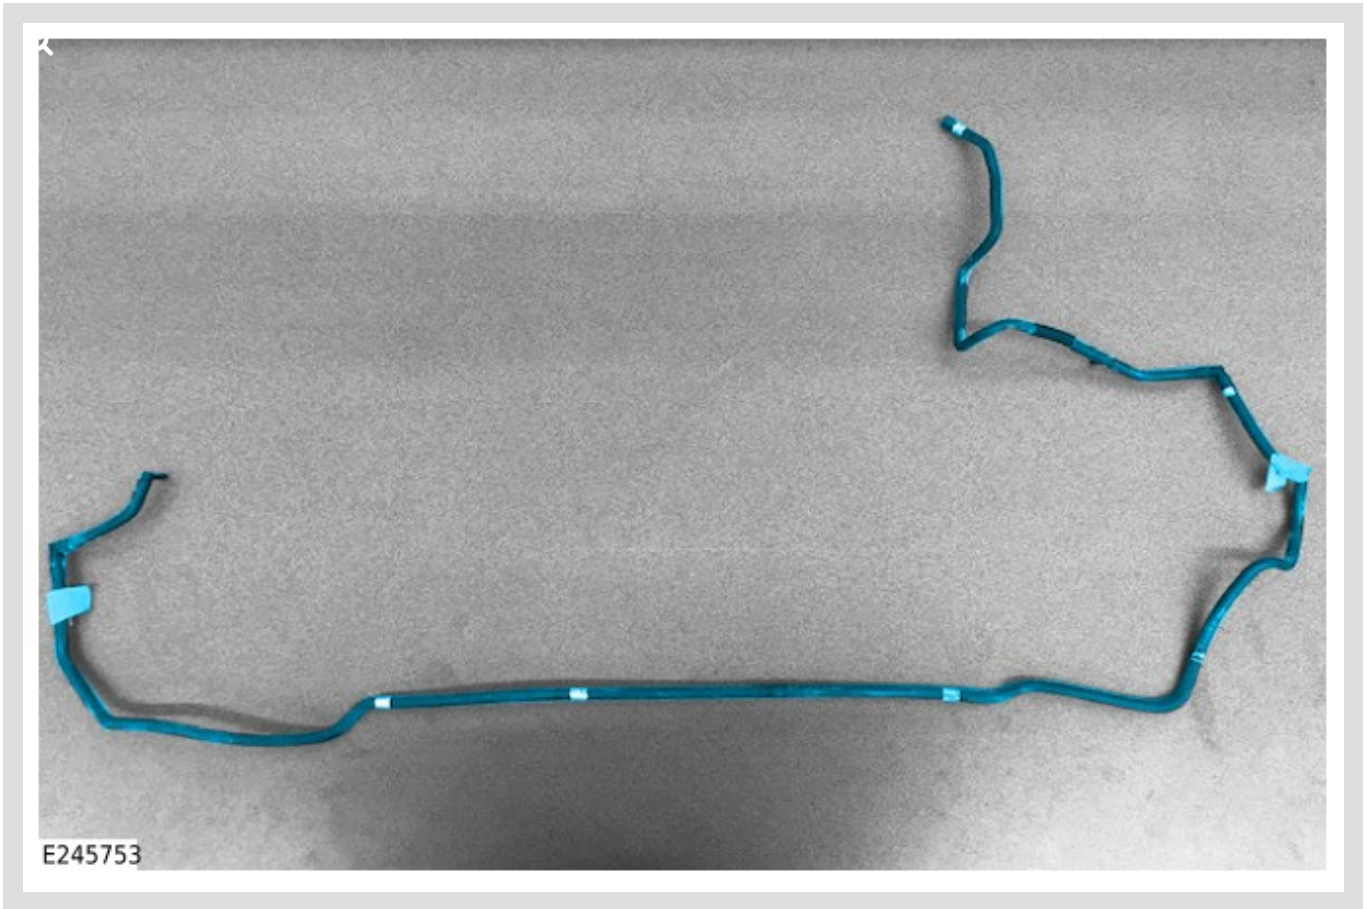
Active engine mount vacuum hose shown removed from the vehicle.

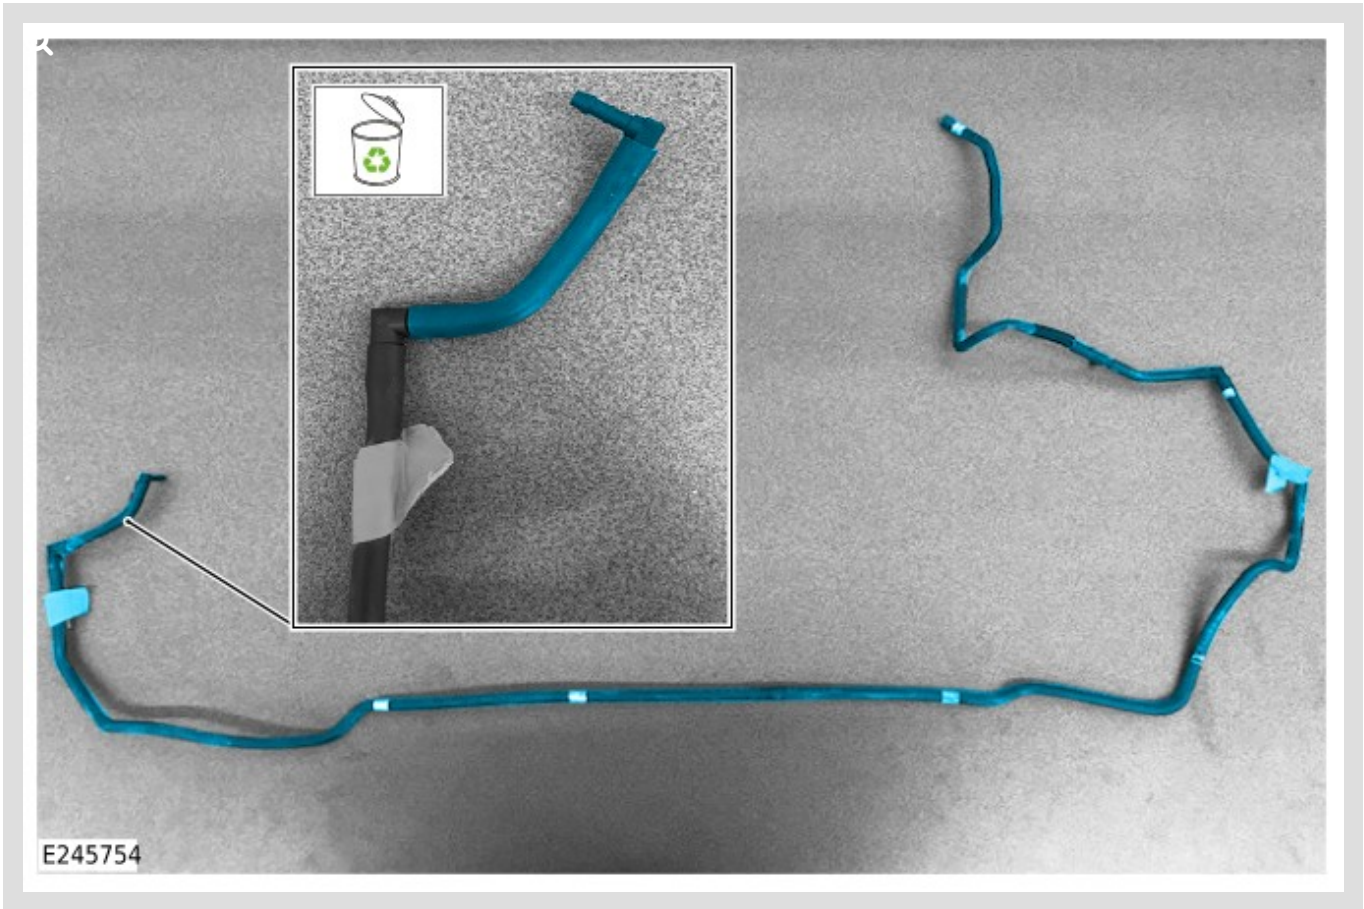
Remove and discard the section of active engine mount vacuum hose.

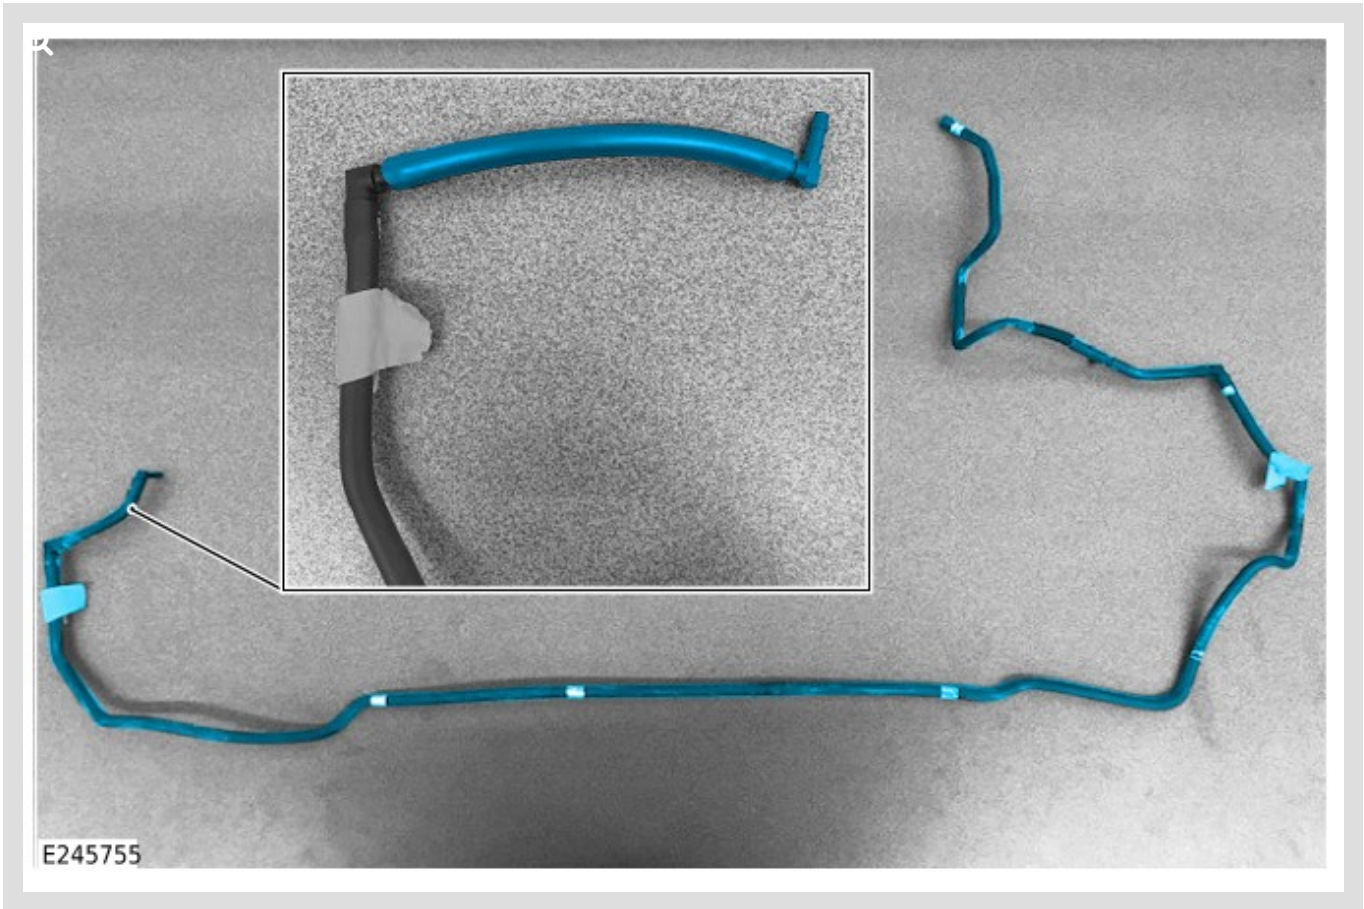
Install the section of active engine mount vacuum hose as shown.

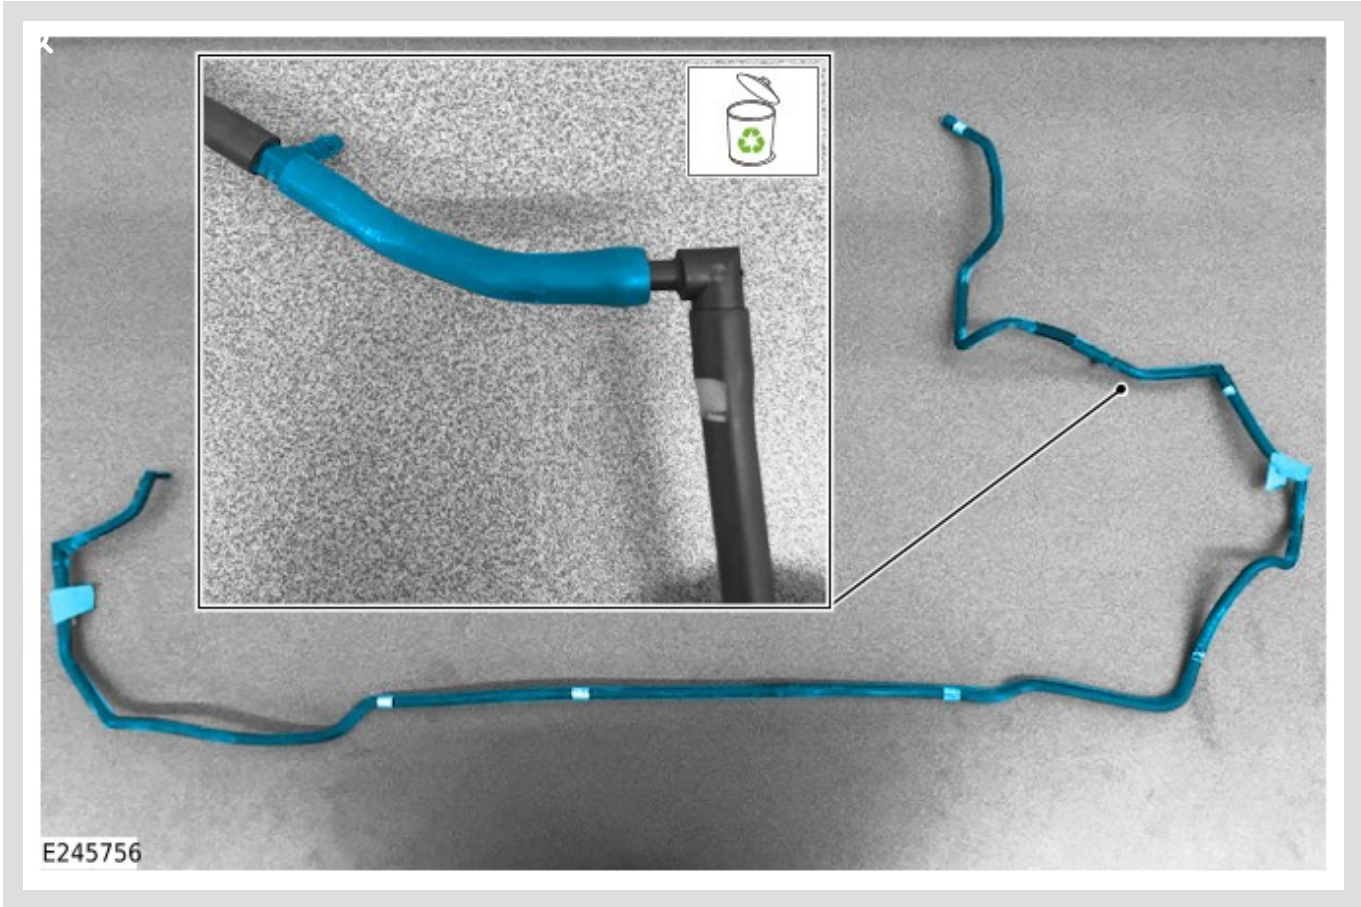
Remove and discard the section of active engine mount vacuum hose.

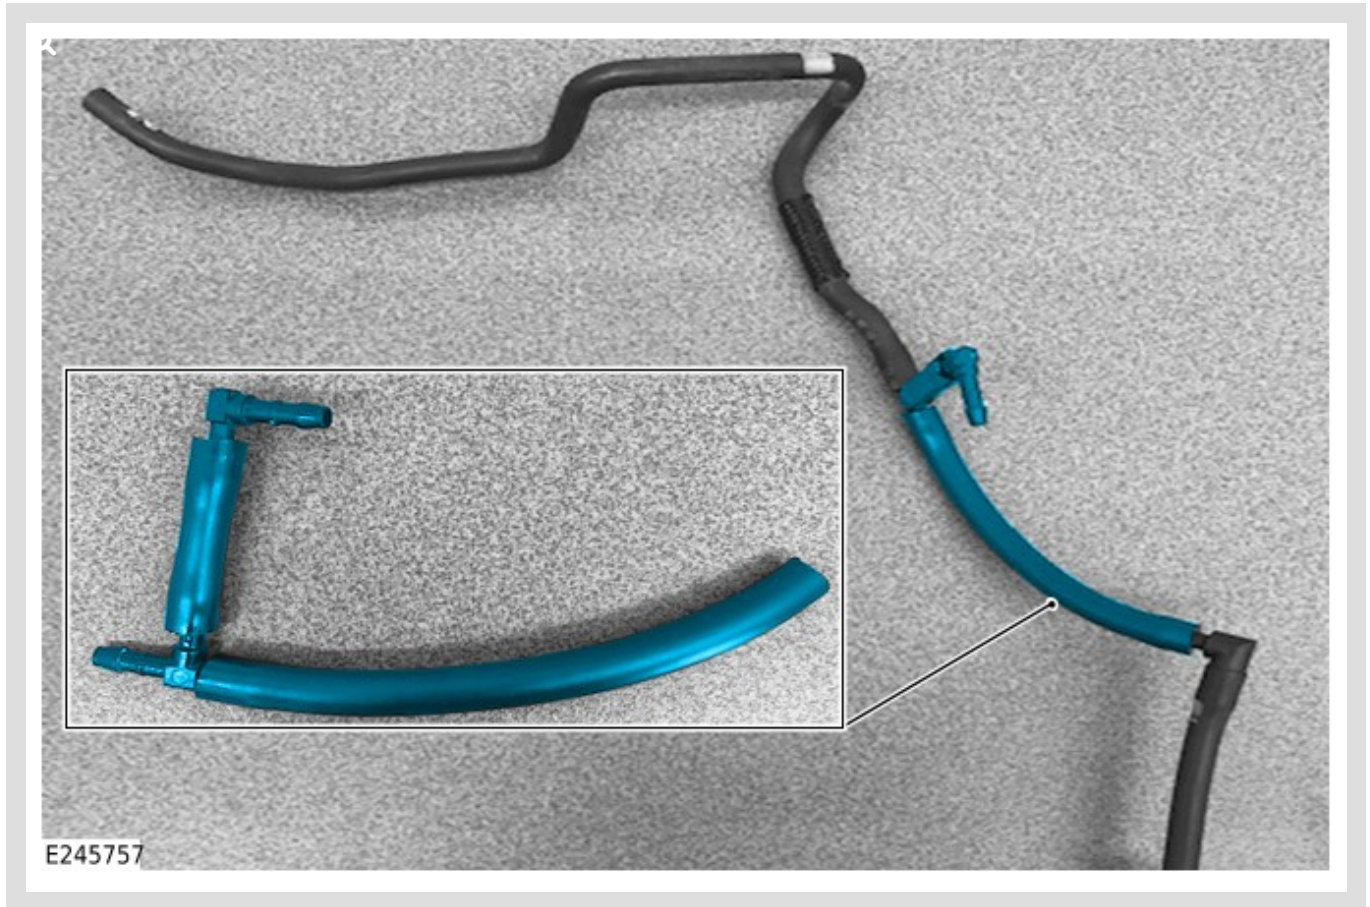
13

Install the section of active engine mount vacuum hose as shown.
