# Newmar Corporation

**TSB 544**  
**June 04, 2019**

## TECHNICAL SERVICE BULLETIN

## Shade and Valance Replacement for 2019 Bay Star 3628 (Select Coaches Only)

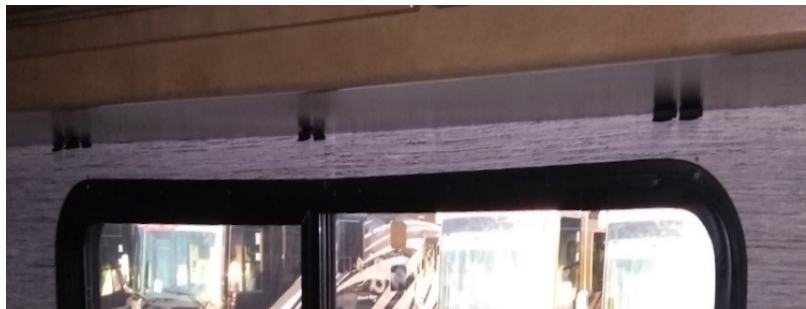
6. Install the five shade clips to the bottom overhead where marked using  $10 \times \frac{3}{4}$ " screws (part #25756).
7. Install the new shade on the clips, making sure all of the clips are securely latched in the shade.

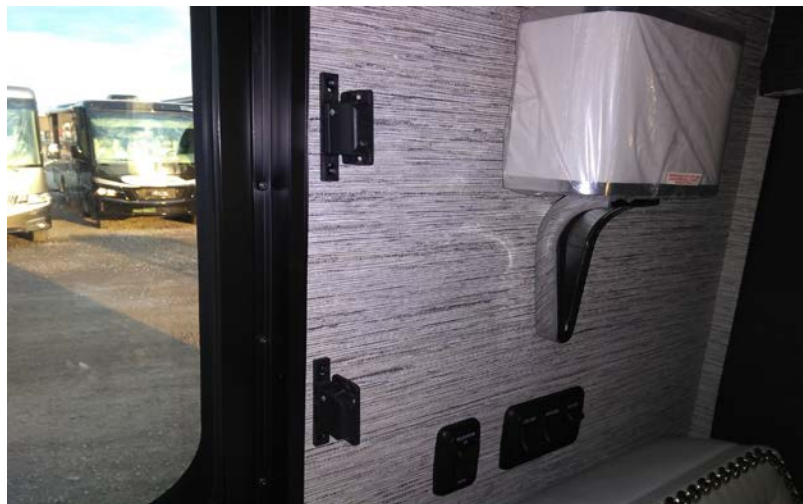
8. Place the valance, or measure and mark the wall for Friction Catch locations.

Fasten two Friction Catches per side to the sidewall using  $8 \times 1\frac{1}{2}$ " screws (part #42229).

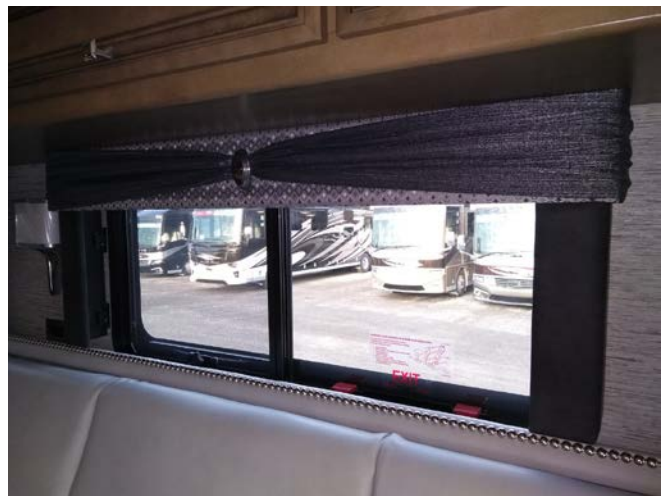
10. Take a picture of the finished shade and valance after installation, and submit it with the claim.
