Technical Service Bulletin

91 Rattling noise from the lower (HVAC) MMI screen area

91 19 66 2054163/2 June 18, 2019. Supersedes Technical Service Bulletin Group 91 number 19-49 dated March 20, 2019 for reasons listed below.

Model(s)	Year	VIN Range	Vehicle-Specific Equipment
A6	2019	000001 - 076999	Not Applicable

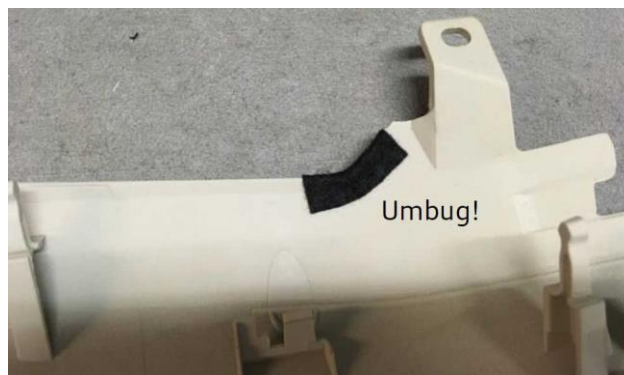
Figure 4. Apply the felt tape around the edge of the trim as shown.

2. Remove the dash trim and apply felt around the corners (Figure 2, 3 and 4).
