Safety Recall Campaign

RC-19-70-01

MODEL: 2018 Karma Revero (All)

TITLE: Front Doors Upper Intrusion Bar Recall Campaign

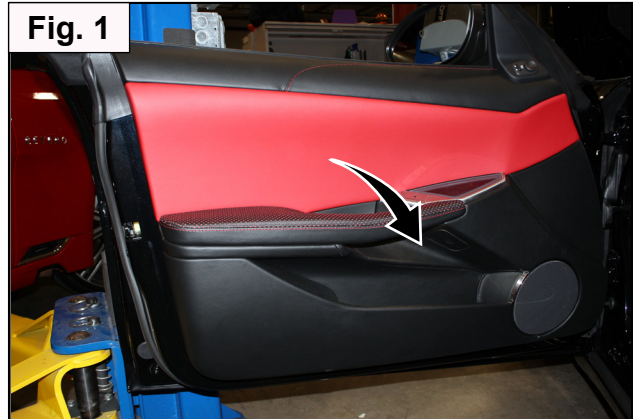
1. Remove the driver's side door panel per the information in the service manual (Fig. 1).

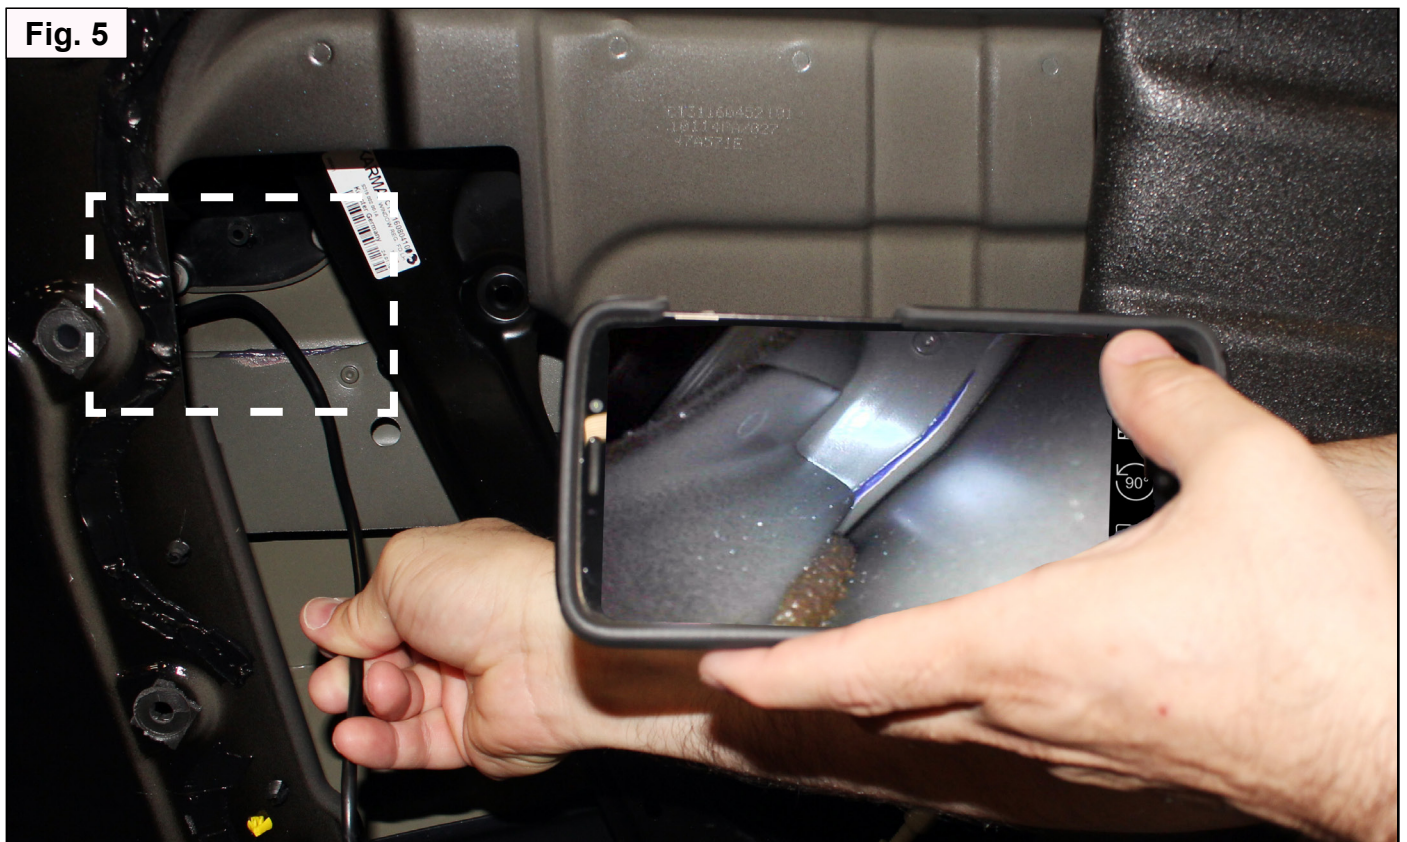
5. Insert the borescope in the space between the inner and outer door skin structures, as shown in Figure 5.

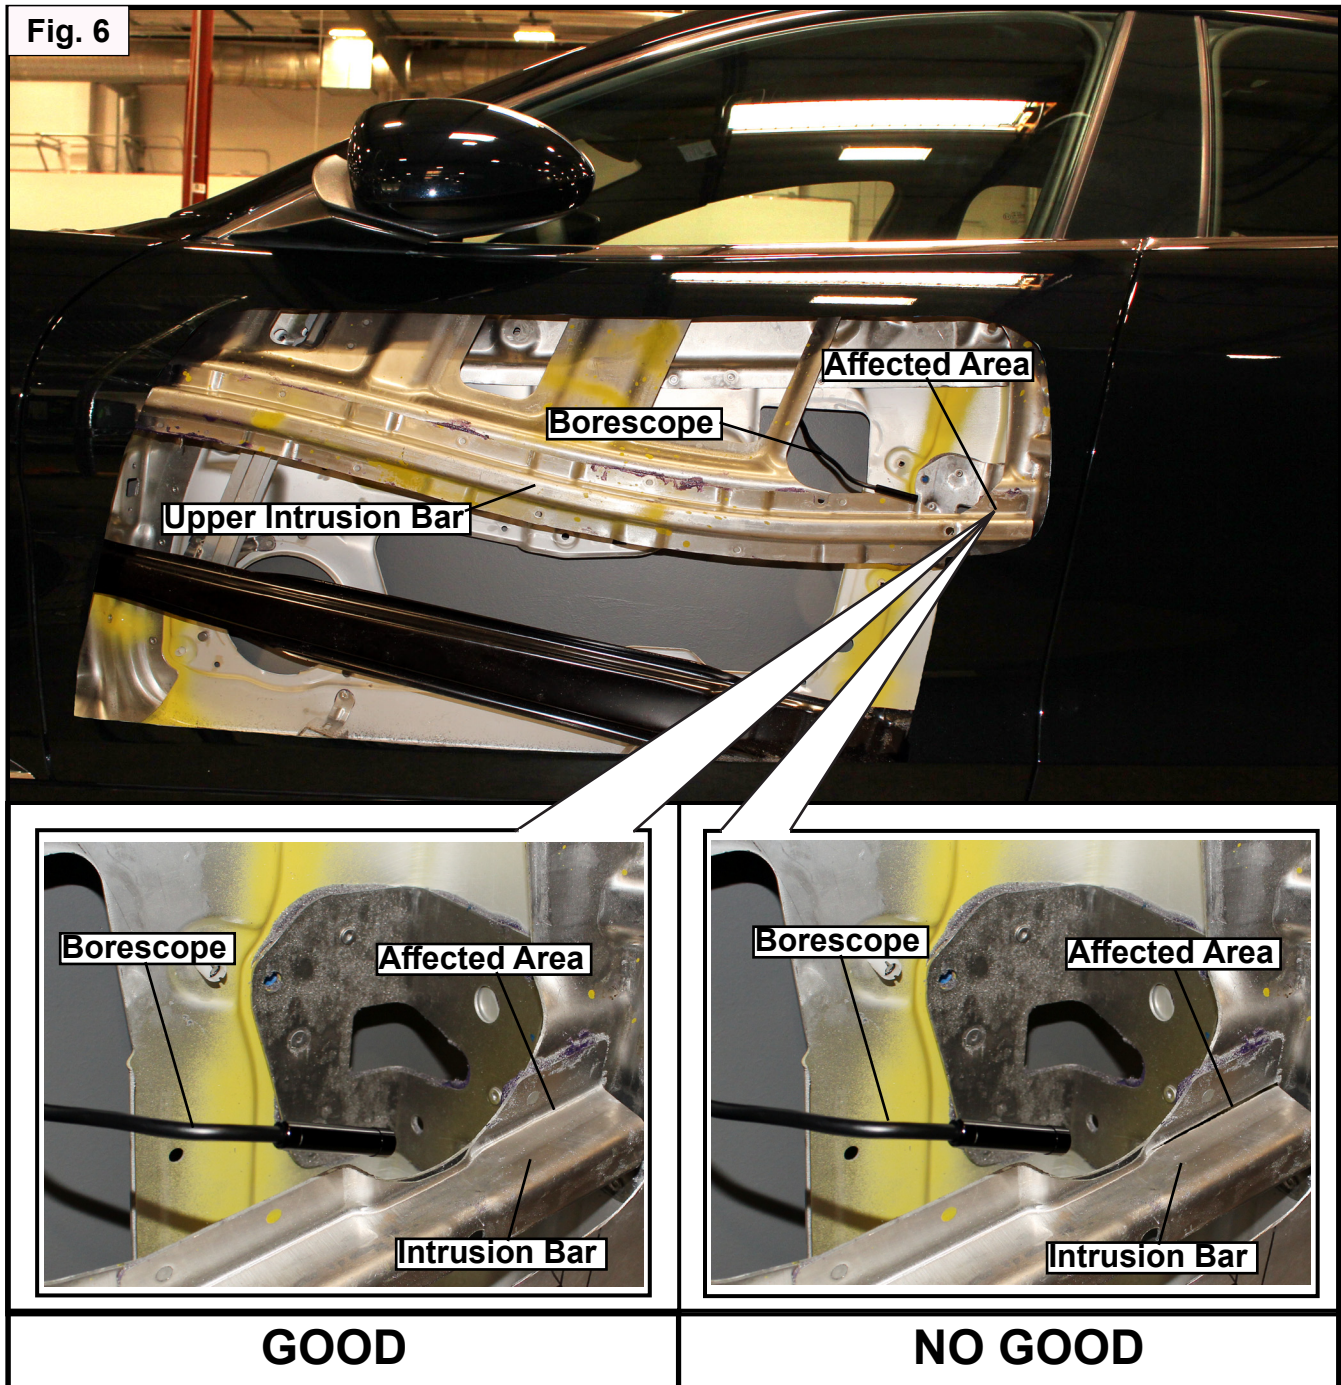
6. Refer to the images below to maneuver the borescope to the affected area on the upper intrusion bar.
